Appendix I Site Photographs

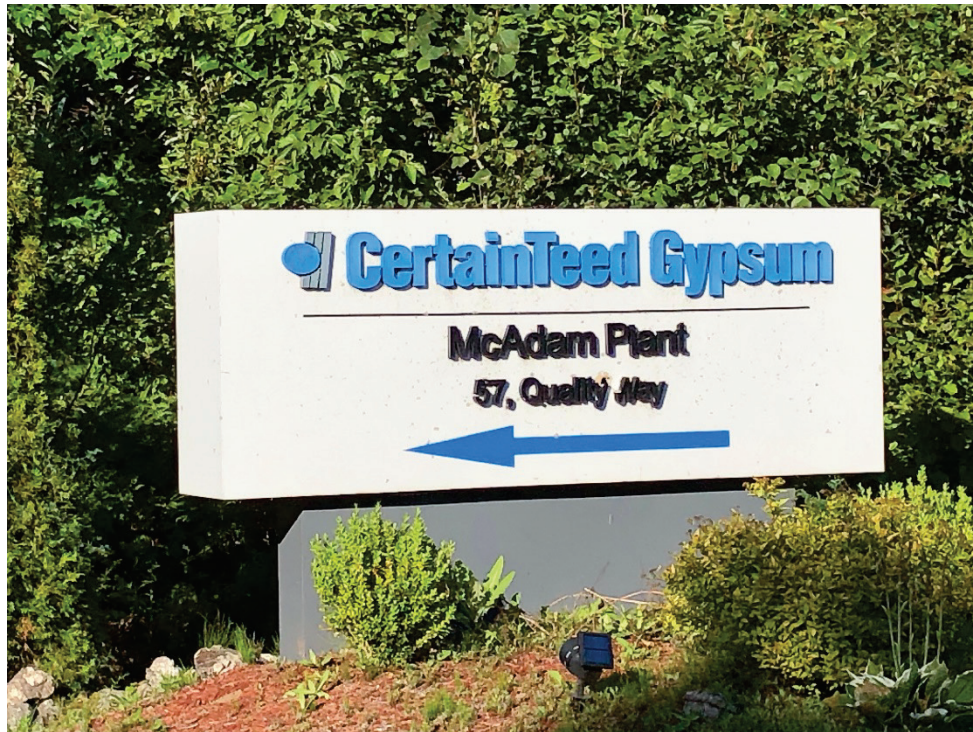
Photo 1 - View of the Site Entrance.

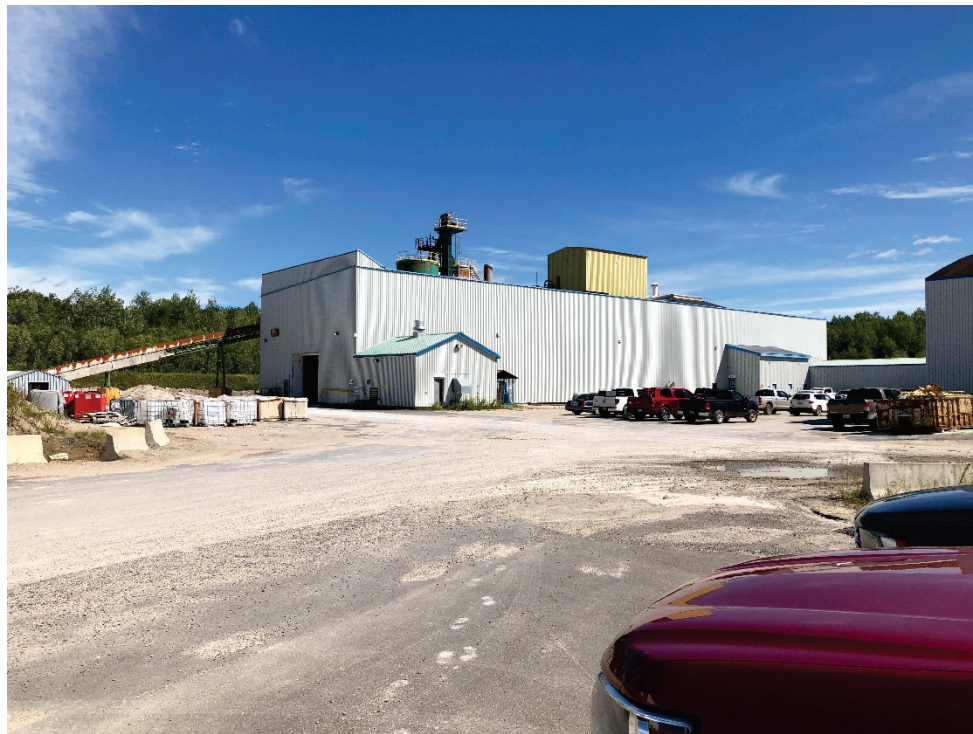
Photo 2 - View of the Site facing southeast (rock dryer and calcine tower).

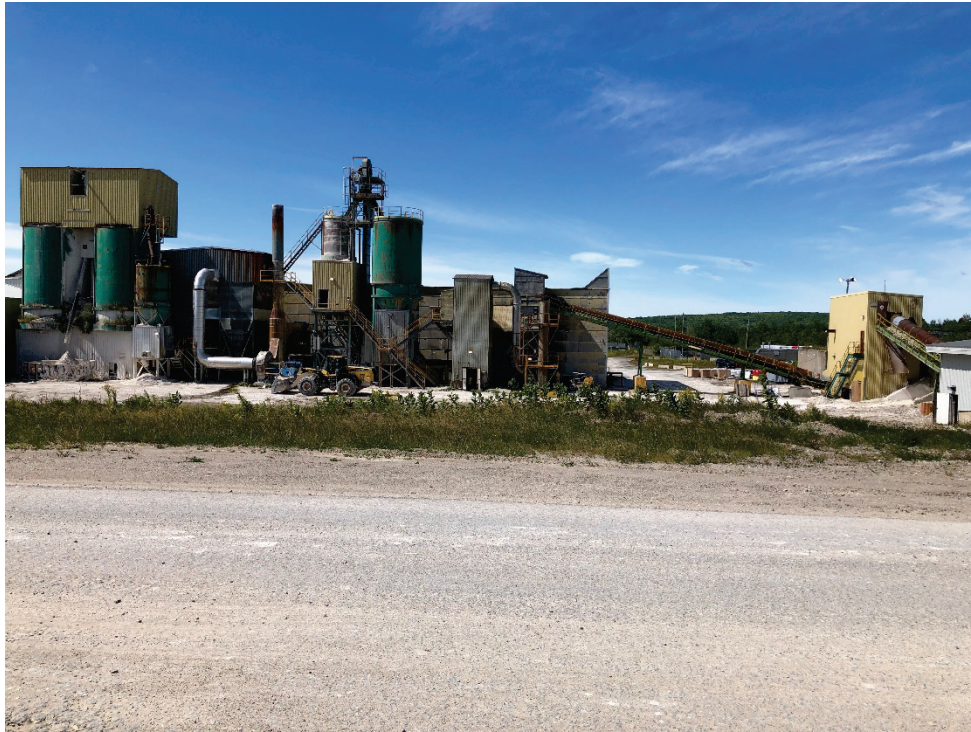
Photo 3 - View of the Site facing west (rock crusher, calcine baghouse and stucco tanks).

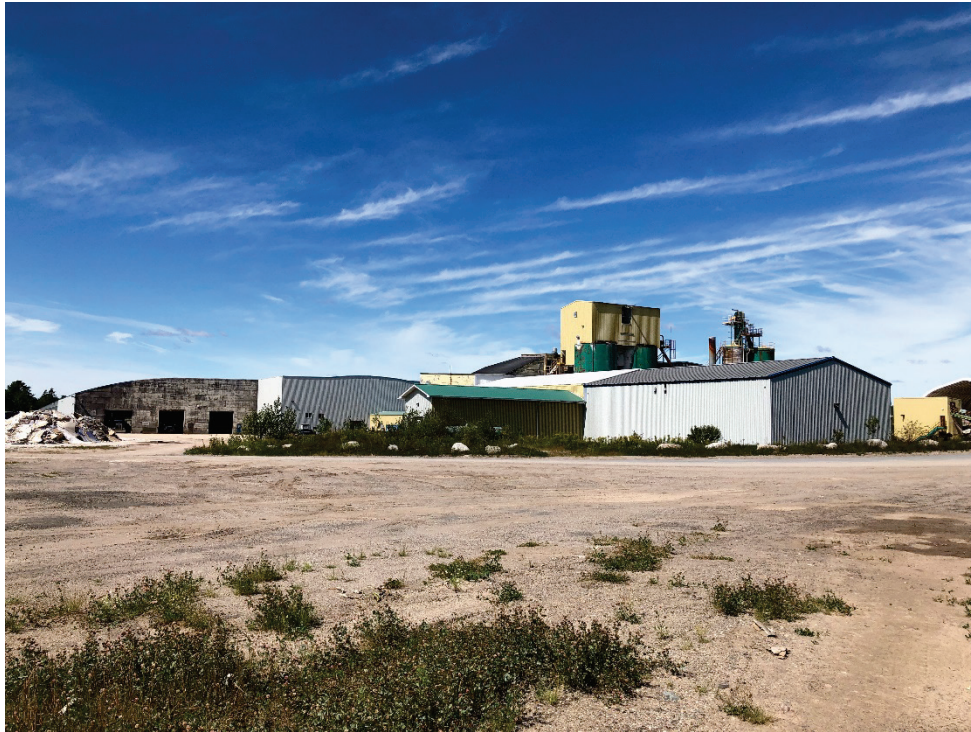
Photo 4 - View of the Site facing northwest (forklift maintenance, paper storage, paper delivery, and south warehouse).

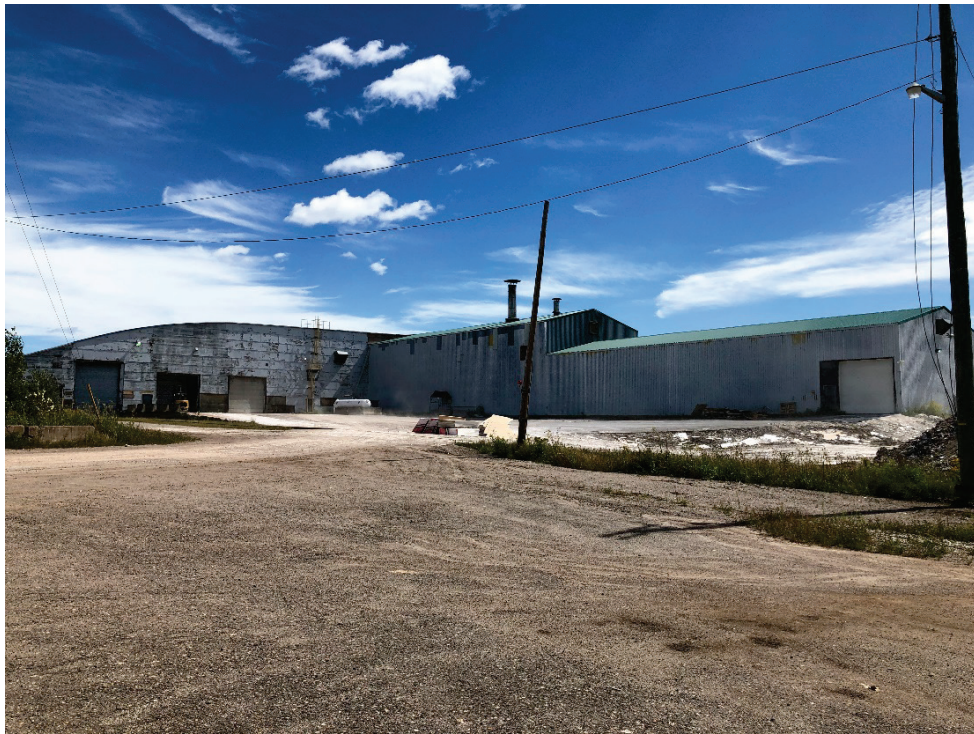
Photo 5 - View of Site facing east (outlet rolls, dryer zone #1 and north warehouse).

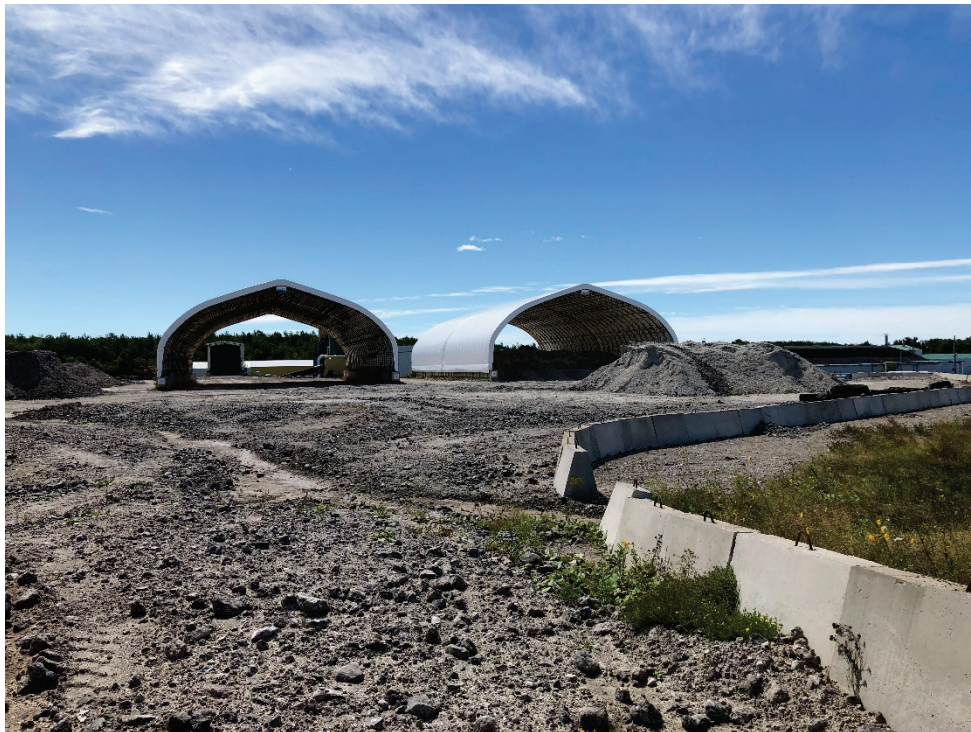
Photo 6 - View facing south of rock storage area.

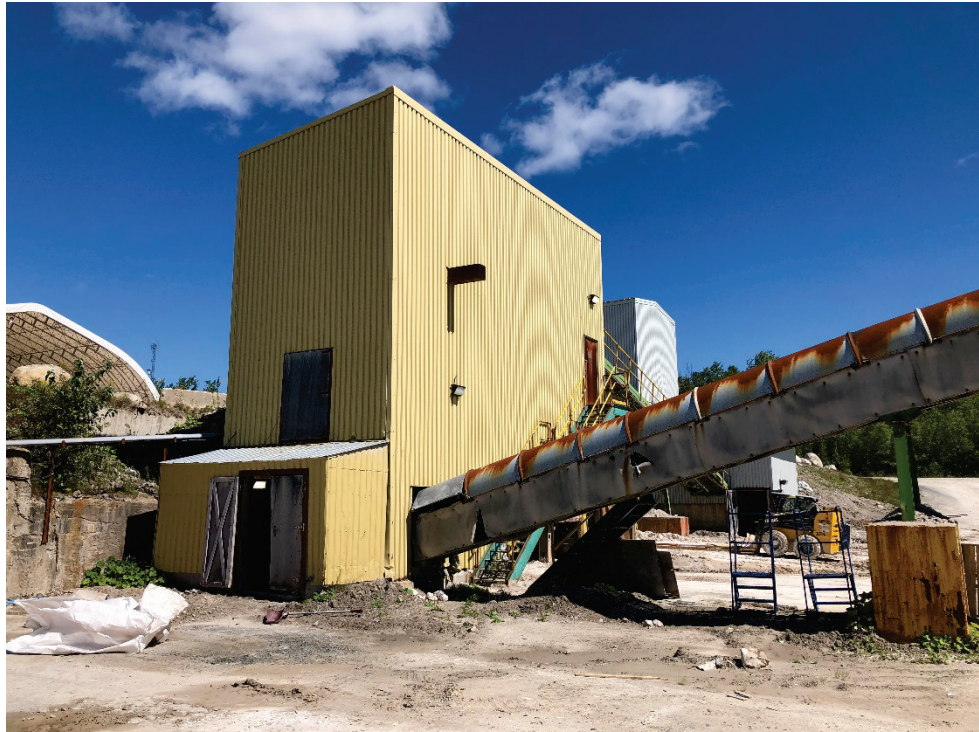
Photo 7 - View of Rock crusher, looking northeast.

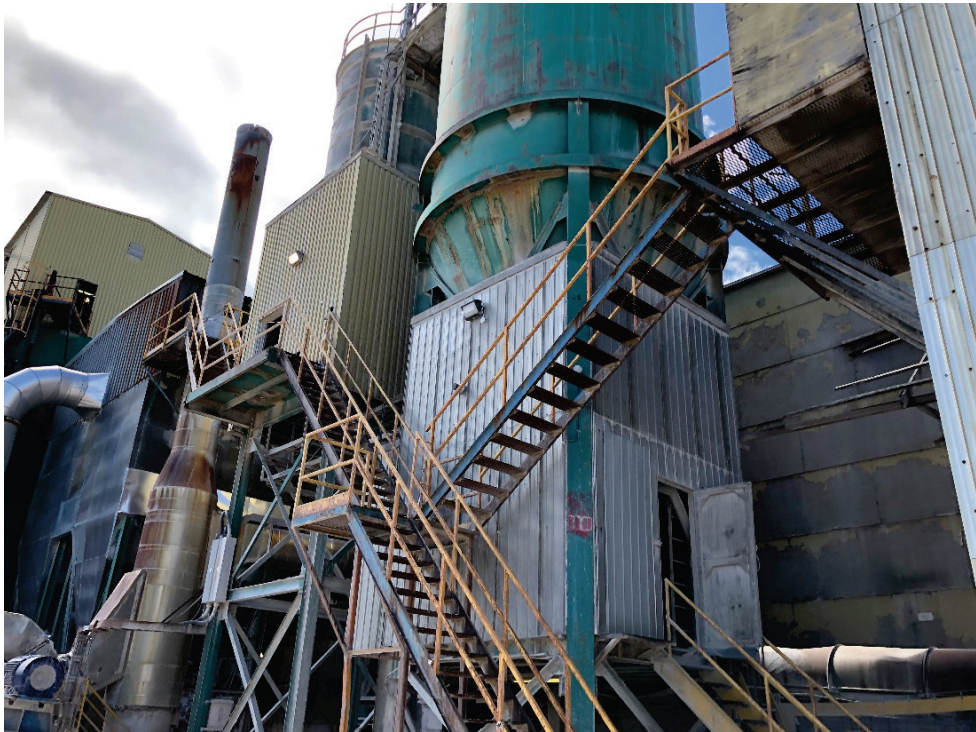
Photo 8 - View of calcine baghouse, looking southwest.

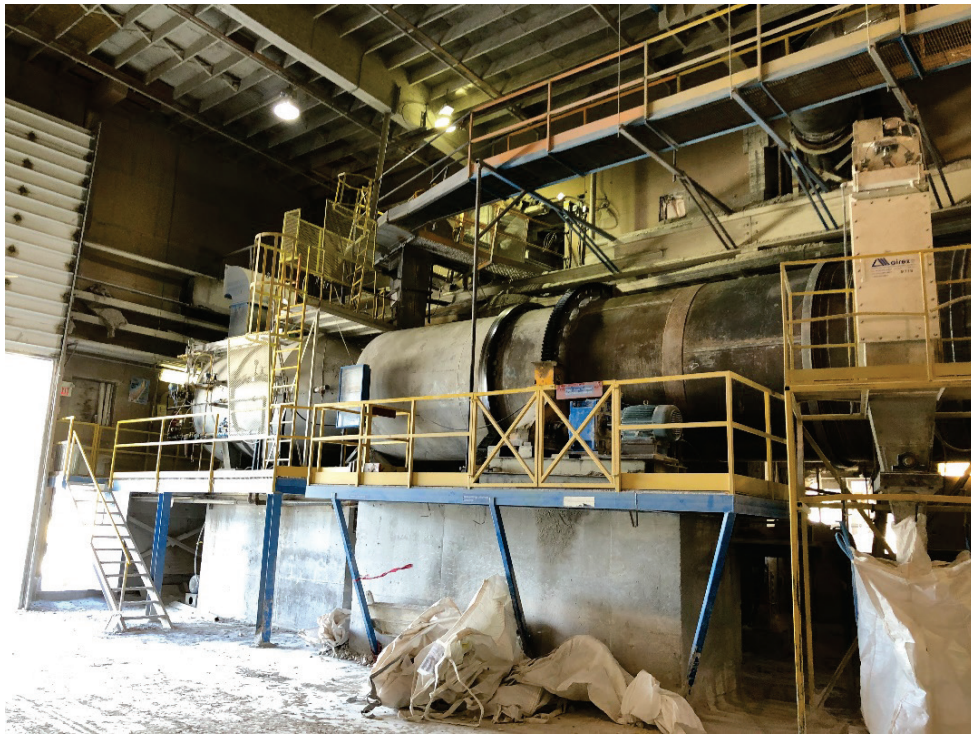
Photo 9 - Photo of rock dryer.

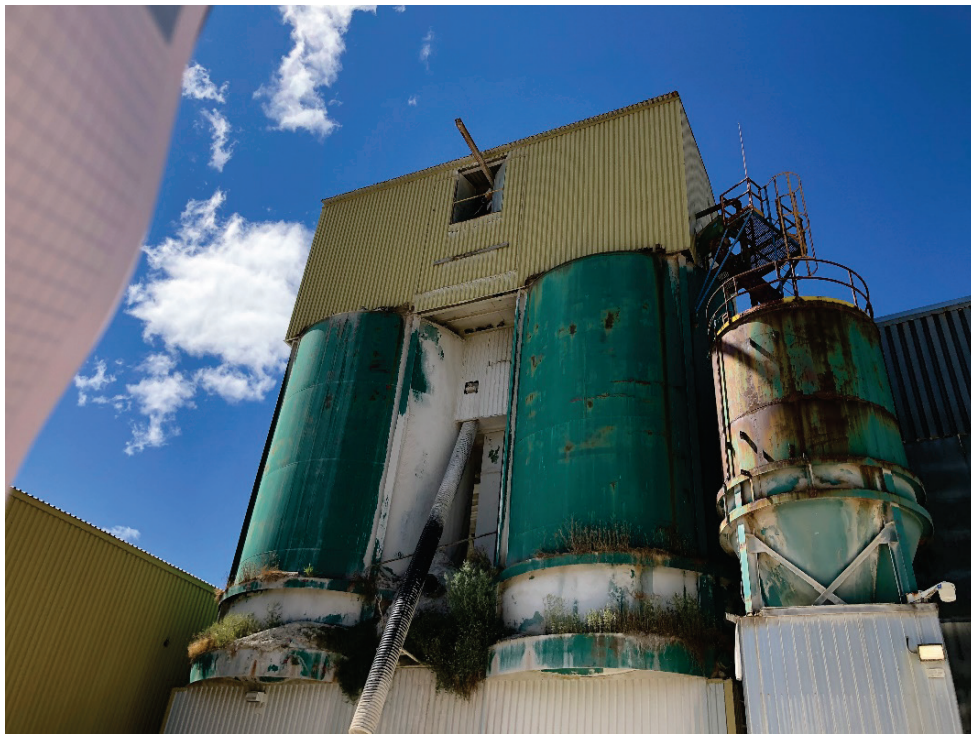
Photo 10 - Photo of stucco storage tanks, looking southwest.

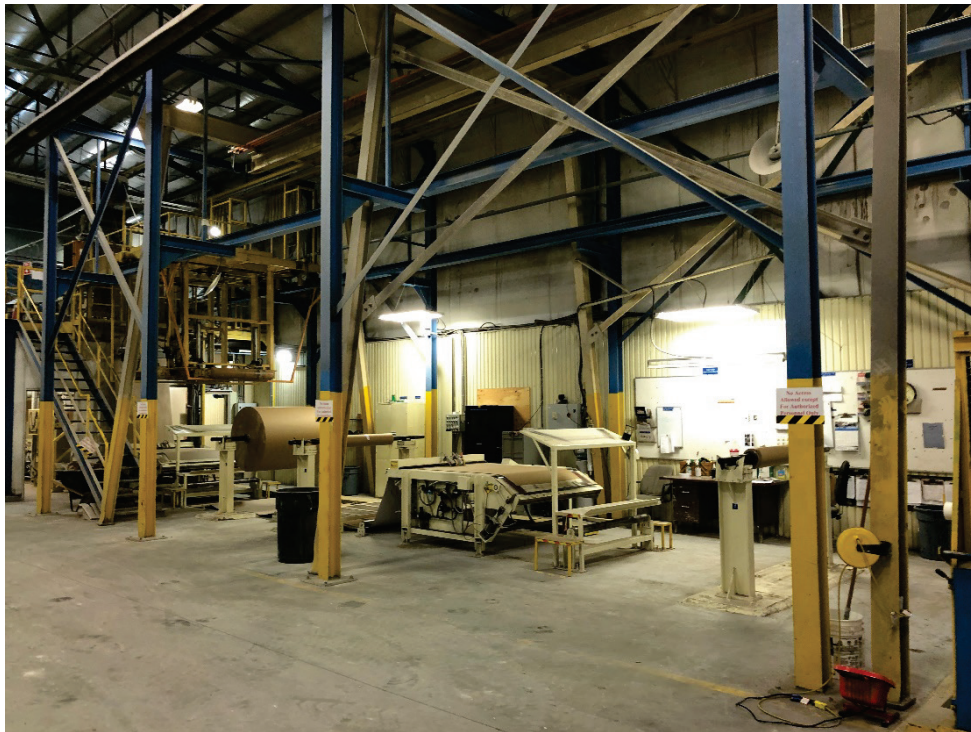
Photo 11 - Photo of unwind stand in paper staging area.

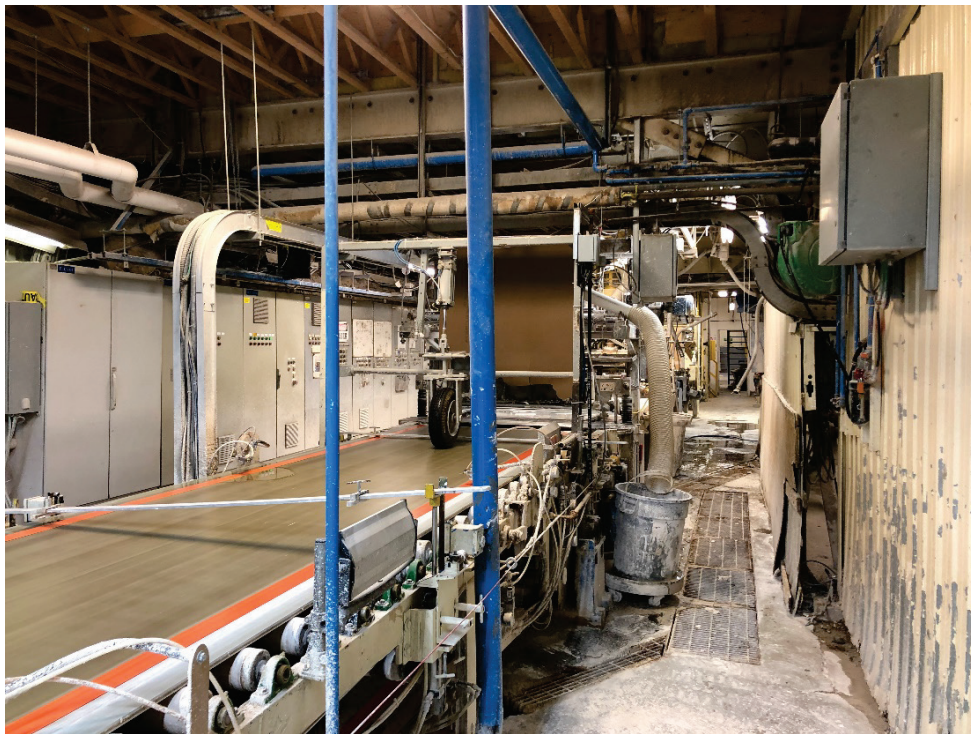
Photo 12 - Photo of wet additives area, leading onto belt #1.

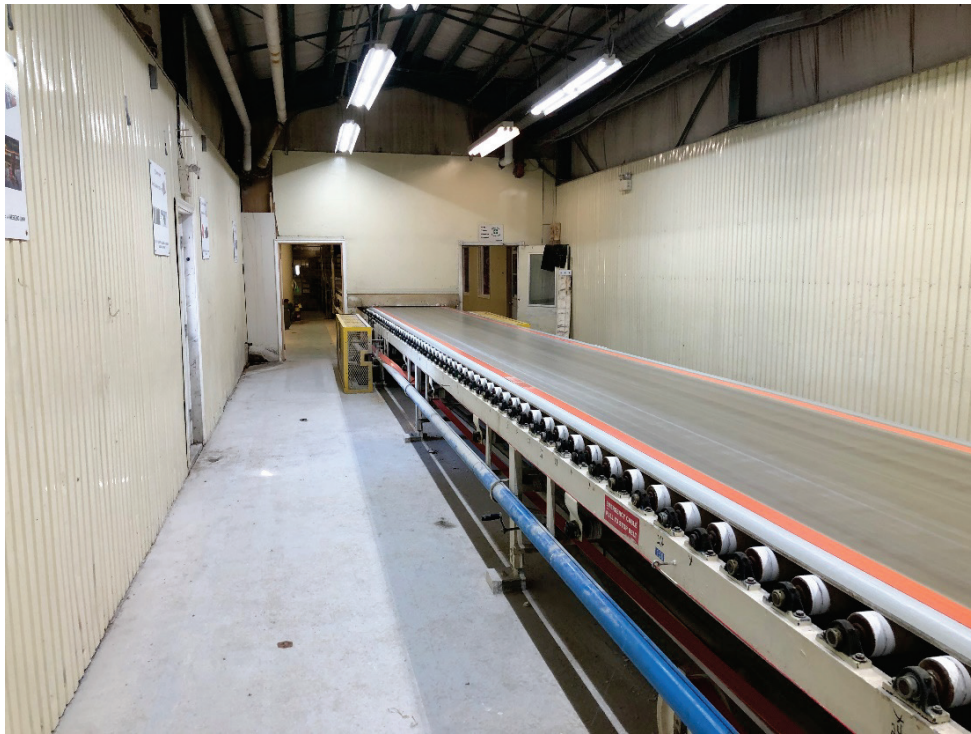
Photo 13 - Photo of belt #1 area.

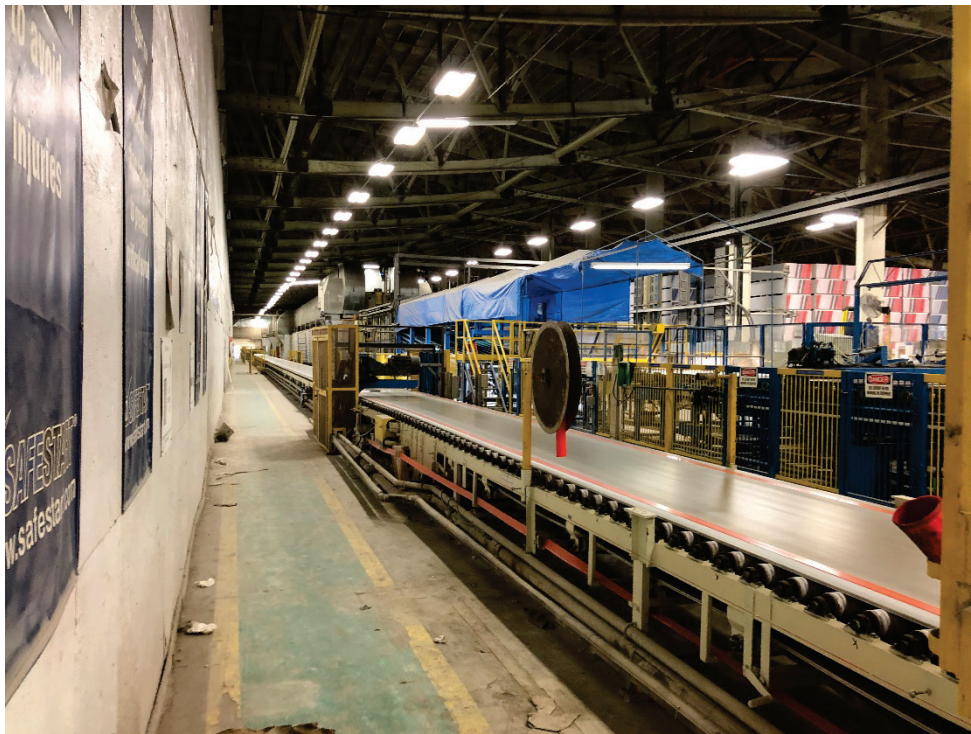
Photo 14 - Photo of belt #2 area in north warehouse.

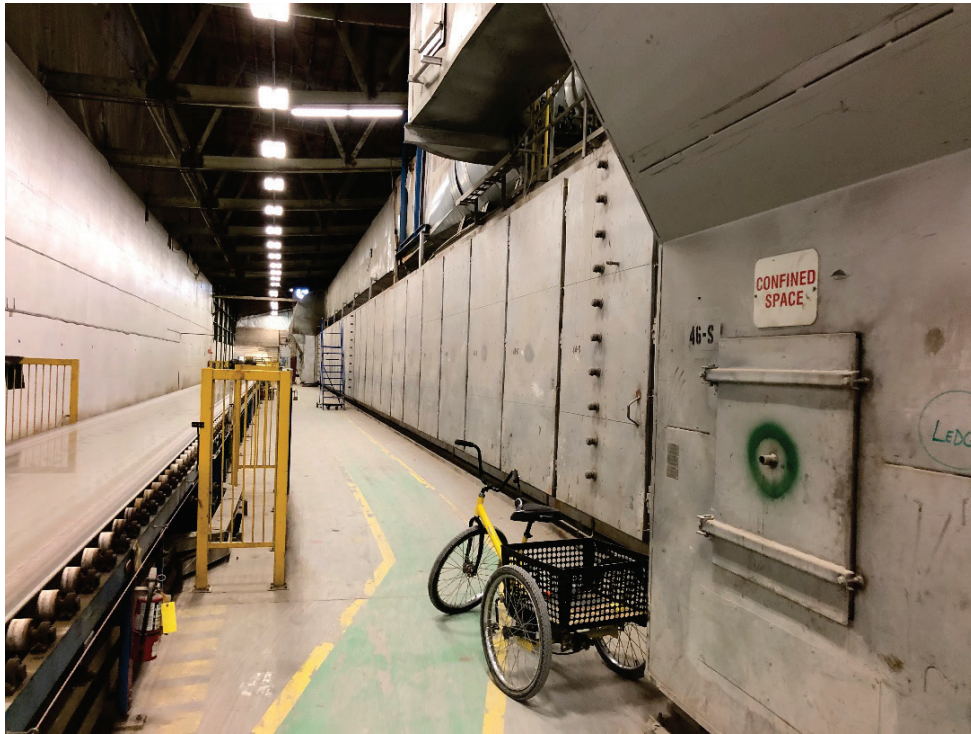
Photo 15 - Photo of accelerator rolls #1 on the left and dryer zone #2 on the right.

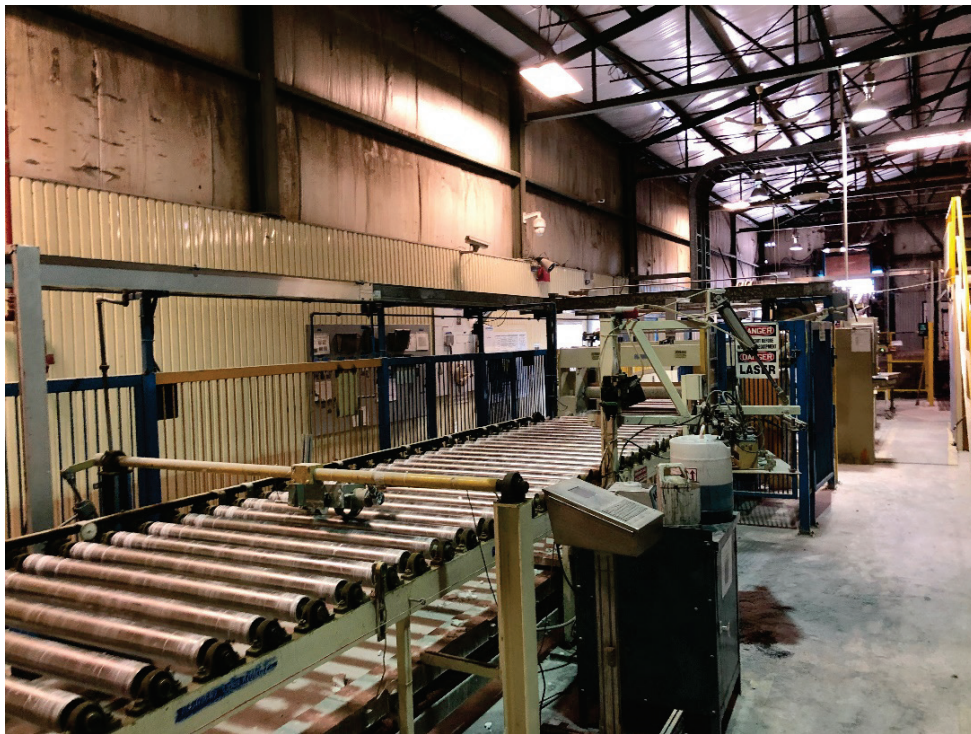
Photo 16 - View of knife area.

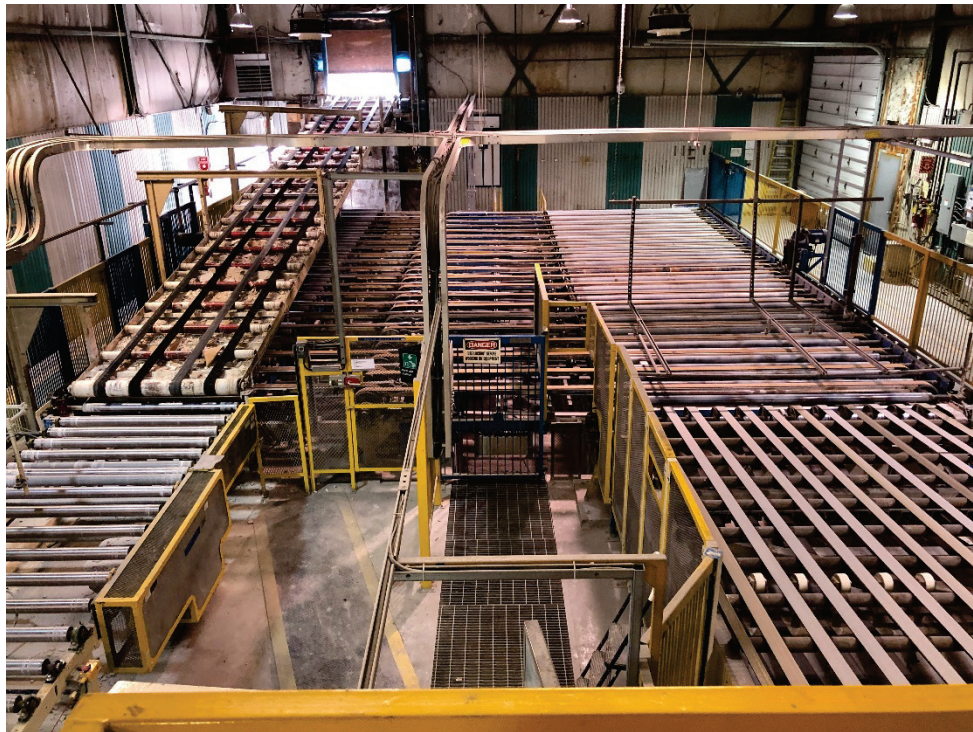
Photo 17 - View of inlet and outlet rolls.

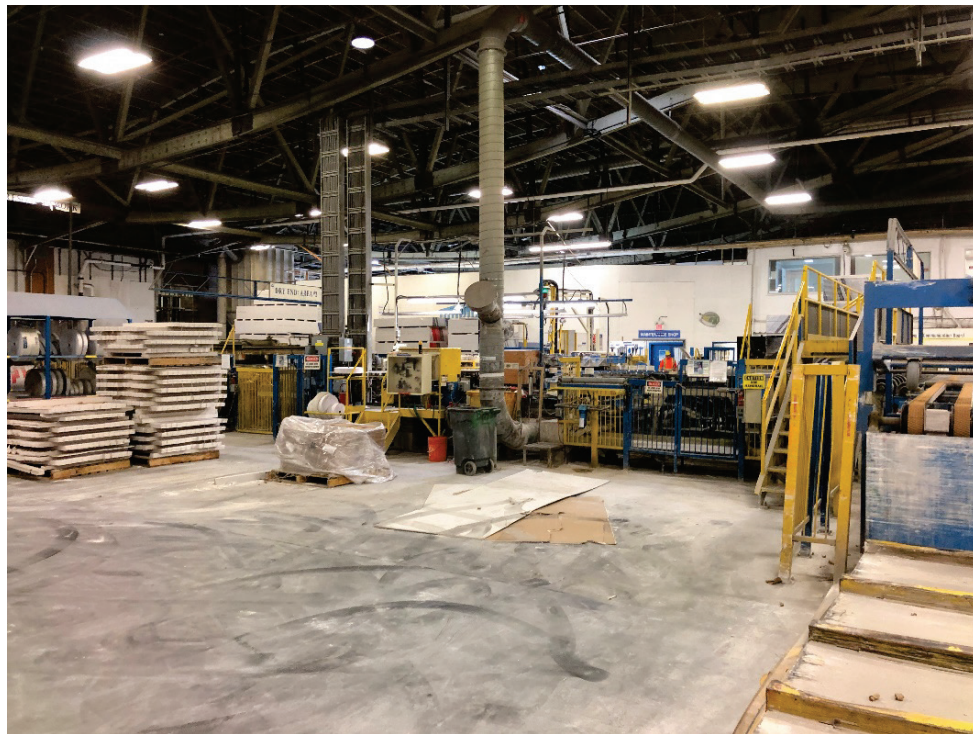
Photo 18 - View of booker, bunder and stacker area.

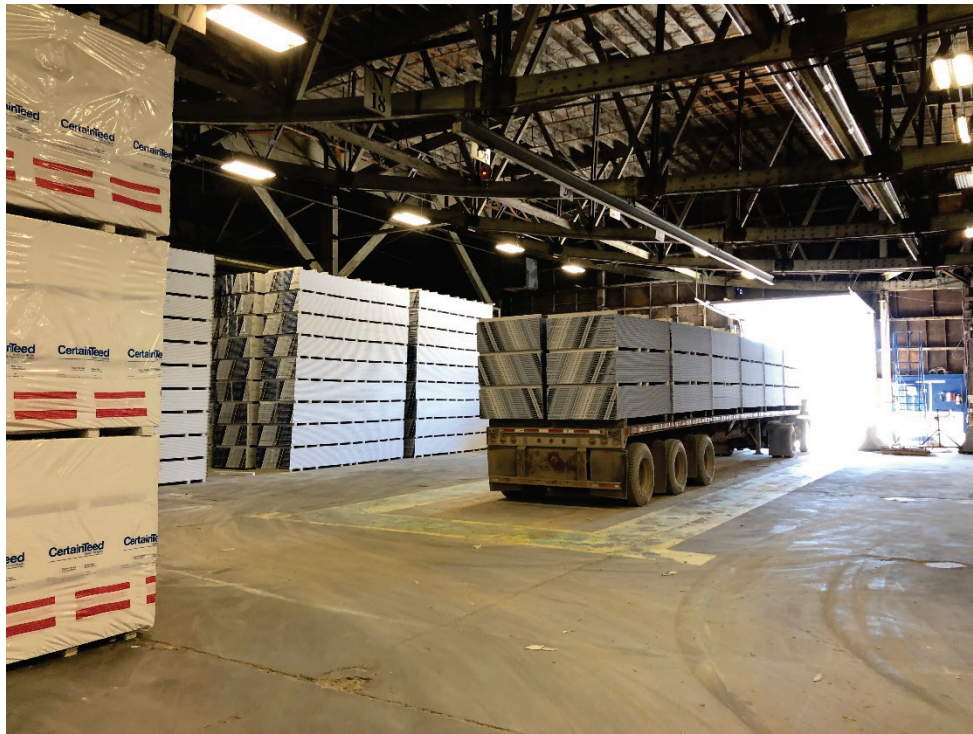
Photo 19 - View of truck loading portion of north warehouse.

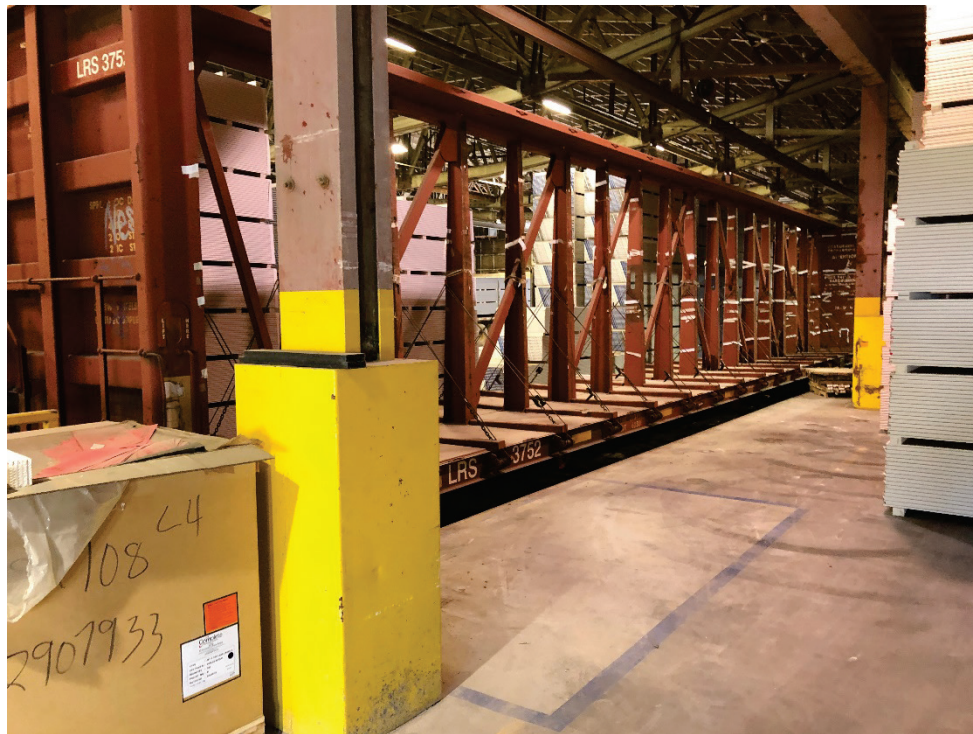
Photo 20 - View of rail loading portion of north warehouse.

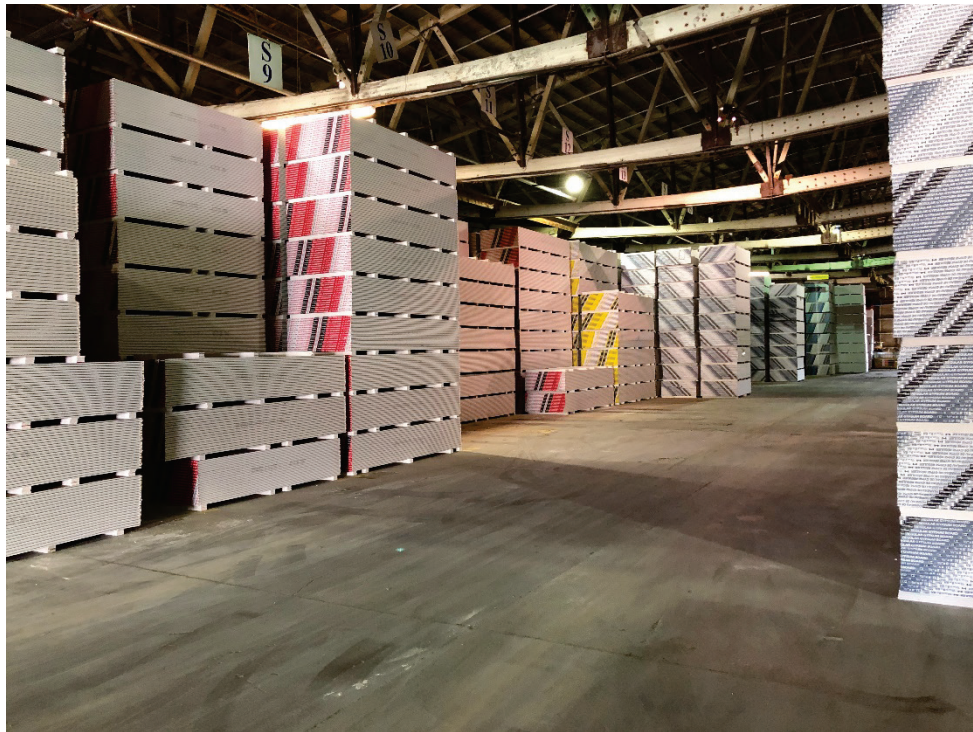
Photo 21 - View of south warehouse.

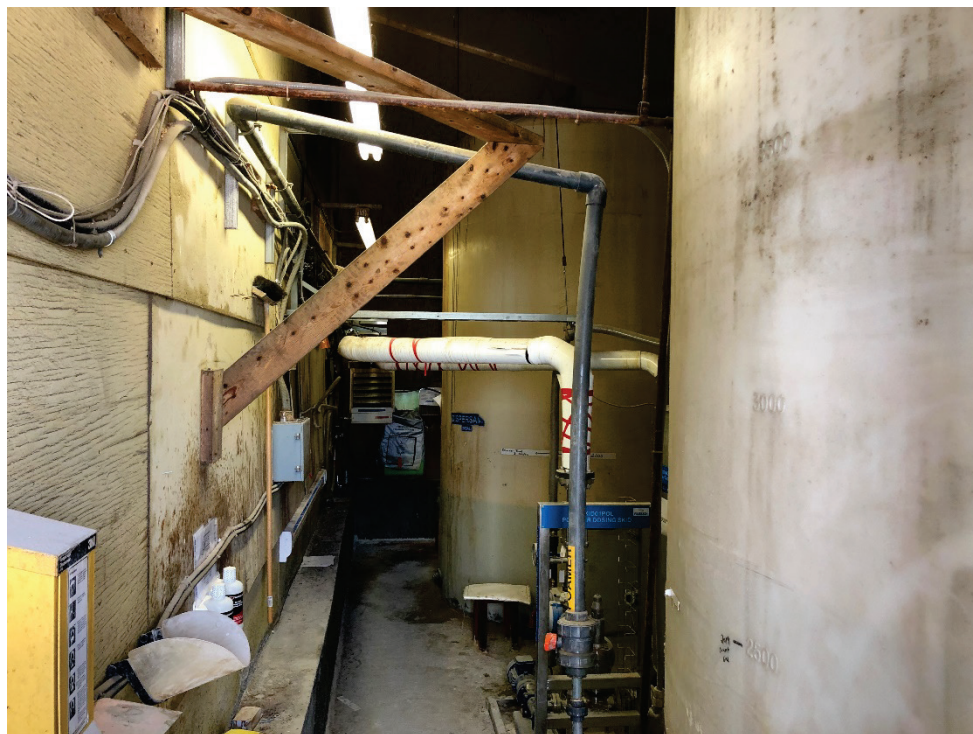
Photo 22 - View of bulk chemical room (Chemical Tanks).

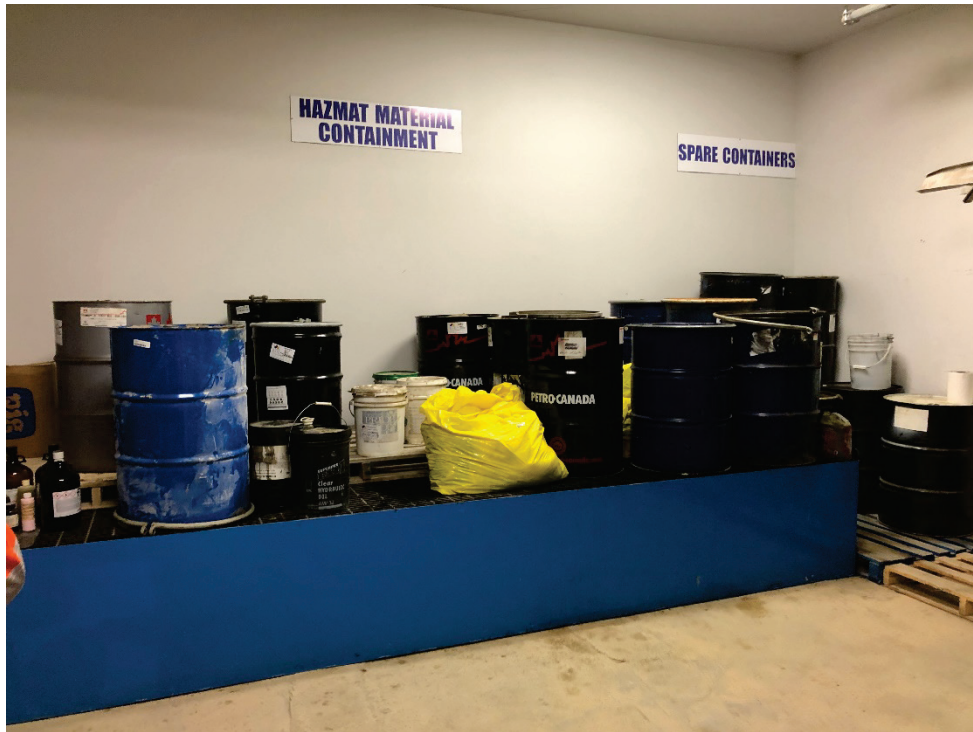
Photo 23 - View of hazmat storage room for waste chemicals and oils.

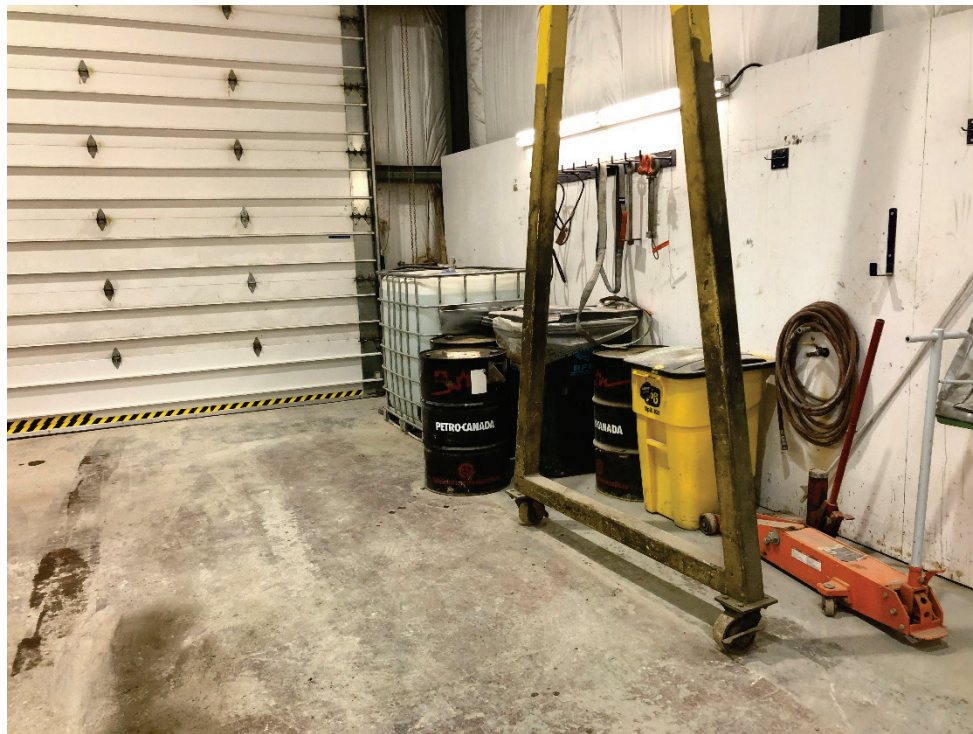
Photo 24 - View of forklift maintenance area (barrels of oils stored in corner).

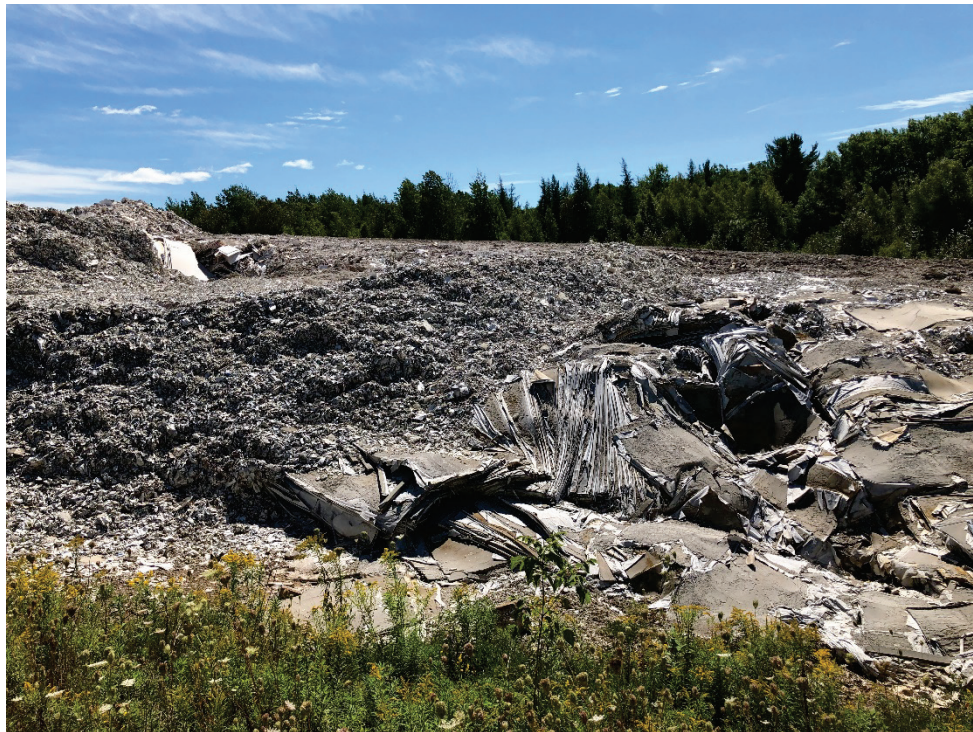
Photo 25 - View of waste wallboard pile, facing southeast.

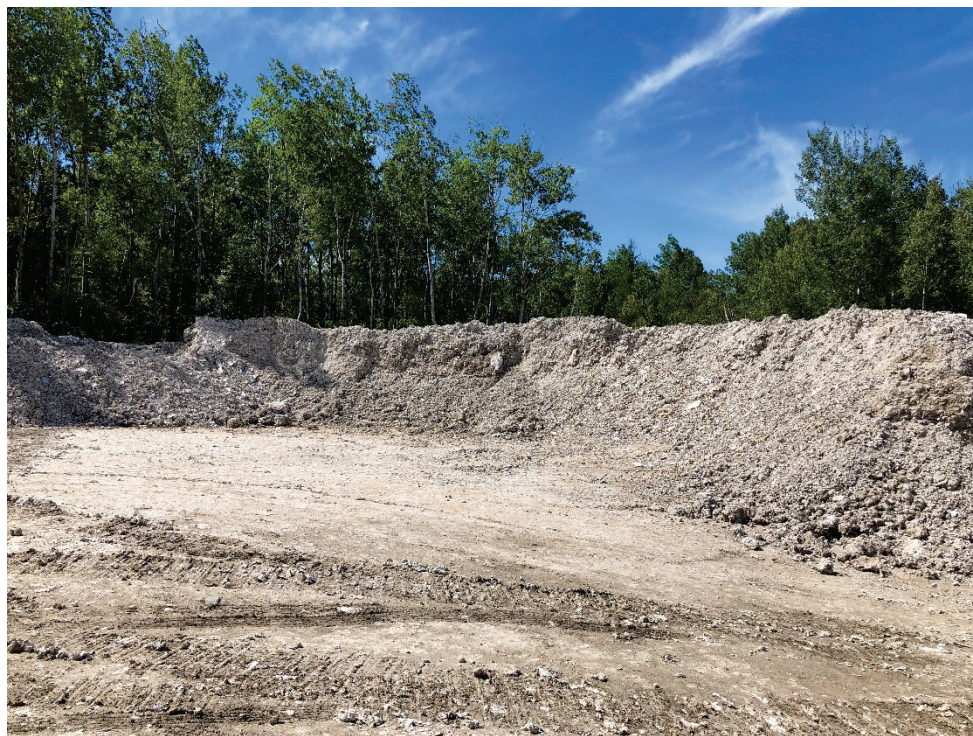
Photo 26 - View of waste paper pile. Facing south.

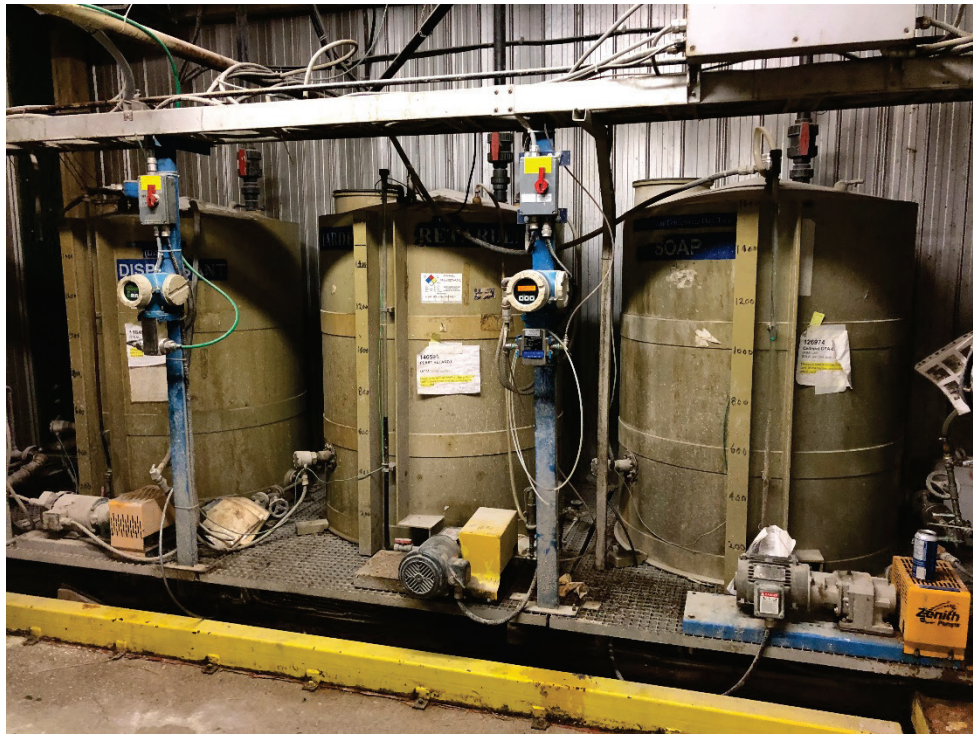
Photo 27 - View of chemical storage tanks in wet additives area.

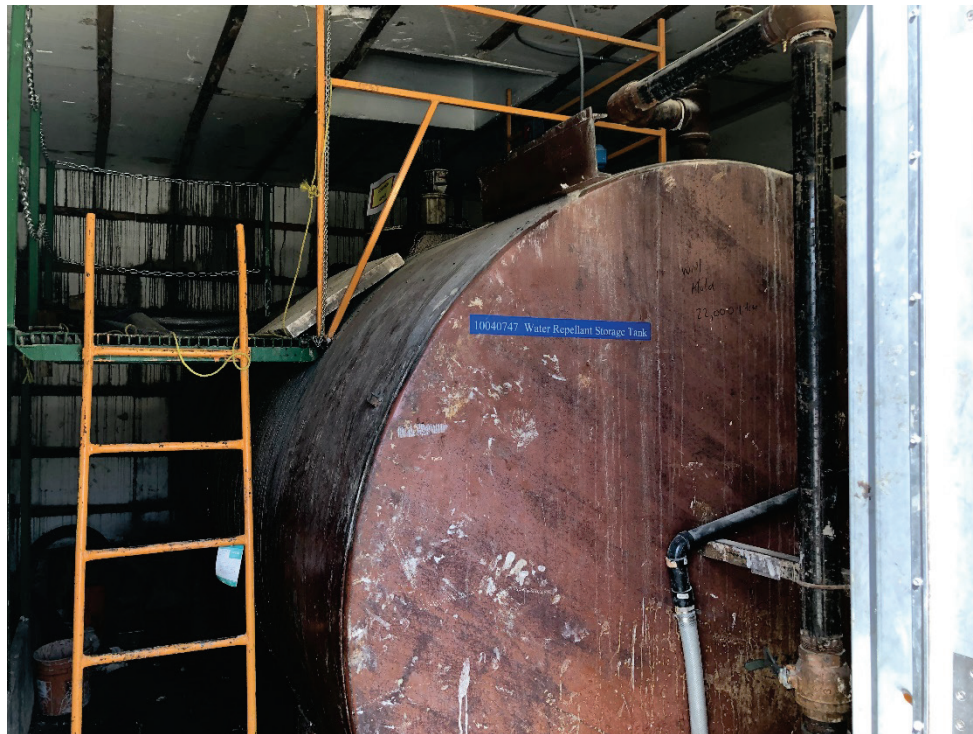
Photo 28 - View of storage tank in AQUA.

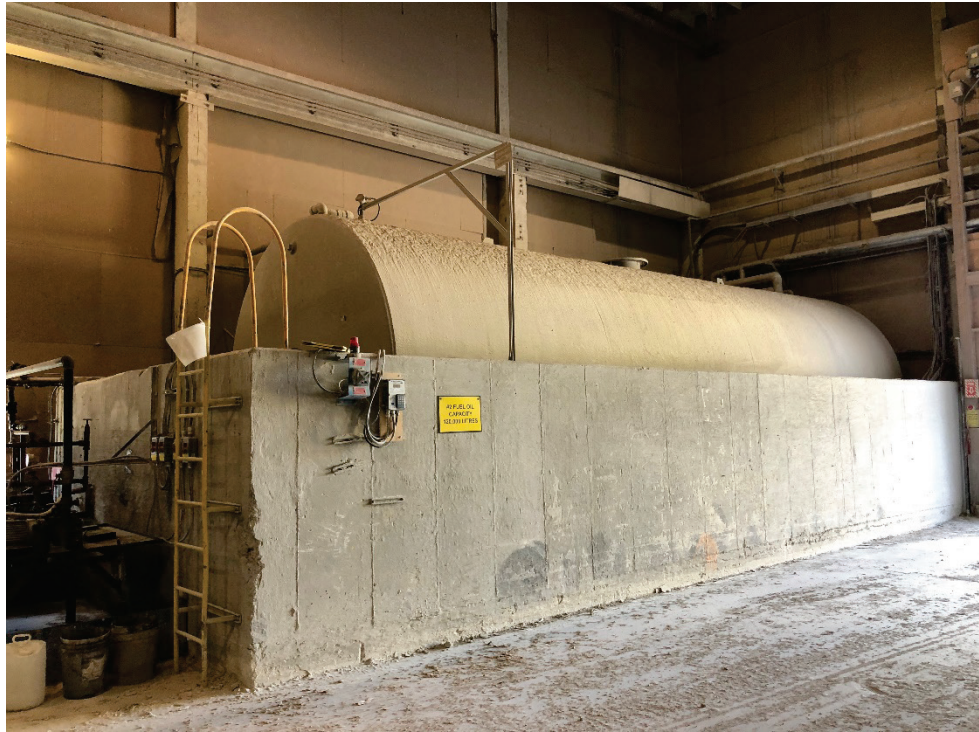
Photo 29 - View of 113,500L Furnace oil tank (formerly bunker C) in rock dryer area.

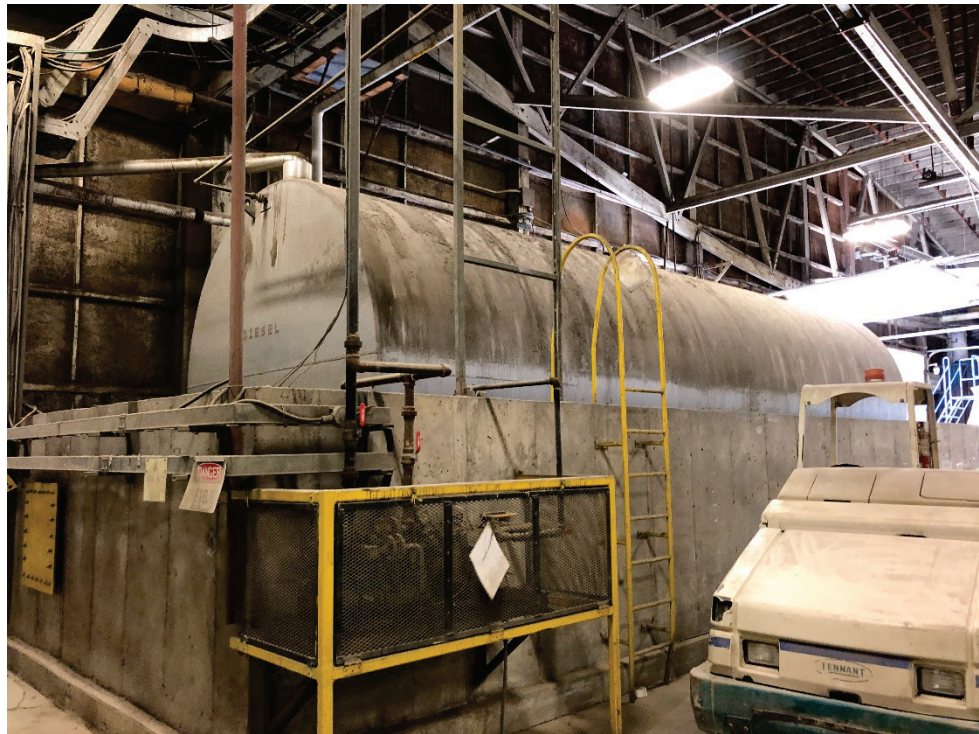
Photo 30 - View of 113,500L Furnace oil tank in north warehouse.

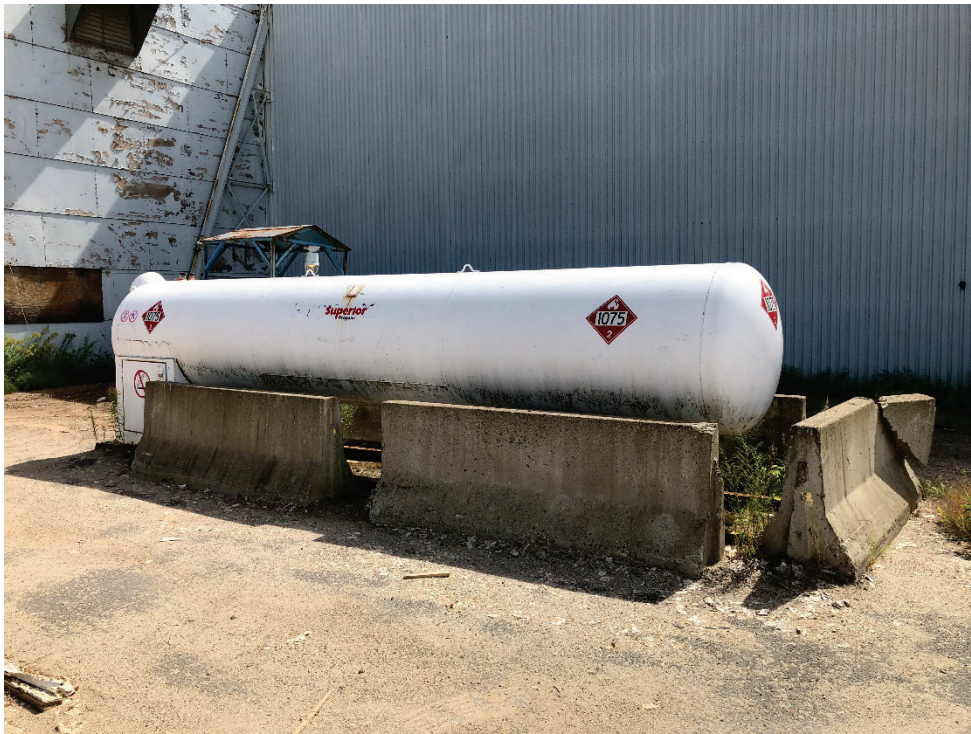
Photo 31 - View of propane storage tank located outside north warehouse to the west.

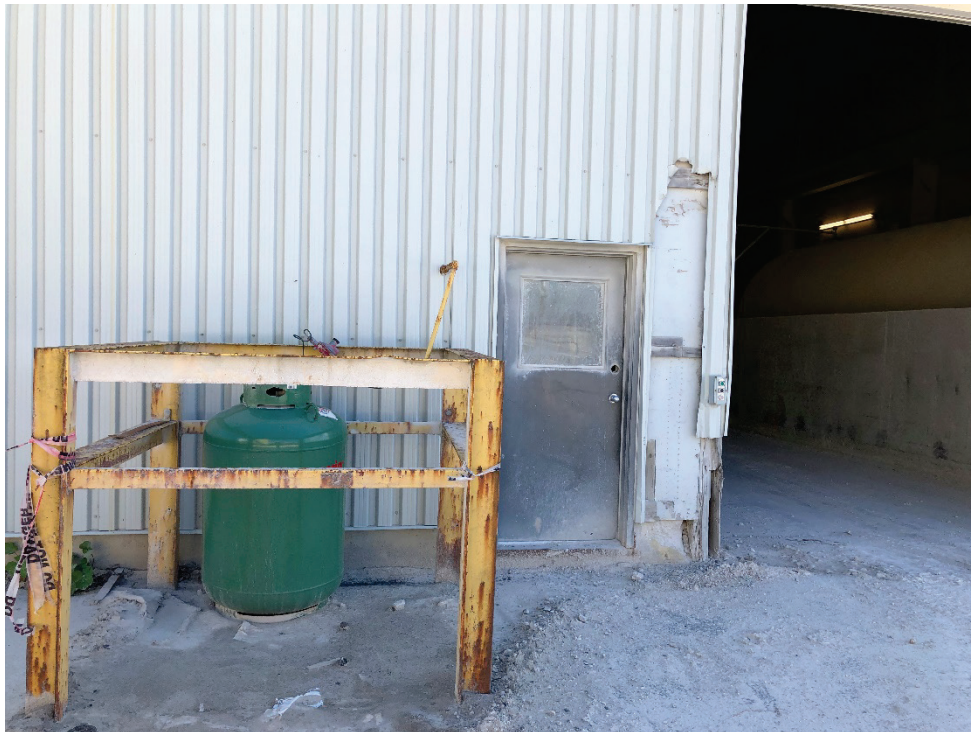
Photo 32 - View of propane storage tank outside rock dryer to the north.
