Appendix I Site Photographs

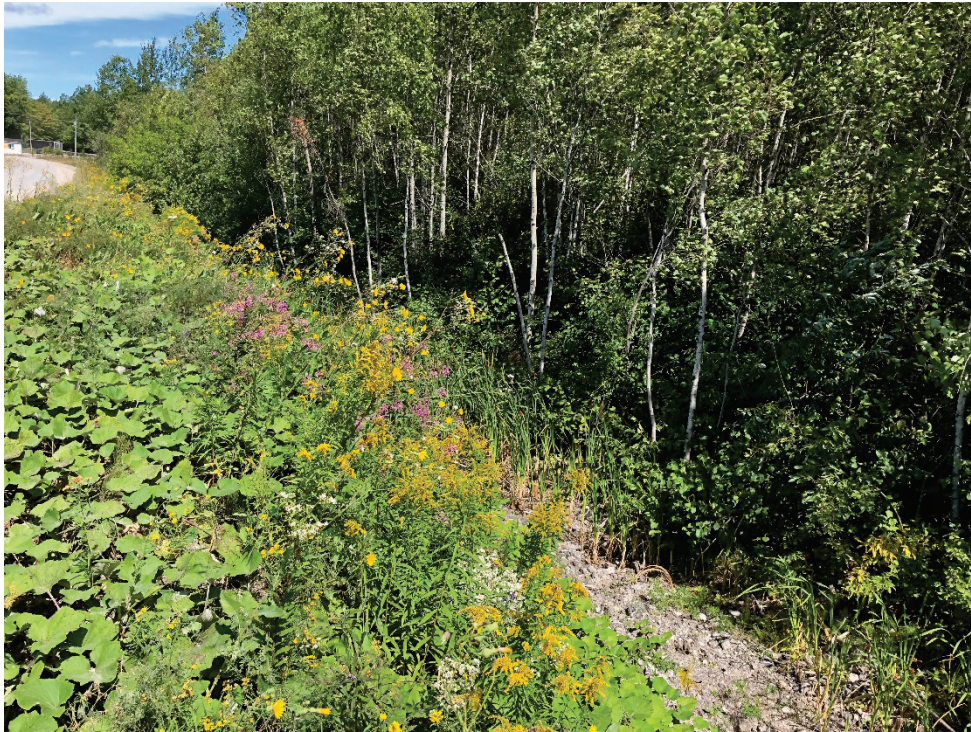
Photo 33 - View of swale ditch on the east side of the property, facing north.

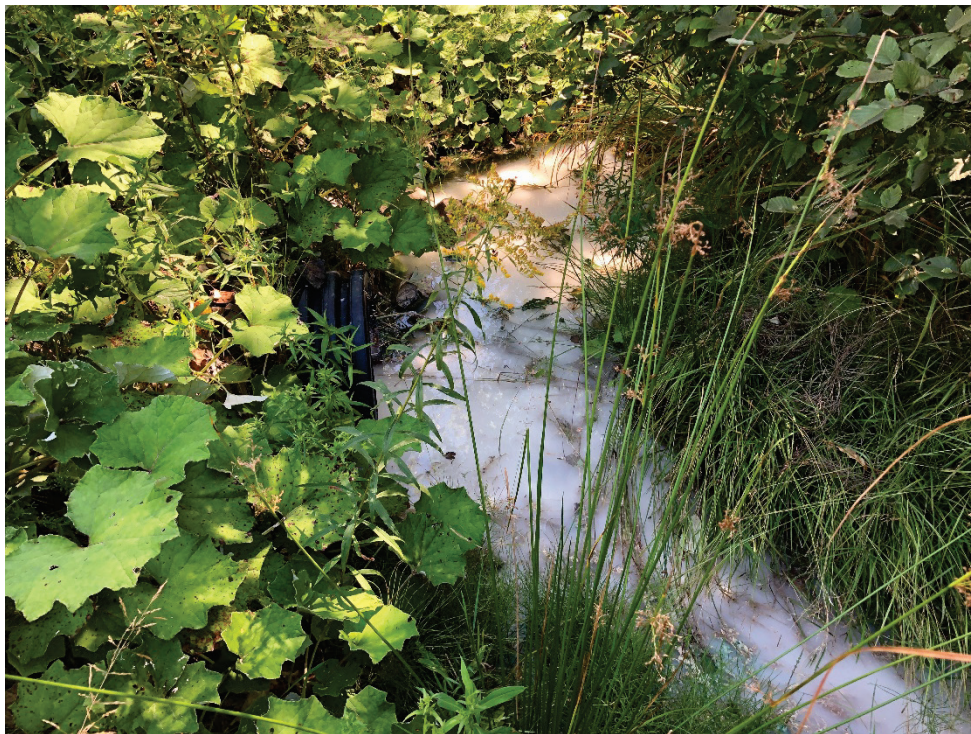
Photo 34 - View of outlet pipe from site surface drainage system, entering swale ditch on the south side of the property.

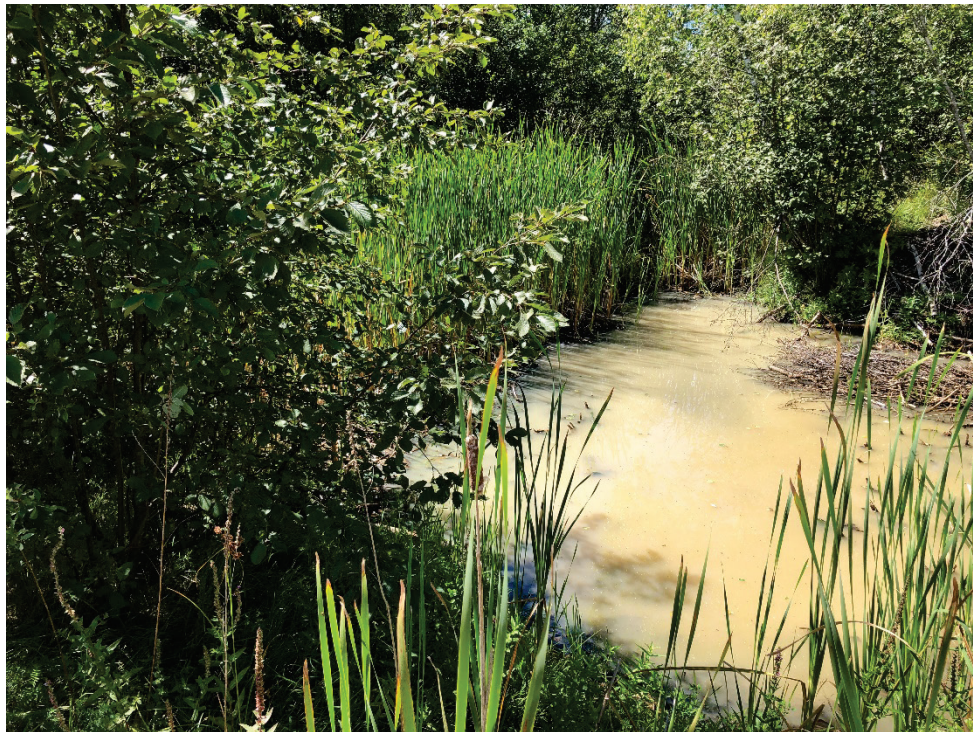
Photo 35 - View of swale ditch entering sedimentation pond on the western edge of the property.

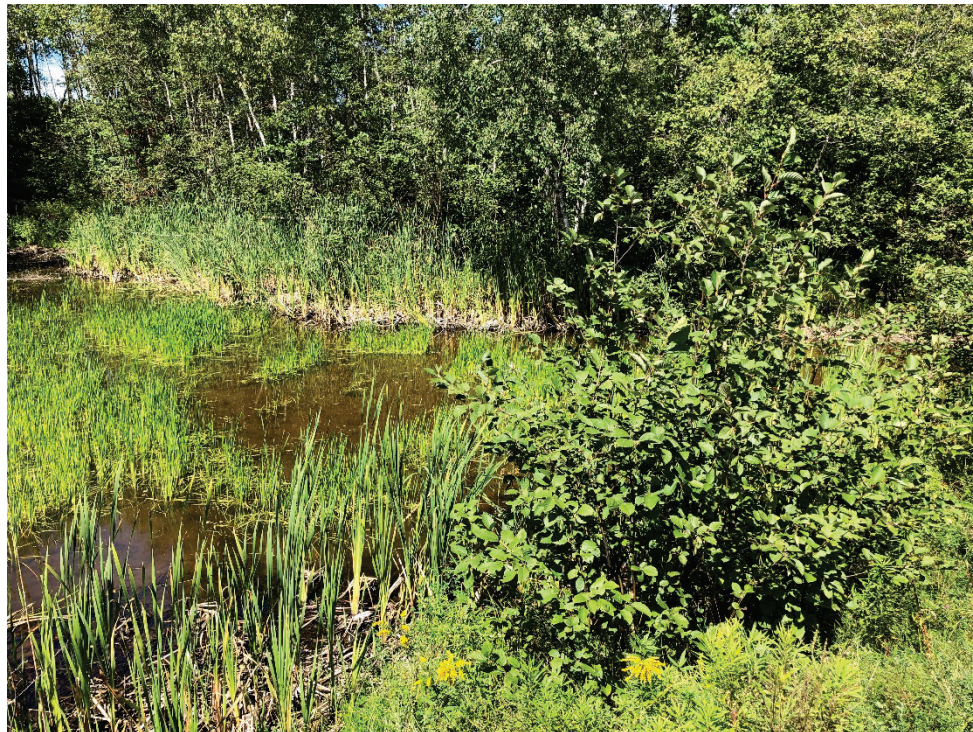
Photo 36 - View of sedimentation pond on the west side of the property.

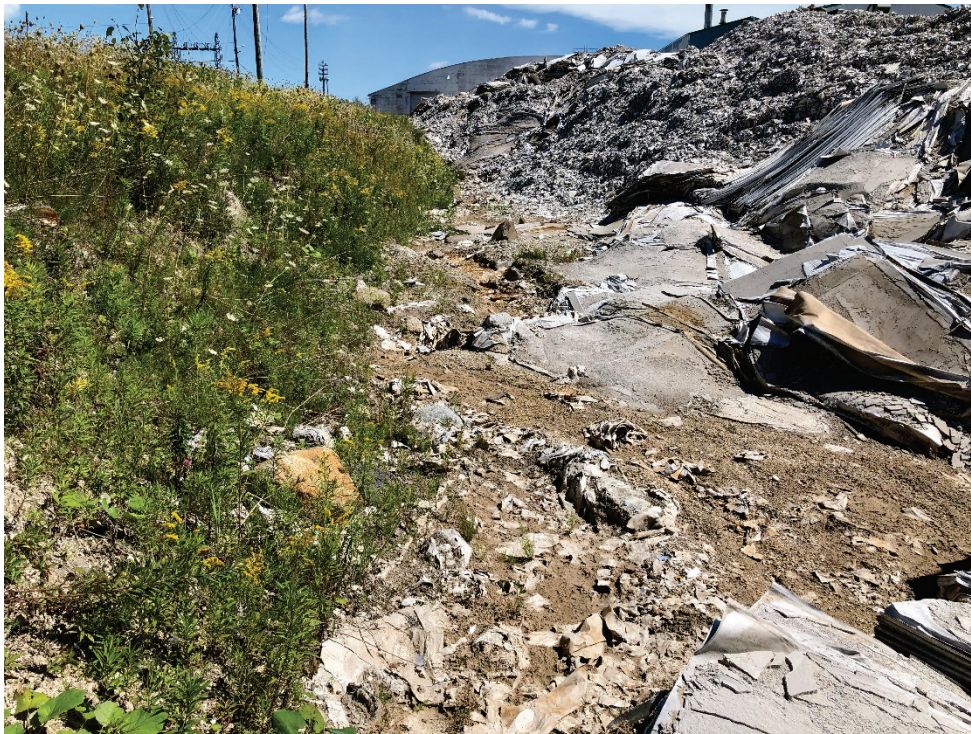
Photo 37 - View of drainage ditch along the edge of the waste wallboard pile.

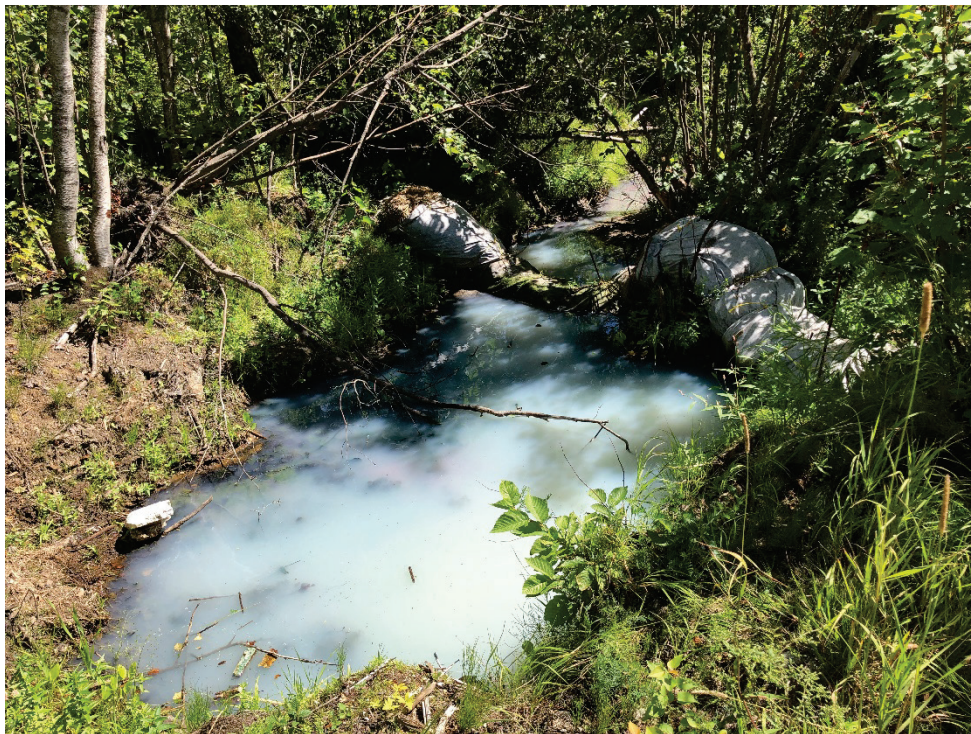
Photo 38 - View of water exiting the sedimentation pond. Siltation device in disrepair.

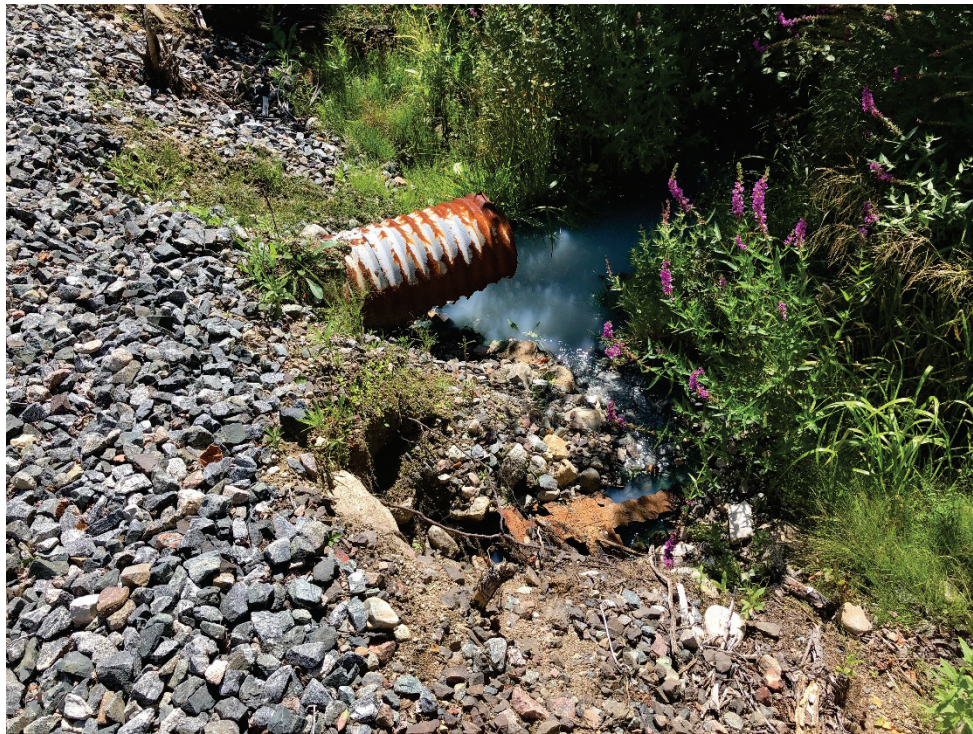
Photo 39 - View of outflow culvert across the main line tracks leading off-site entering designated wetland and the Digdequash water system.

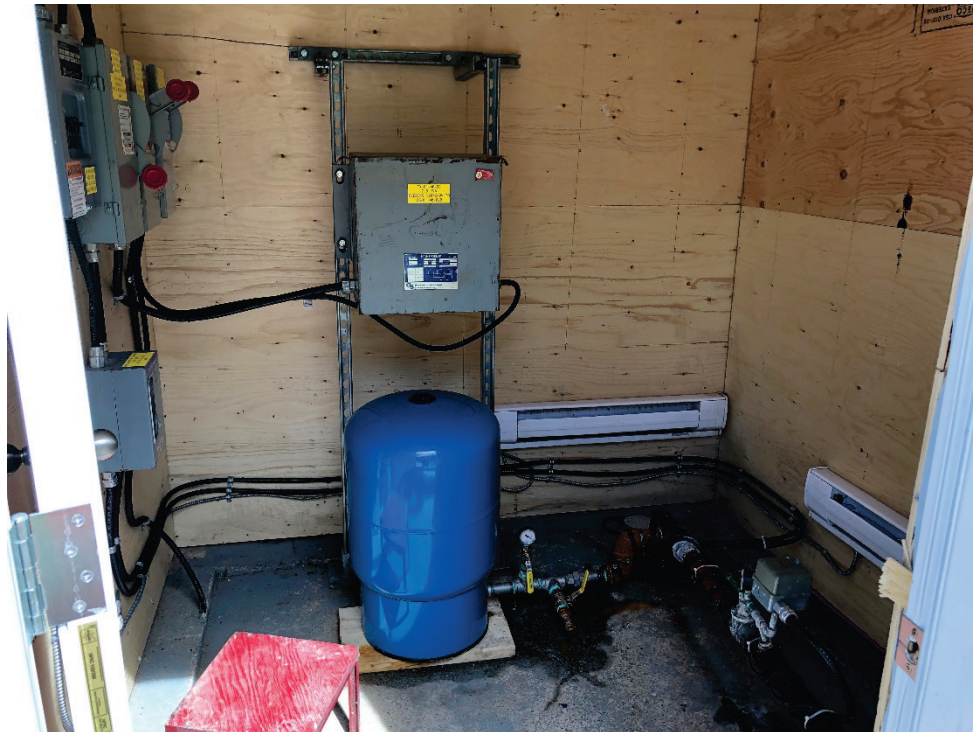
Photo 40 - View of one of the onsite well houses.

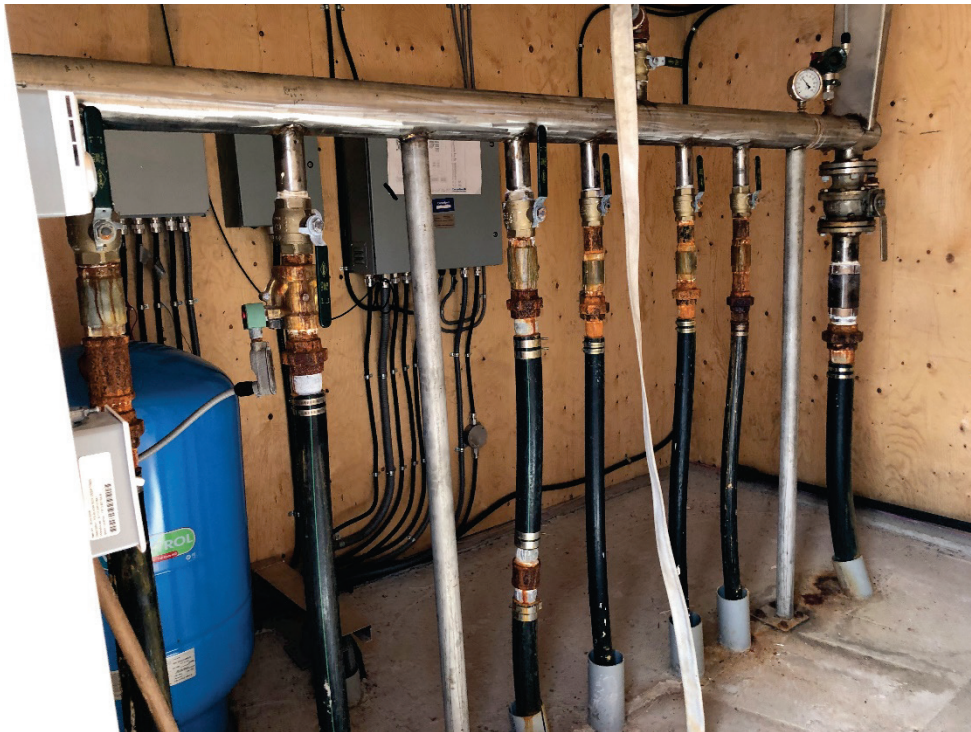
Photo 41 - View of main pump house controlling all the onsite wells.

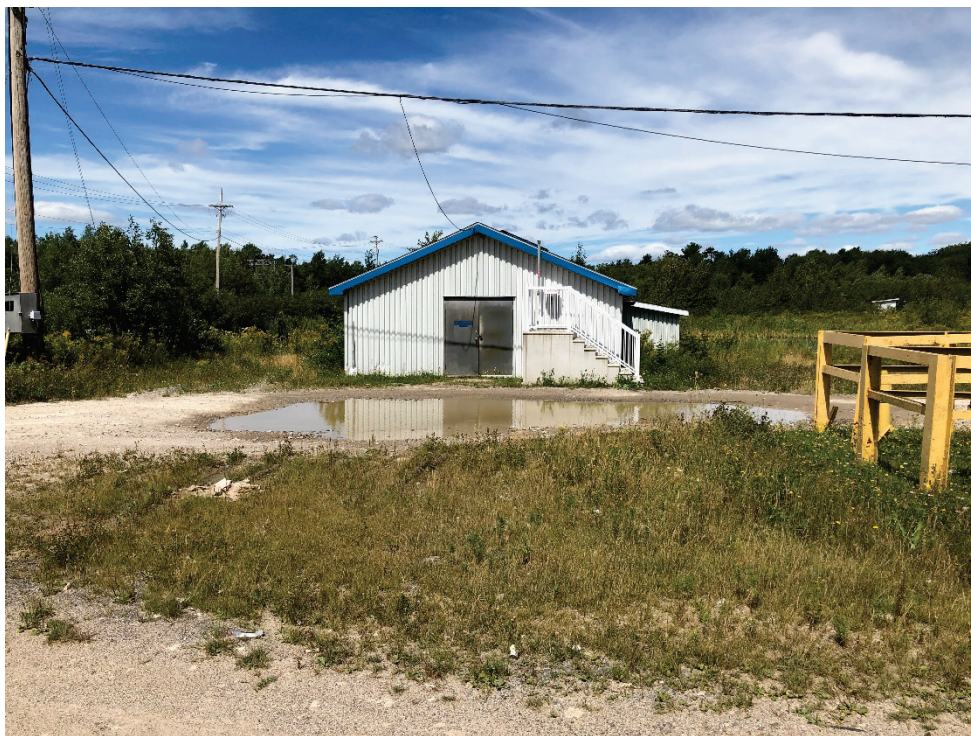
Photo 42 - View of fire pump house, looking north.

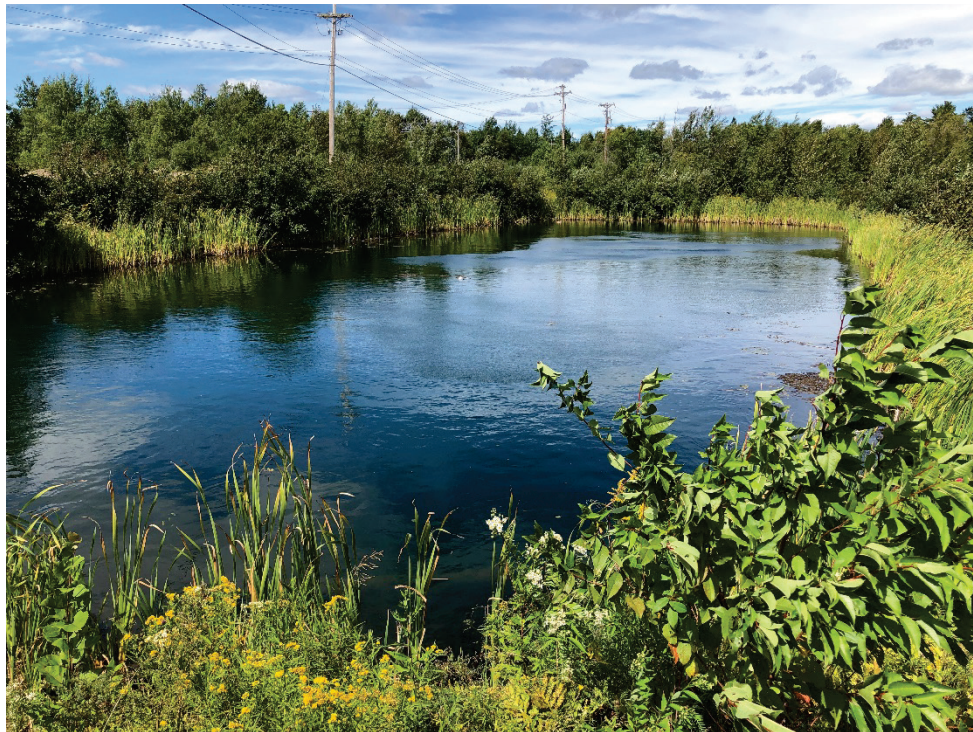
Photo 43 - View of one of two fireponds on site.

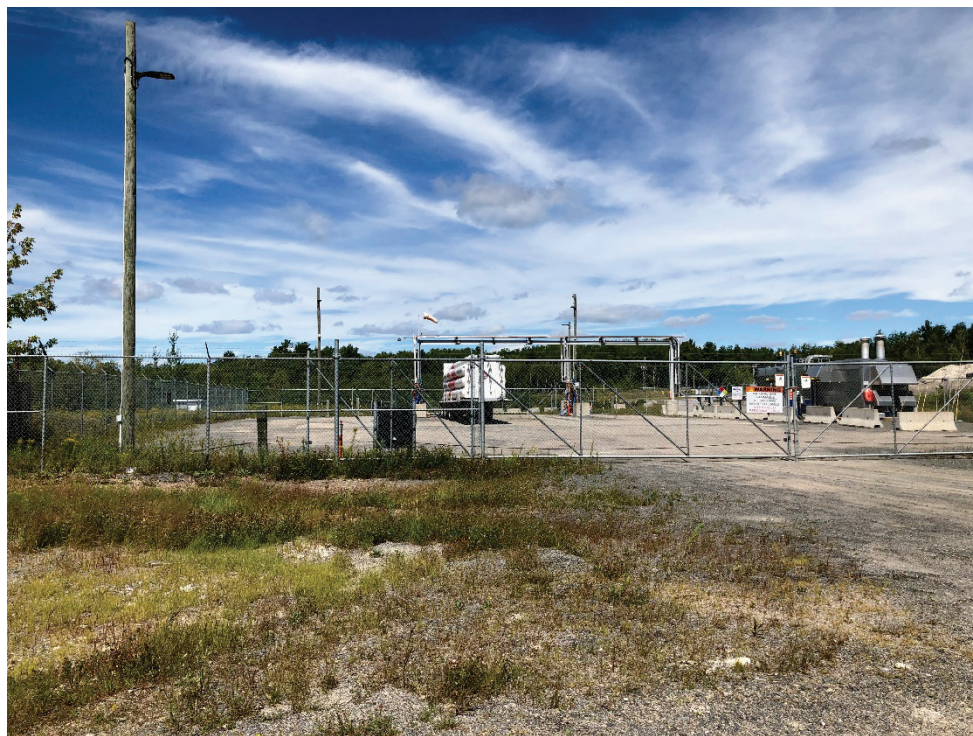
Photo 44 - View of on-site CNG terminal operated by Irving Oil, facing north.

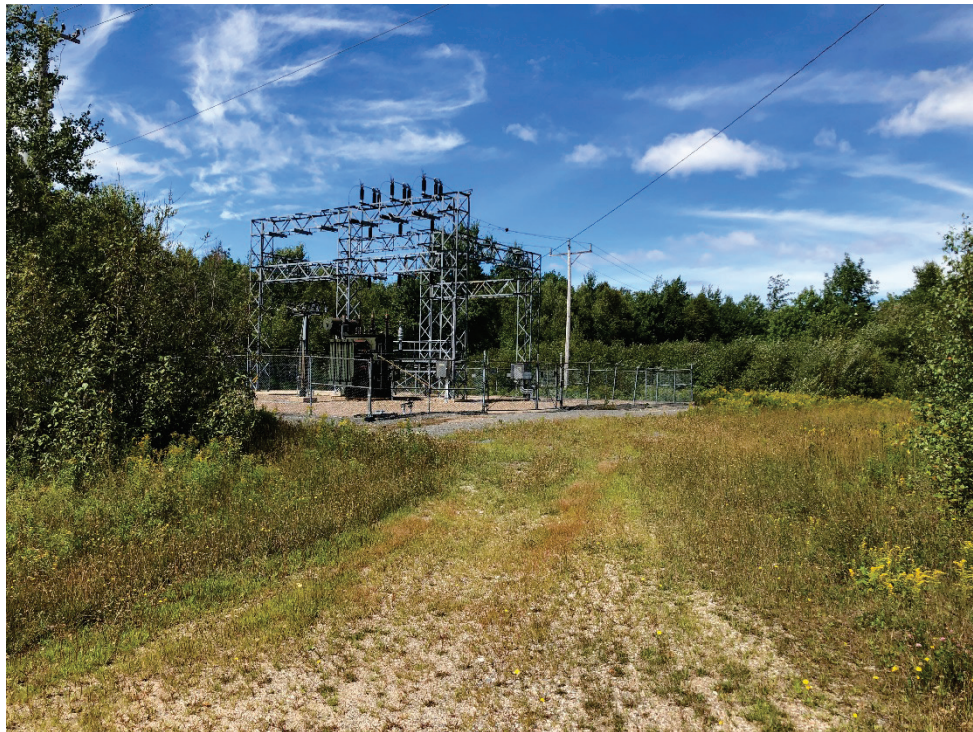
Photo 45 - View of transmission substation located on the northwest corner of the site.

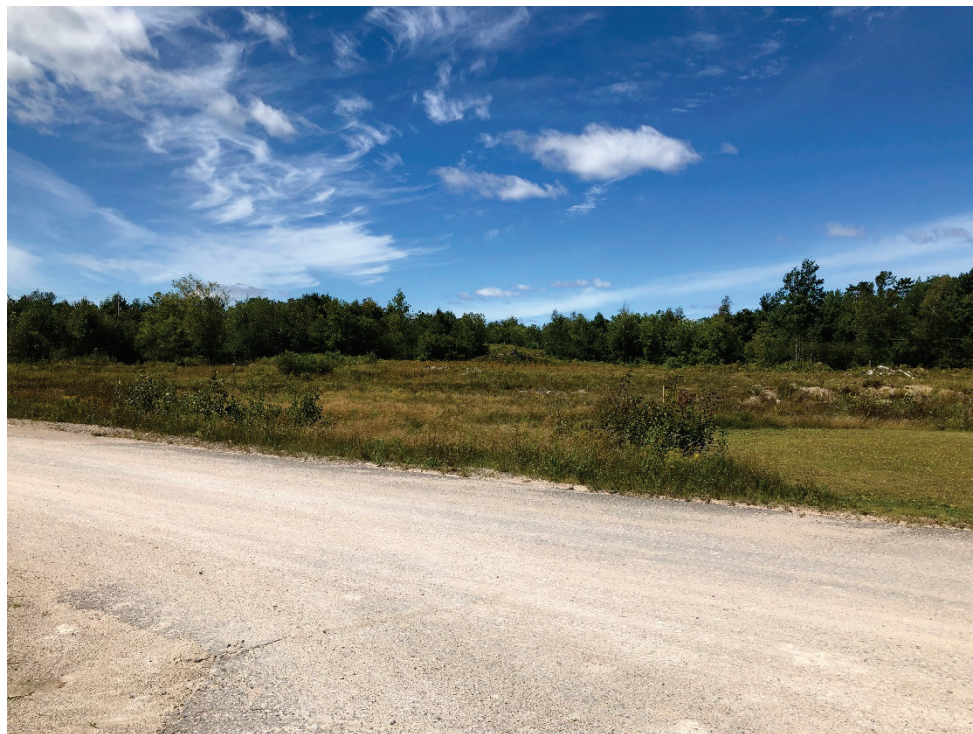
Photo 46 - View of rockhill extension area on the north portion of the property, where old building debris buried.

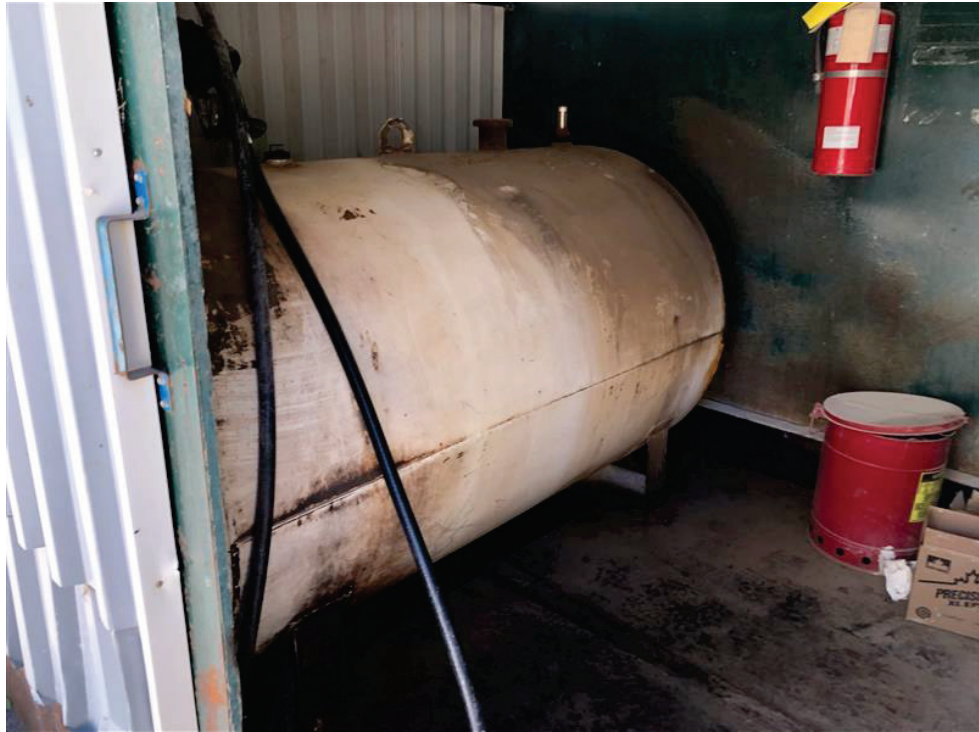
Photo 47 - View of 1,100 L diesel tank located in the Loader Shed.
