**PHASE II AND III  
ENVIRONMENTAL SITE ASSESSMENT  
AND REMEDIAL CONSIDERATIONS  
MARINE EXTRACT LIMITED  
PECHERIES FN FISHERIES LTEE  
EASTPRE FEEDS LTD.  
SHIPPAGAN, NB**

**For  
MARINE EXTRACT LTD  
PECHERIES FN FISHERIES LTEE/LTD  
EASTPRE FEEDS LTD.  
FINAL REPORT  
DATE: MARCH 6, 2020**

Date: March 6, 2020  
File: CBT 60-1

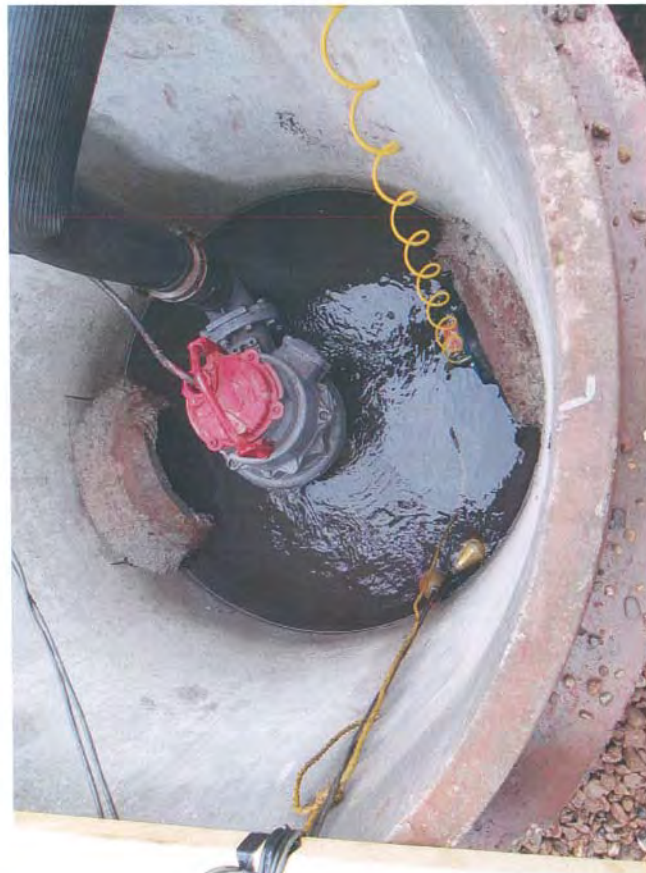
Photo 1-1 Photo showing petroleum sheening in manhole demonstrating that underground services are providing a preferential pathway for movement of contaminated groundwater (from page 11 (A-1871j) of FN A-1871 a,b,c,d,e,f,g,h,i,j, also provided in Appendix 18)

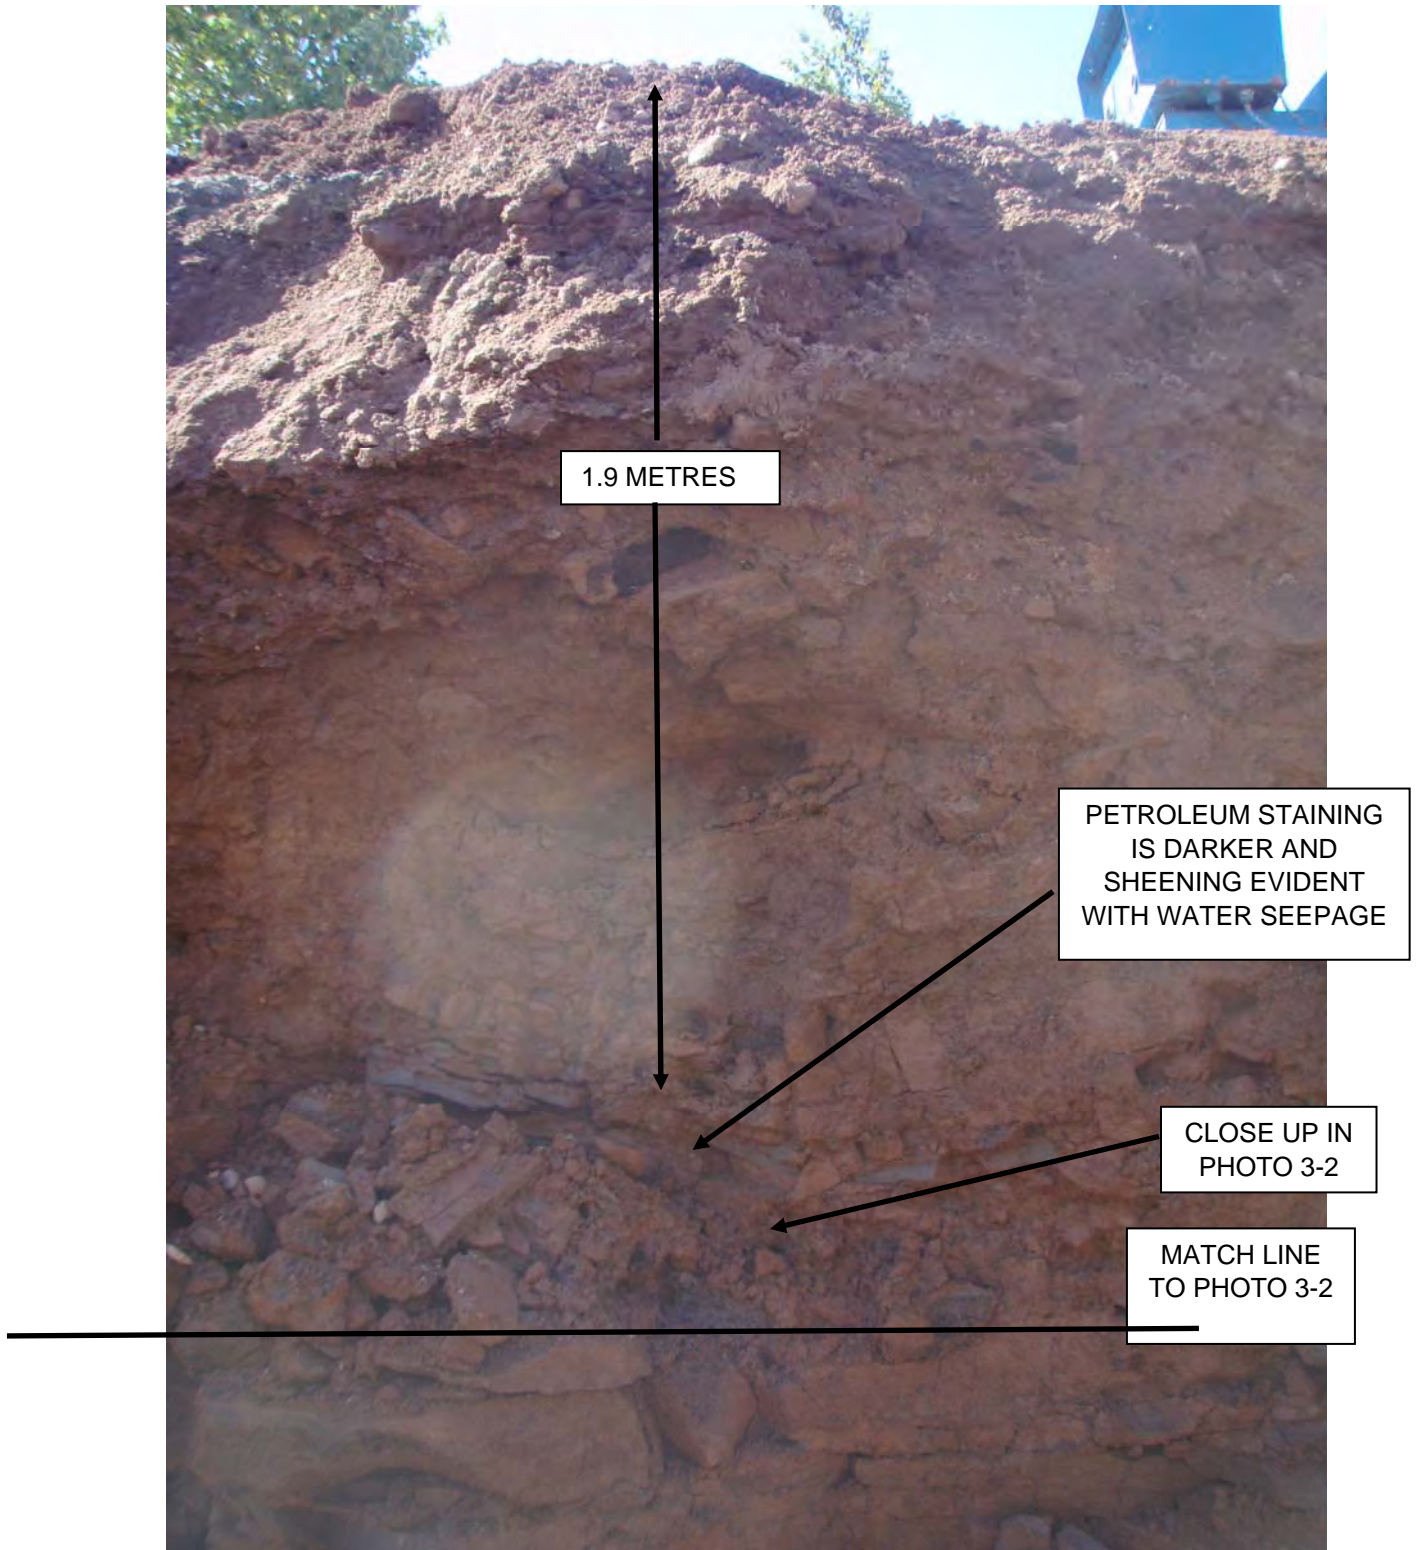
Photo 3-1 at TP3 showing upper 6 feet of test pit profile. See photo 2 for bottom 6 feet with match line.

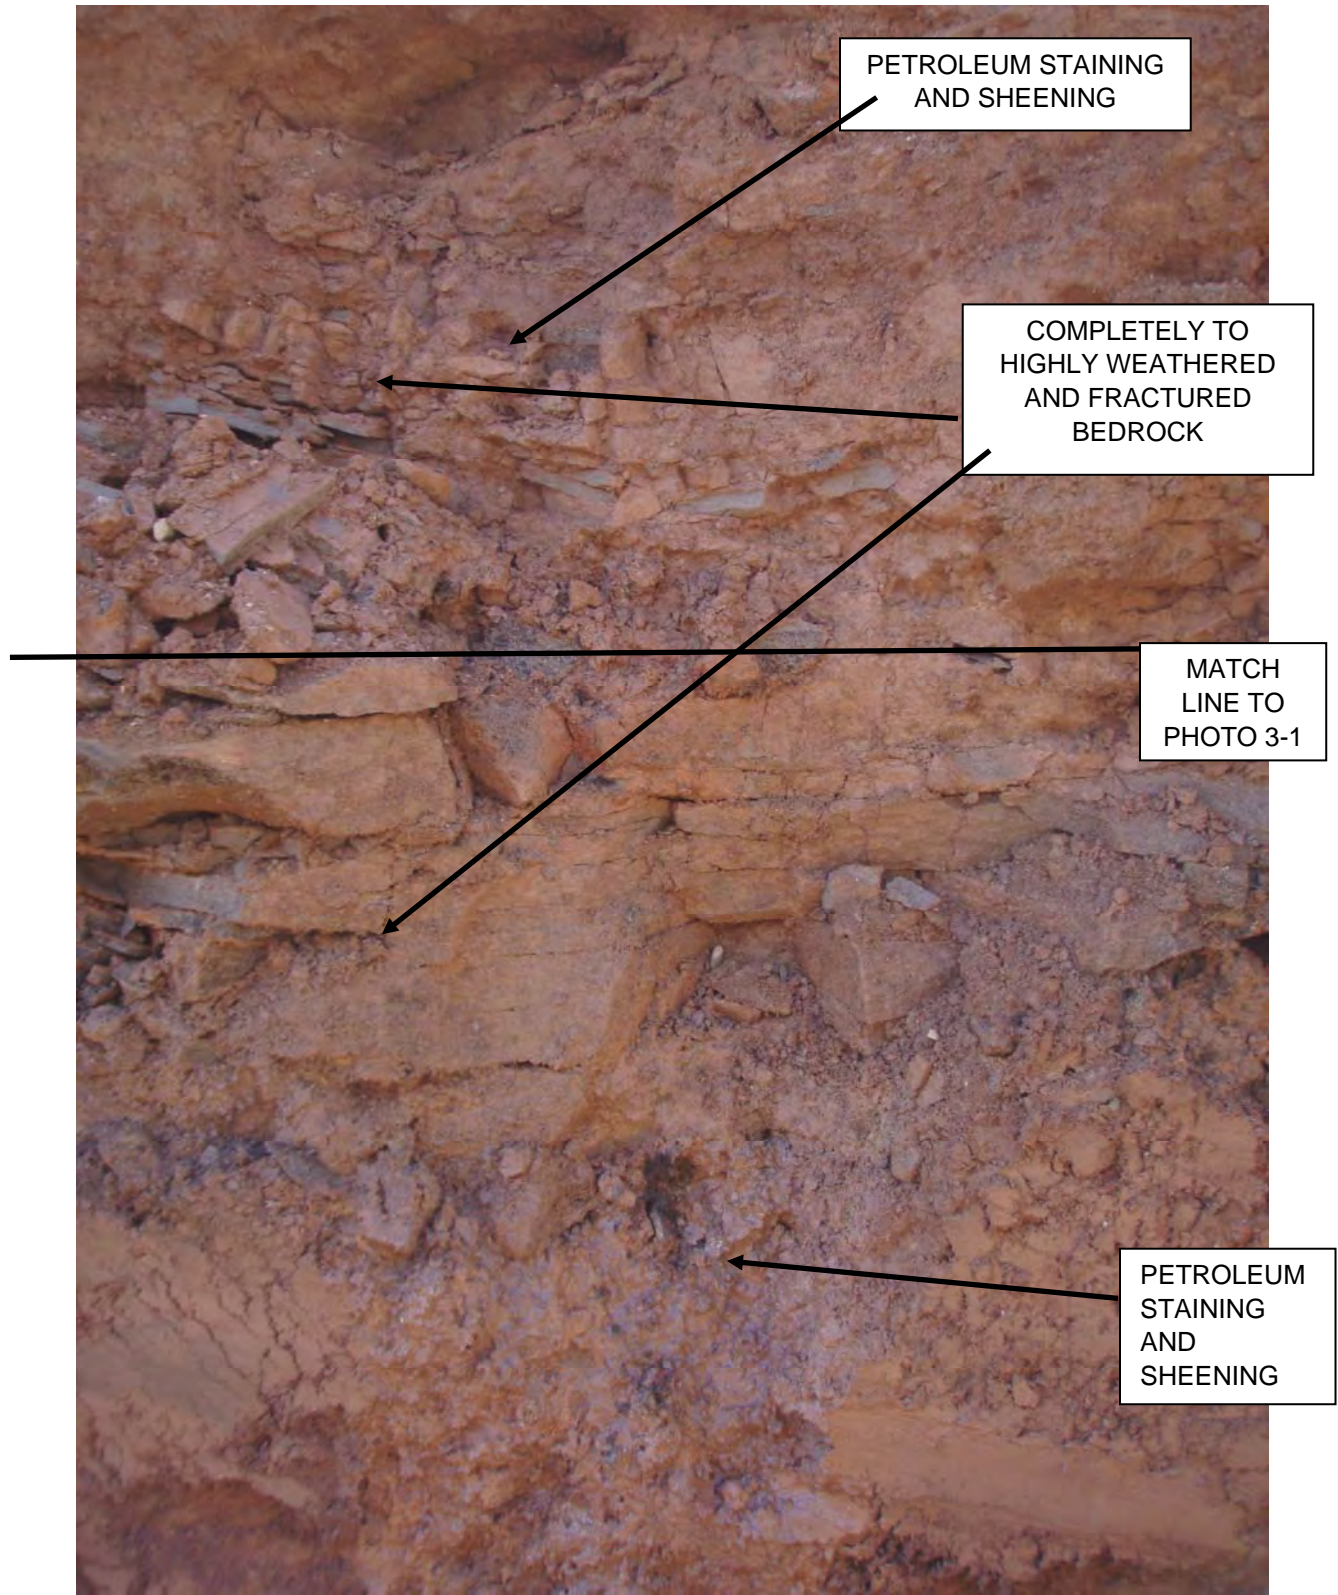
Photo 3-2 at TP 3 at back end of MEL property near 14<sup>th</sup> St showing bottom 6 feet of profile. Upper zone of bedrock fracturing. Petroleum sheening evident.

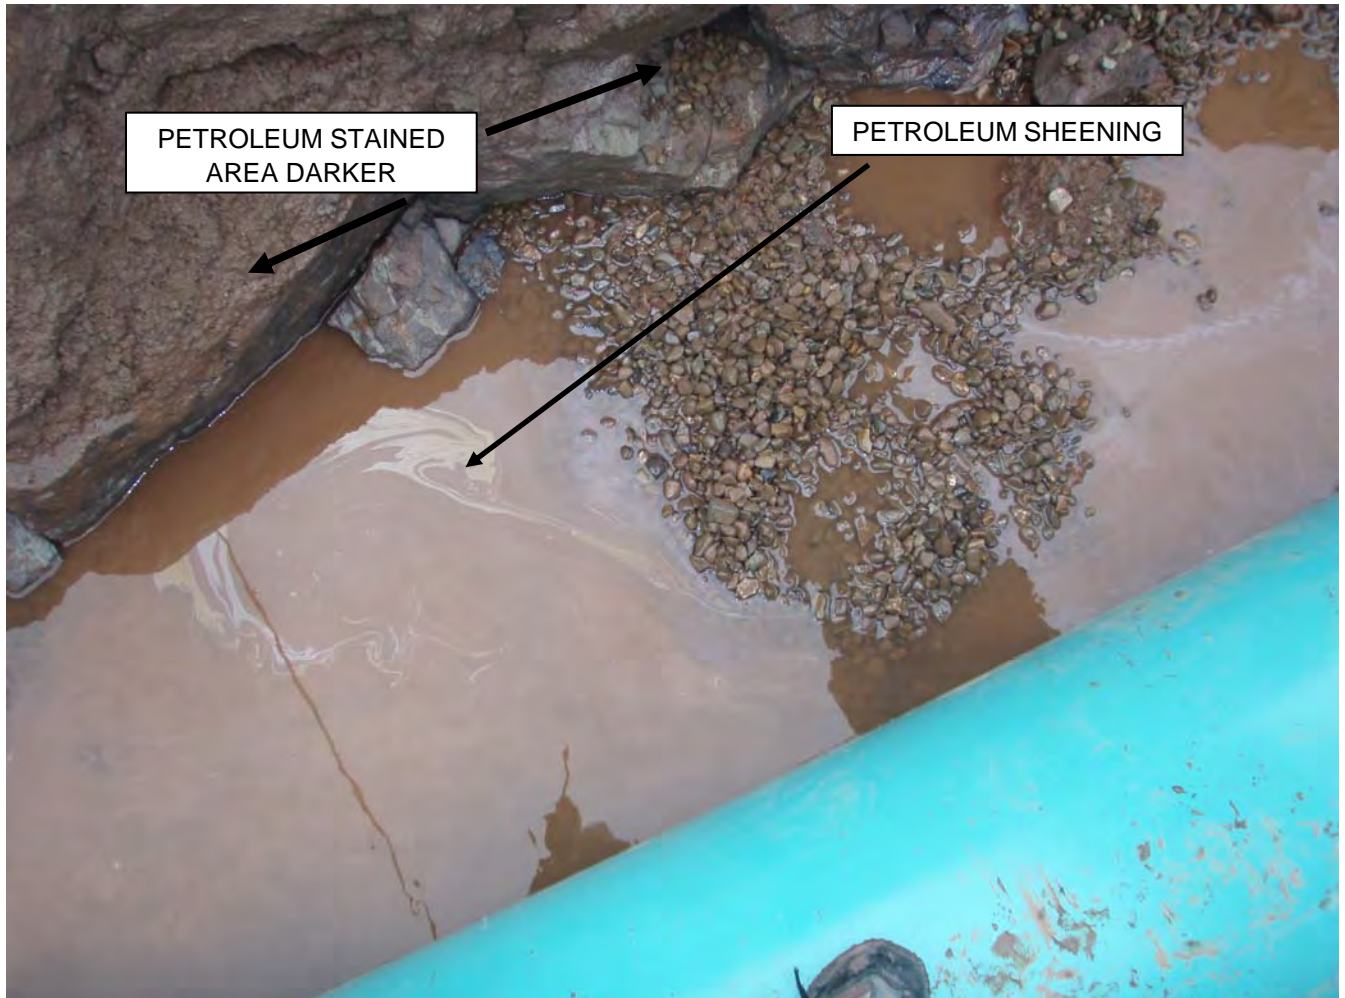
Photo 3-3 showing petroleum sheening in groundwater at TP 3 at back end of MEL property near 14<sup>th</sup> St where petroleum sheening was evident in seepage on the wall of the excavation (see Photo 3-2).

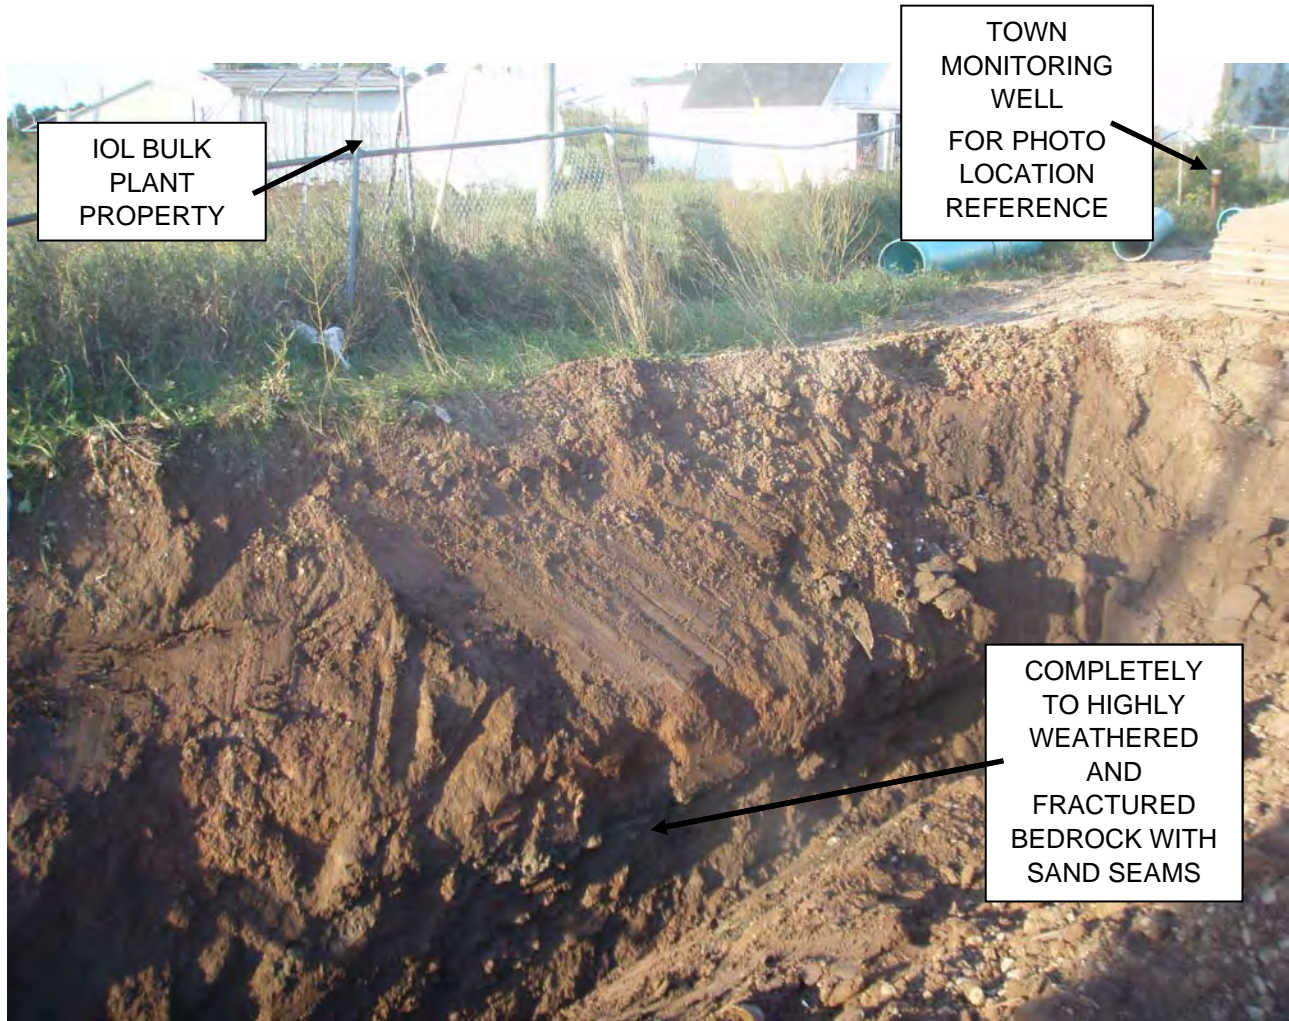
Photo 3-4 Bedrock with interbedding layers with mudstone/siltstone.

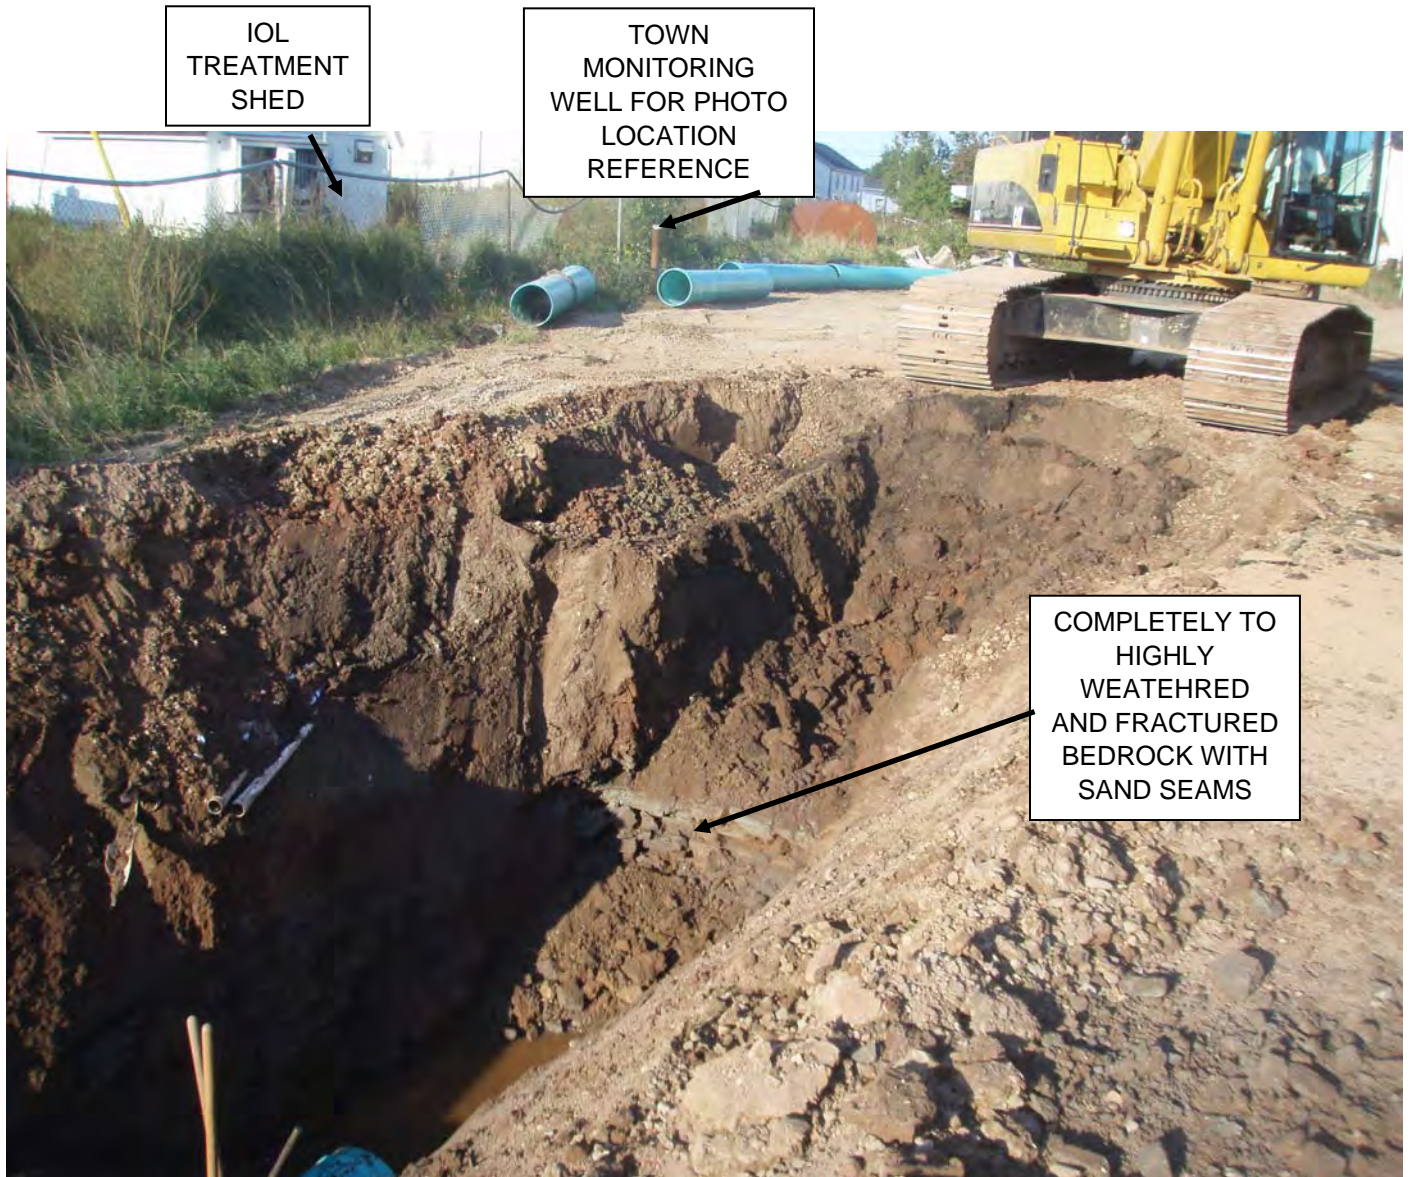
Photo 3-5 Showing highly fractured bedrock.

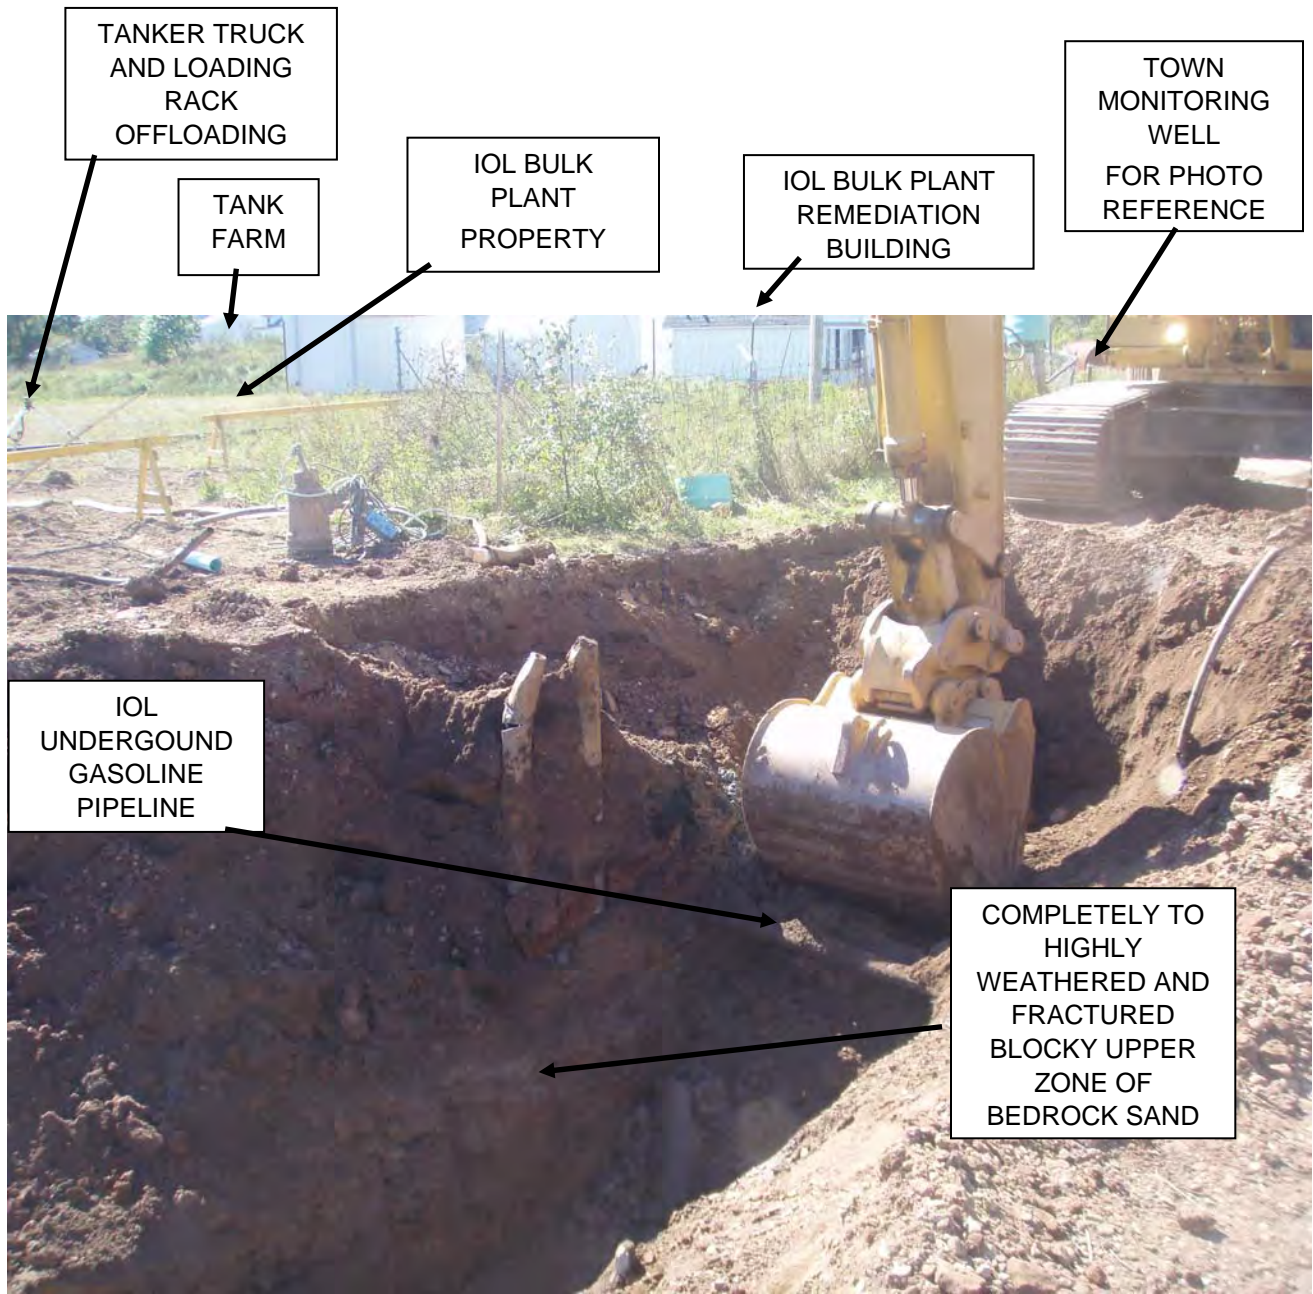
Photo 3-6 Looking towards IOL site from west side of FN/MEL. Bedrock fracturing and horizontal layering shown is typical.

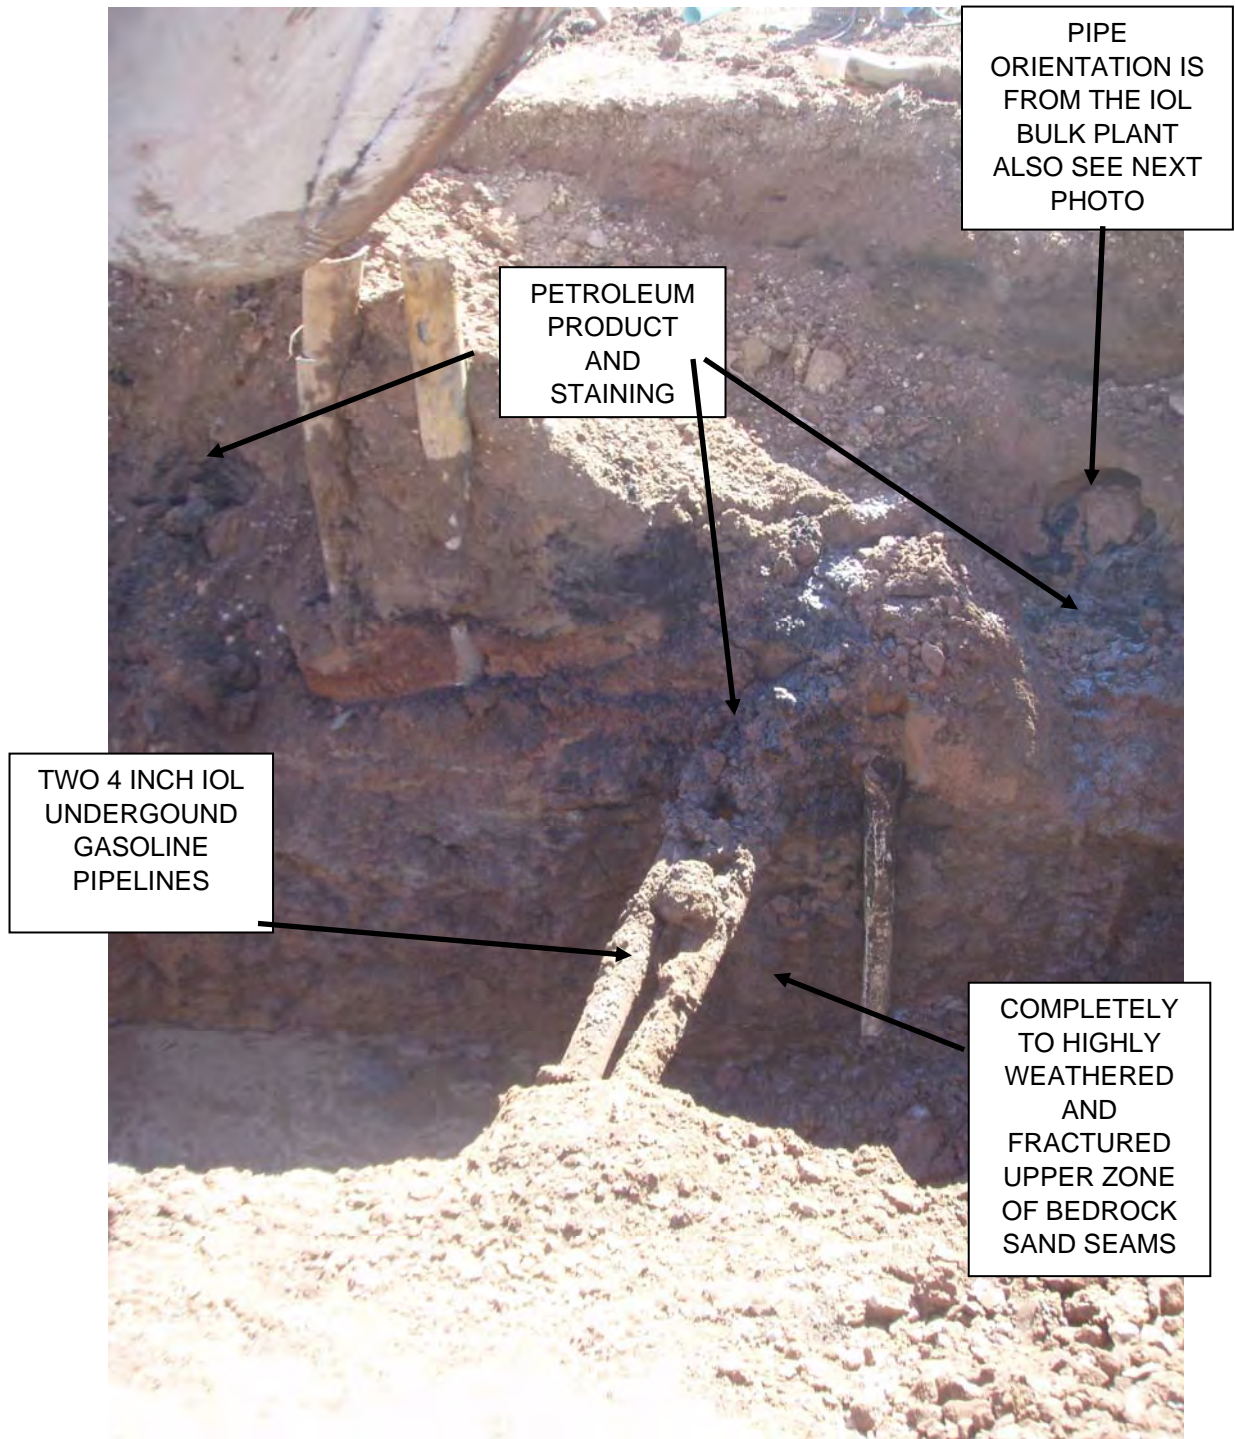
Photo 3-7 Also refer to Photos 3-6 and 3-8. IOL underground gasoline transfer lines. The orientation of the 8 inch pipe with petroleum sludge discharge appears to be from the IOL bulk plant property based on orientation of pipe.

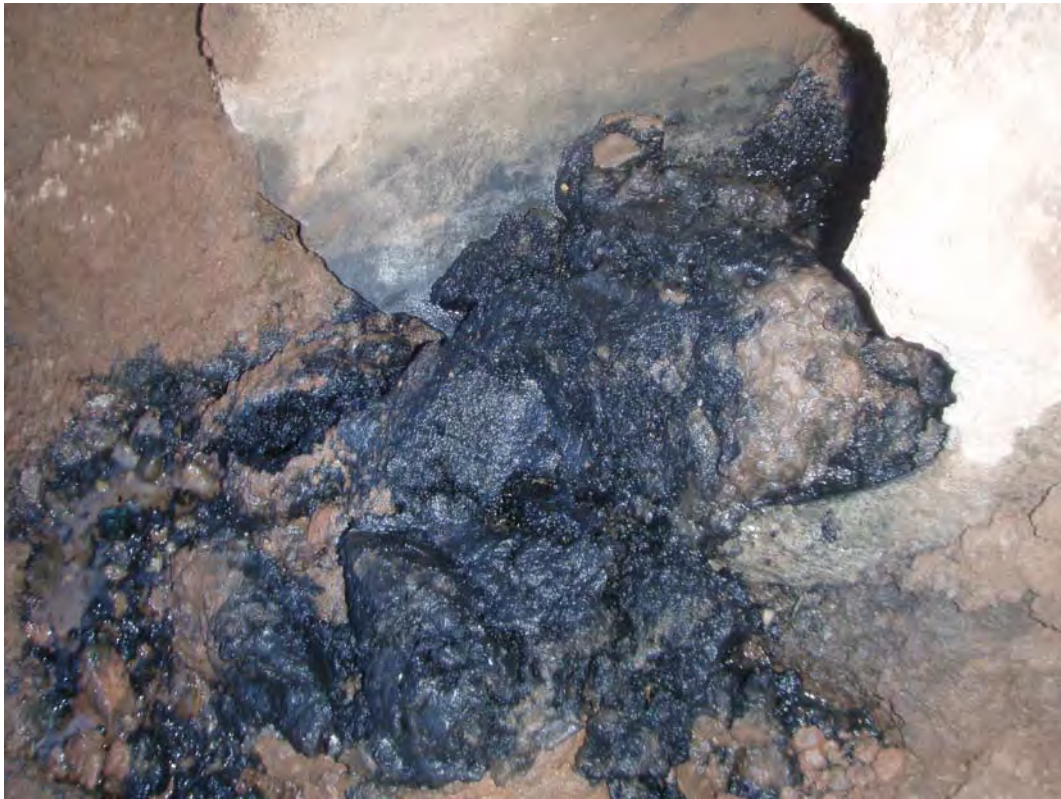
Photo 3-8 Close up shot of petroleum staining for conduit having an orientation that indicates the pipe to be from the IOL bulk plant property. Photos 3-6 and 3-7 shows relative location of pipe with the IOL buildings apparent and Town well noted “for “ reference on photos.

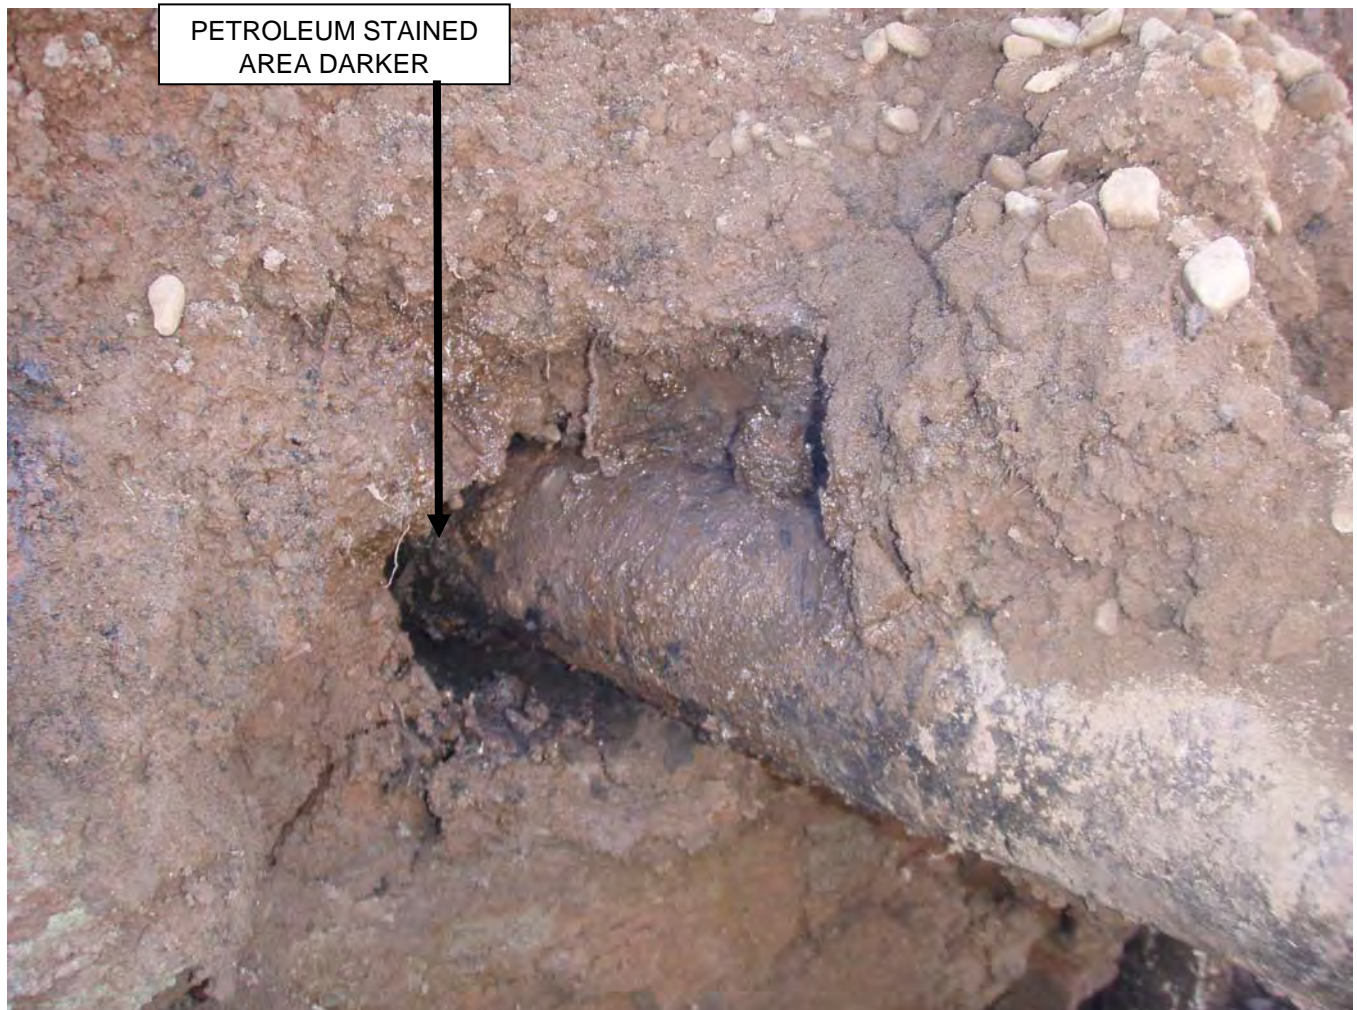
Photo 3-9 This is a photo underneath one of the IOL 4 inch underground gasoline transfer lines showing petroleum product and staining. Location shown in previous photos. Photos 3- 6 and 3-7 shows relative location of pipe with the IOL buildings apparent and Town well noted "for " reference on photos.

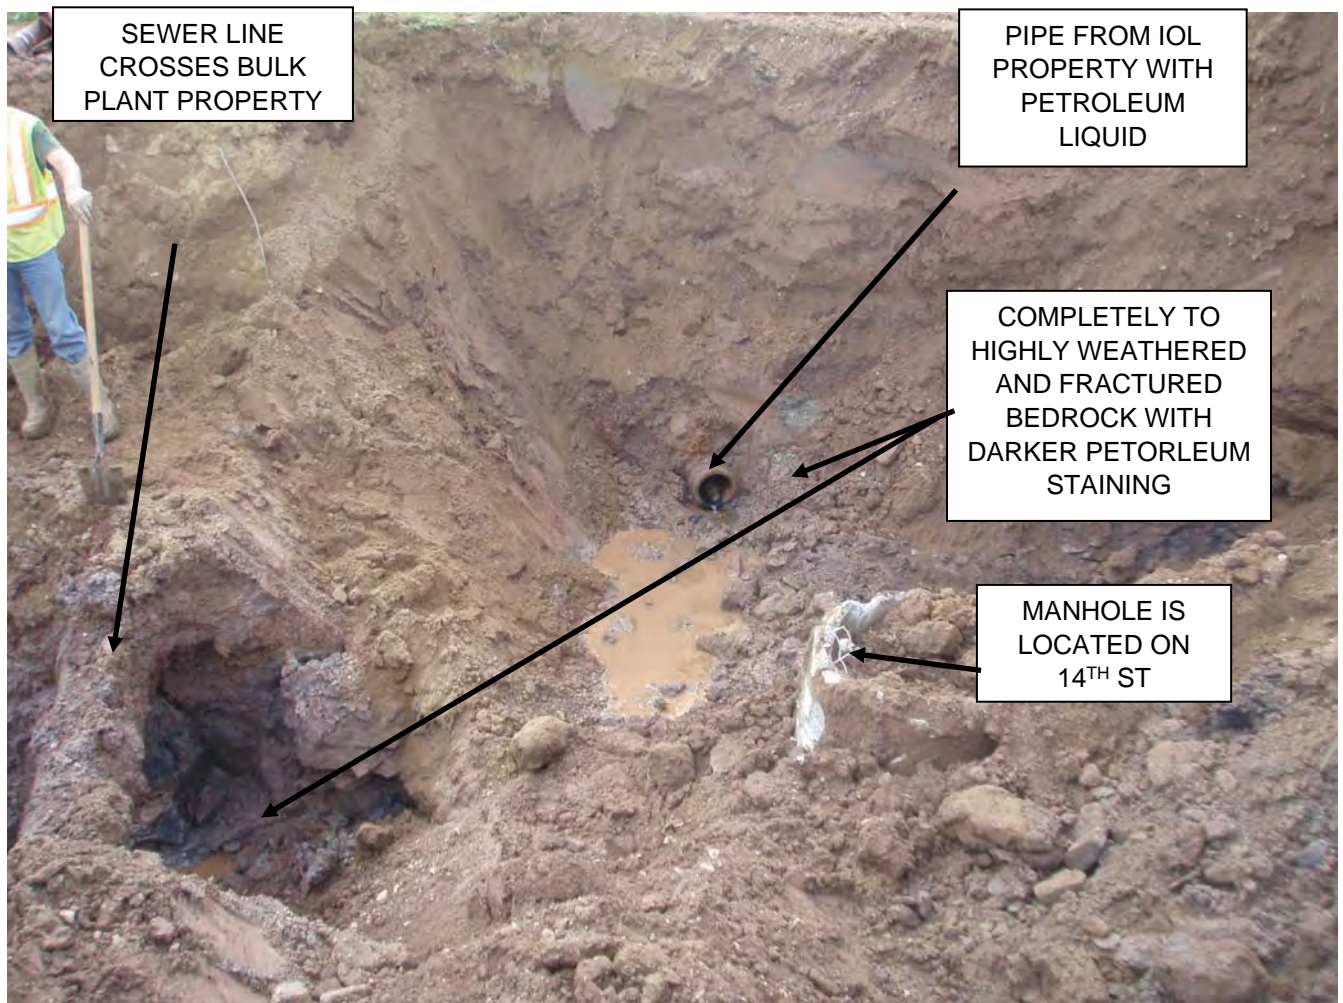
Photo 3-10. Underground sewer line at the boundary of IOL bulk plant and 14<sup>th</sup> street. Original sewer line located on the bulk plant property and parallel to the east side of the IOL bulk plant. IOL would not allow the line to be upgraded and Town had to do a build around. A four inch pipe was also encountered at the IOL bulk plant property boundary, with petroleum contaminated liquid being emitted.

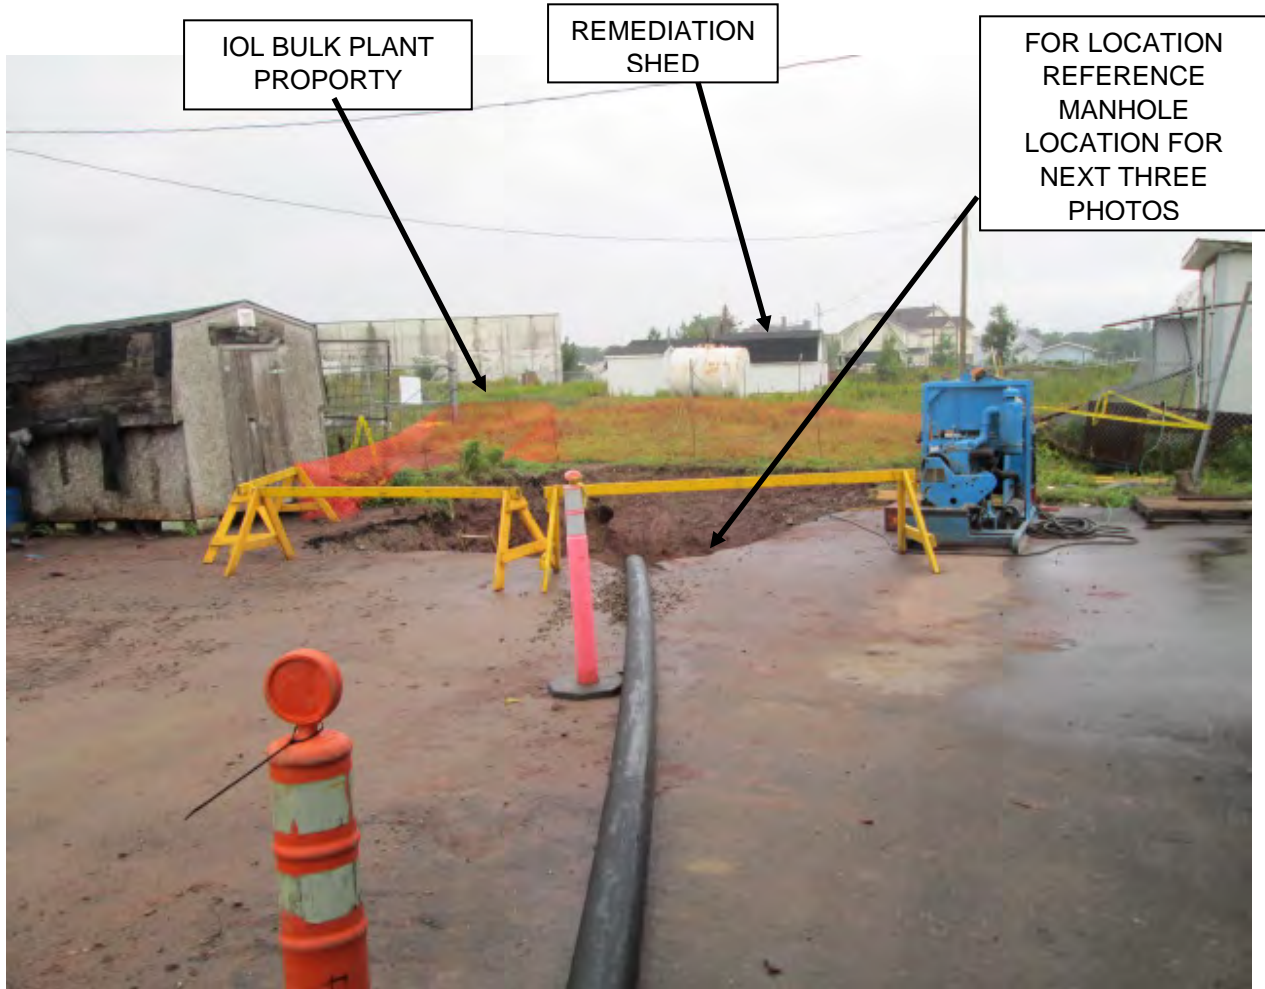
Photo 3-11. Underground sewer line at the boundary of IOL bulk plant and 14<sup>th</sup> street. Manhole location upgrades reference location to IOL bulk plant. Also see Photos 3-10, 3-12, 3-13 and 3-14.

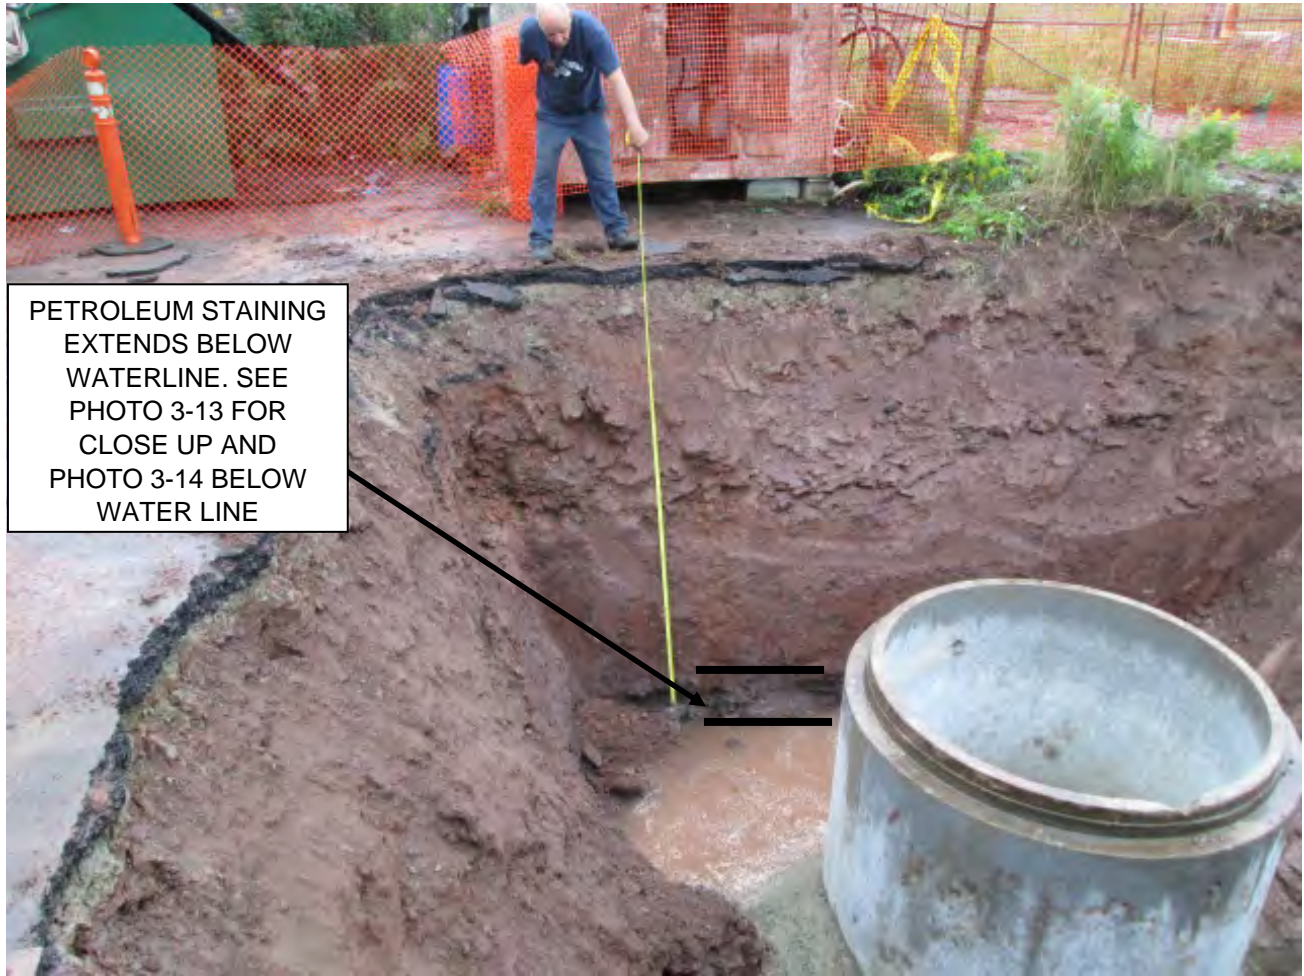
Photo 3-12. See Photo 3-12 for reference location. Underground sewer line at the boundary of IOL bulk plant and 14<sup>th</sup> street with new manhole installed. Grey area at water line showing petroleum staining. Also see Photos 3-10, 3-11, 3-13 and 3-14.

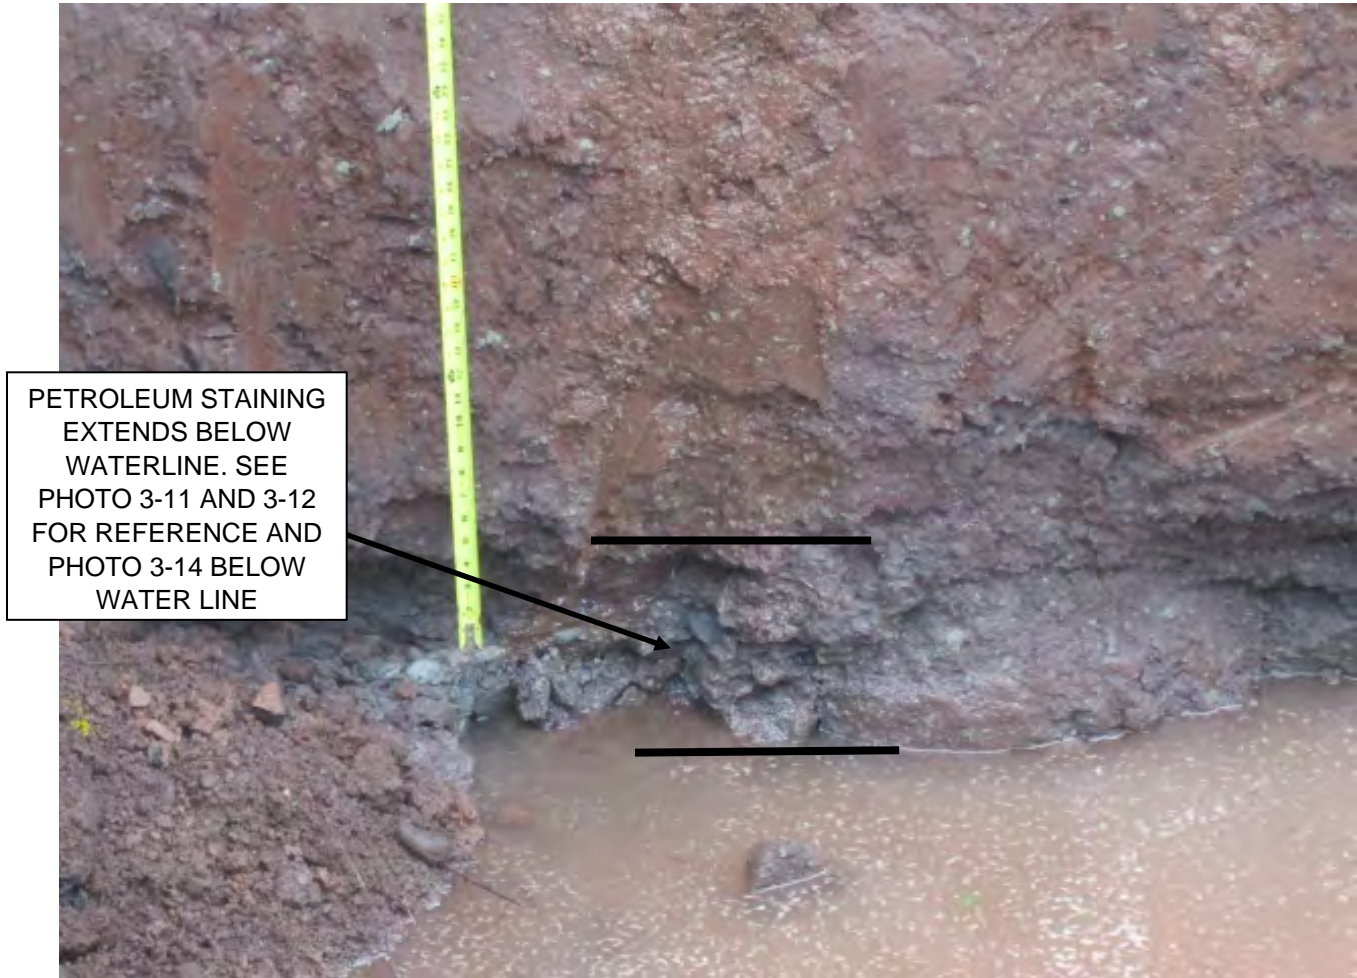
Photo 3-13. Close up of petroleum staining at water line shown in Photo 3-12. See Photos 3-11 and 3-12 for reference location. Underground sewer line at the boundary of IOL bulk plant and 14<sup>th</sup> street with new manhole installed. Darker grey area at water line showing petroleum staining. Also see Photos 3-10 and 3-14.

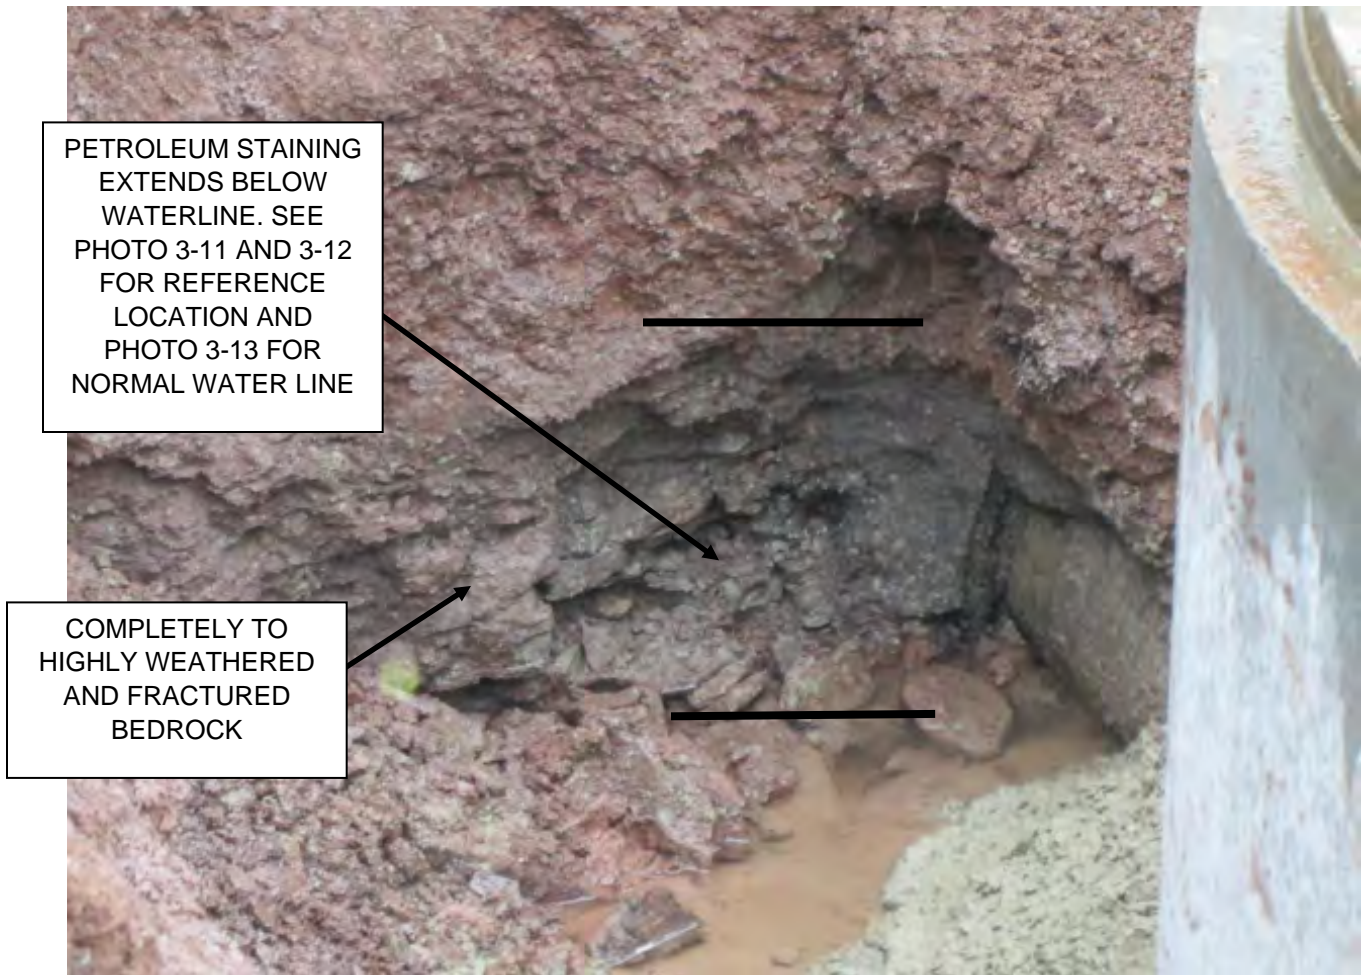
Photo 3-14. Demonstration of preferential flow pathway associated with extensive network of underground services and highly fractured bedrock conditions. Close up of petroleum staining at water line FOR shown in Photo 3-12. See Photos 3-11 and 3-12 for reference location. Underground sewer line at the boundary of IOL bulk plant and 14<sup>th</sup> street with new manhole installed. Darker grey area at water line showing petroleum staining as a result of contaminate migration associated with groundwater flow along underground services. Also see Photos 3-10 and 3-14.
