**PHASE II AND III  
ENVIRONMENTAL SITE ASSESSMENT  
AND REMEDIAL CONSIDERATIONS  
MARINE EXTRACT LIMITED  
PECHERIES FN FISHERIES LTEE  
EASTPRE FEEDS LTD.  
SHIPPAGAN, NB**

**For  
MARINE EXTRACT LTD  
PECHERIES FN FISHERIES LTEE/LTD  
EASTPRE FEEDS LTD.  
FINAL REPORT  
DATE: MARCH 6, 2020**

Date: March 6, 2020  
File: CBT 60-1

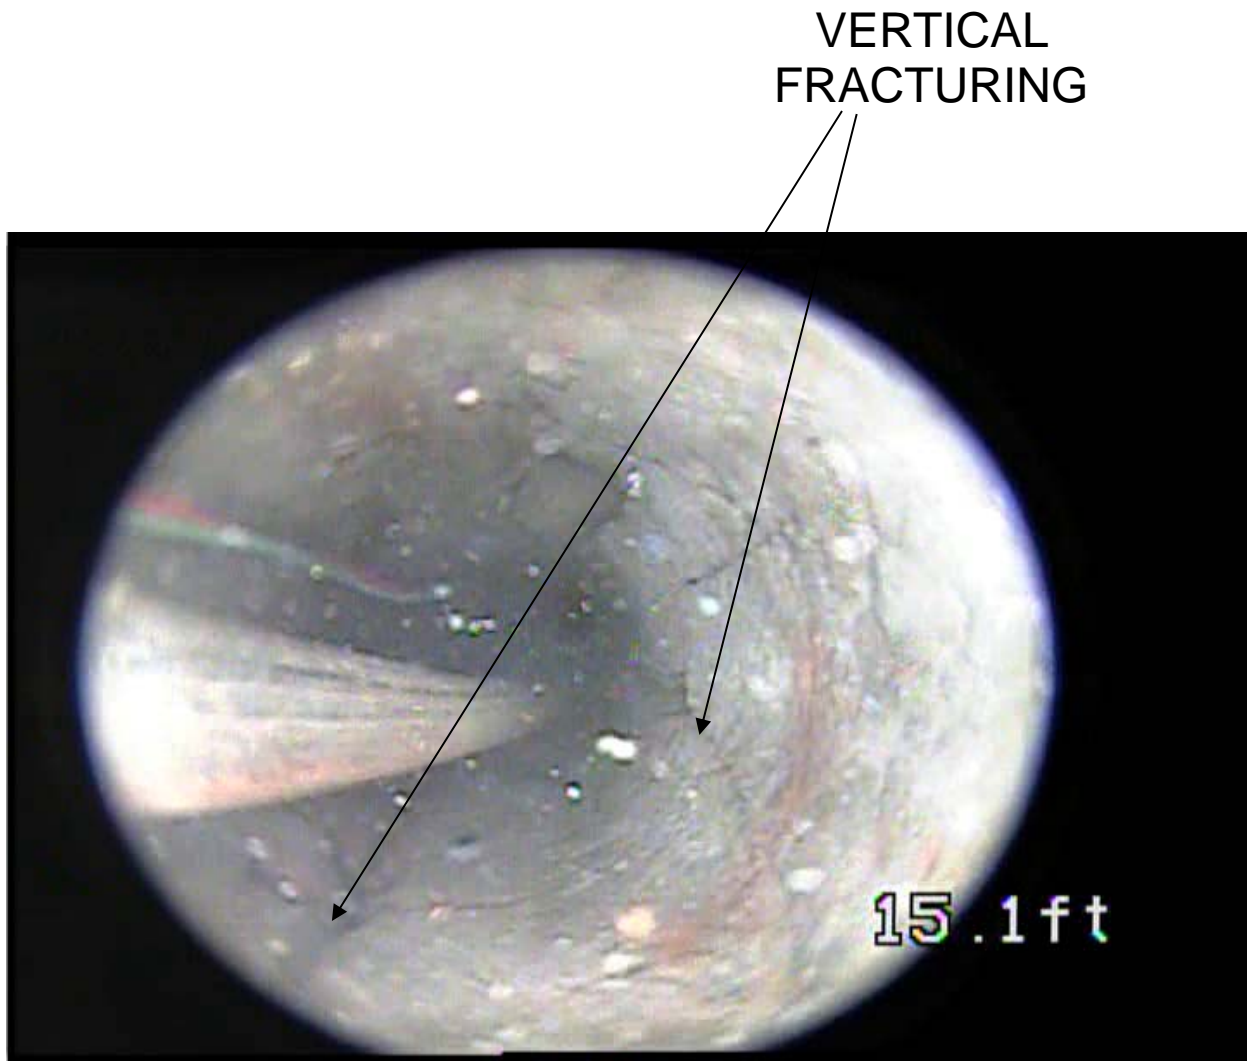
Several downhole video stills showing the extensive and significant fracturing in the bedrock are provided in Photos 3-15 to 3-18 for 16MW20A located on the IOL bulk plant and adjacent to 14<sup>th</sup> St. and Photos 3-16 to 3-19 for 16MW 22B located about 140 metres down gradient of 16MW20A and are also included in Appendix 72. Monitoring Well 16MW22B is located near the northeast corner of the MEL building about 140 metres from 16MW20 located on the IOL bulk plant property, in the direction of the wharf and several metres from the IOL underground gasoline transfer line and the FN water supply well that is constructed to 120 foot depth. The cobble

Photo 3-15 Of Photo group 3-15 to 3-18 for Video Snapshots showing major fracturing from 14 ft. to 19 ft. at 16MW20A. Well 16MW20A is located near IOL and 14th St. boundary. Photo also included in Appendix 72

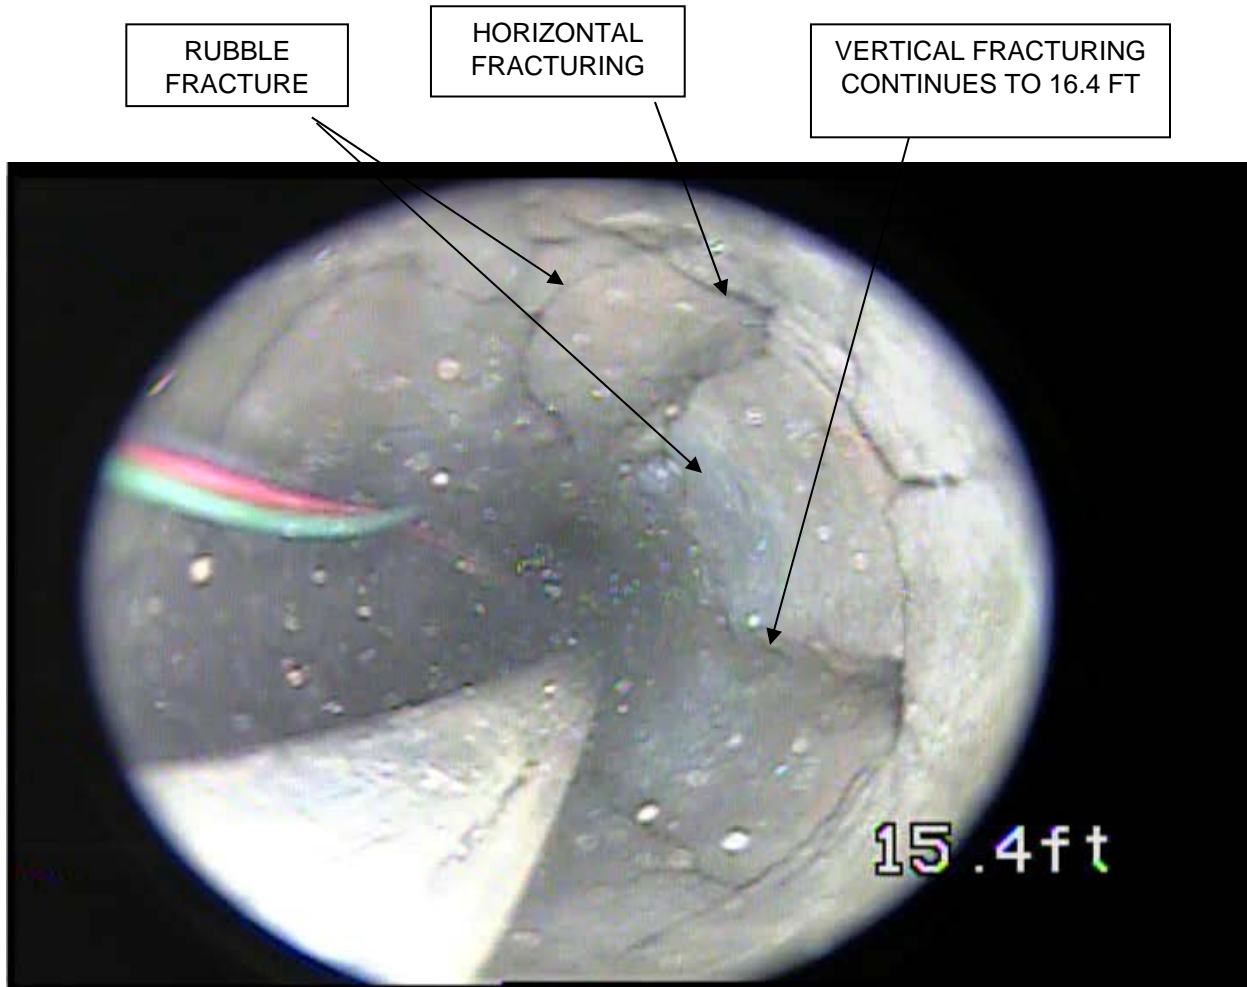
Photo 3-16 Of Photo group 3-15 to 3-18 for Video Snapshots showing major fracturing from 14 ft. to 19 ft. at 16MW20A. Well 16MW20A is located near IOL and 14th St. boundary. Photo also included in Appendix 72.

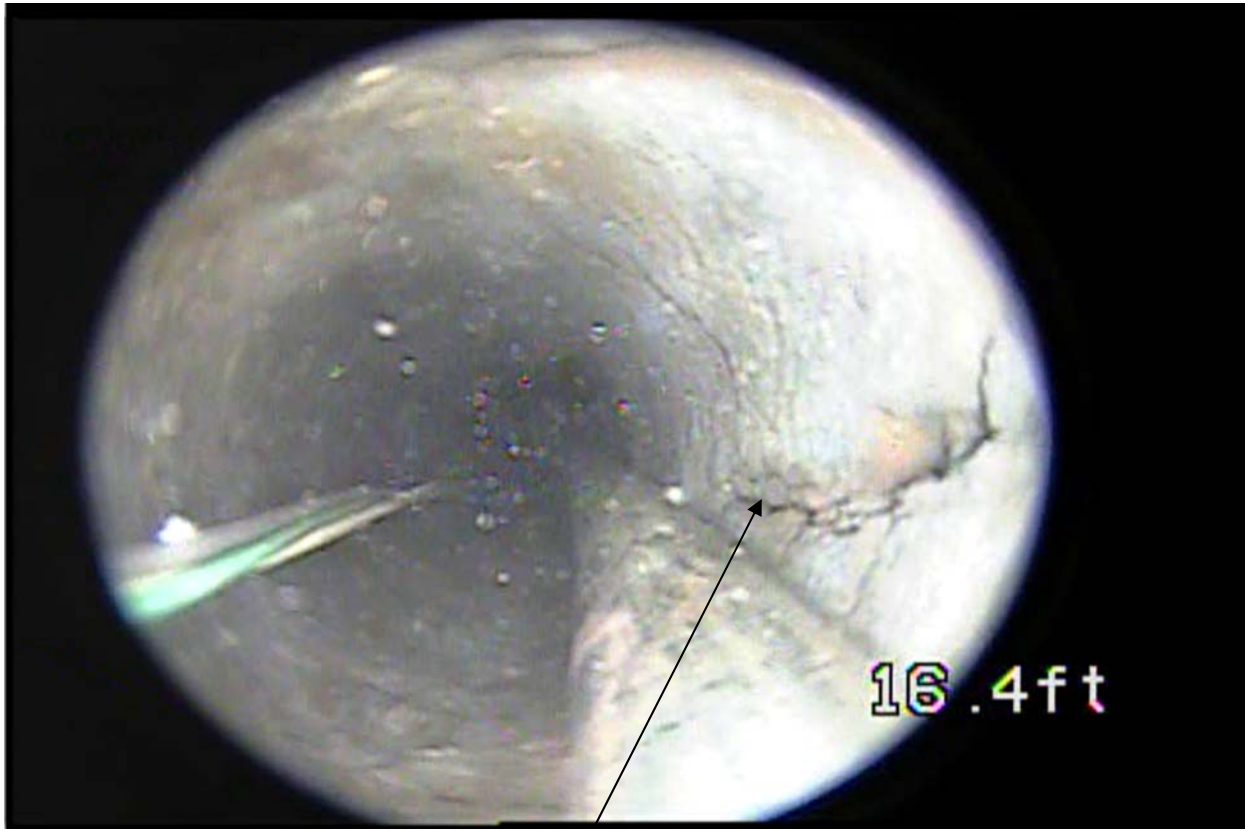
VERTICAL FRACTURING  
CONTINUES AT 16.4 FT

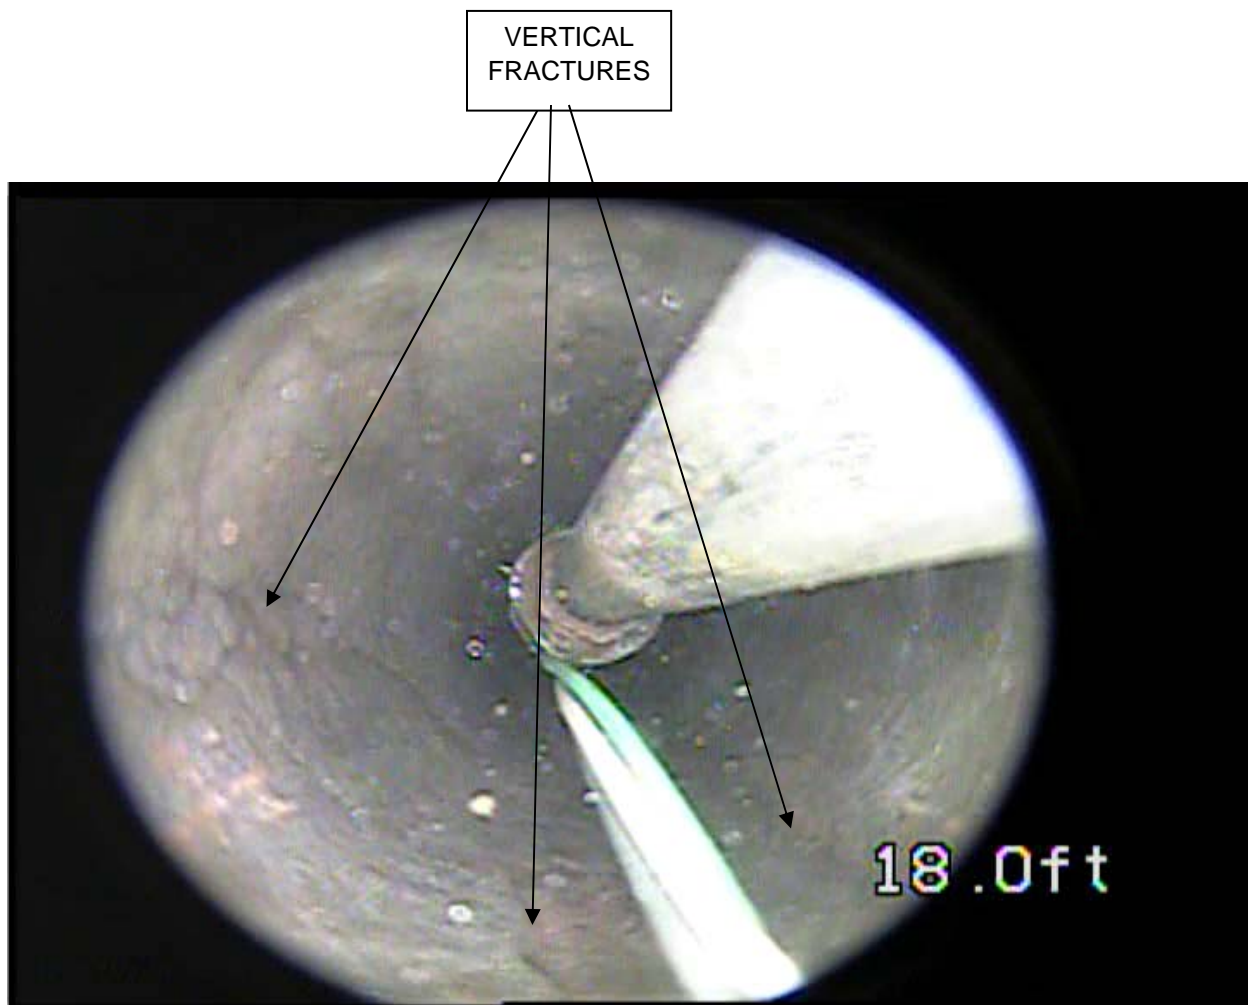
Photo 3-18 Of Photo group 3-15 to 3-18 for Video Snapshots showing major fracturing from 14 ft. to 19 ft. at 16MW20A. Well 16MW20A is located near IOL and 14th St. boundary. Photo also included in Appendix 72.

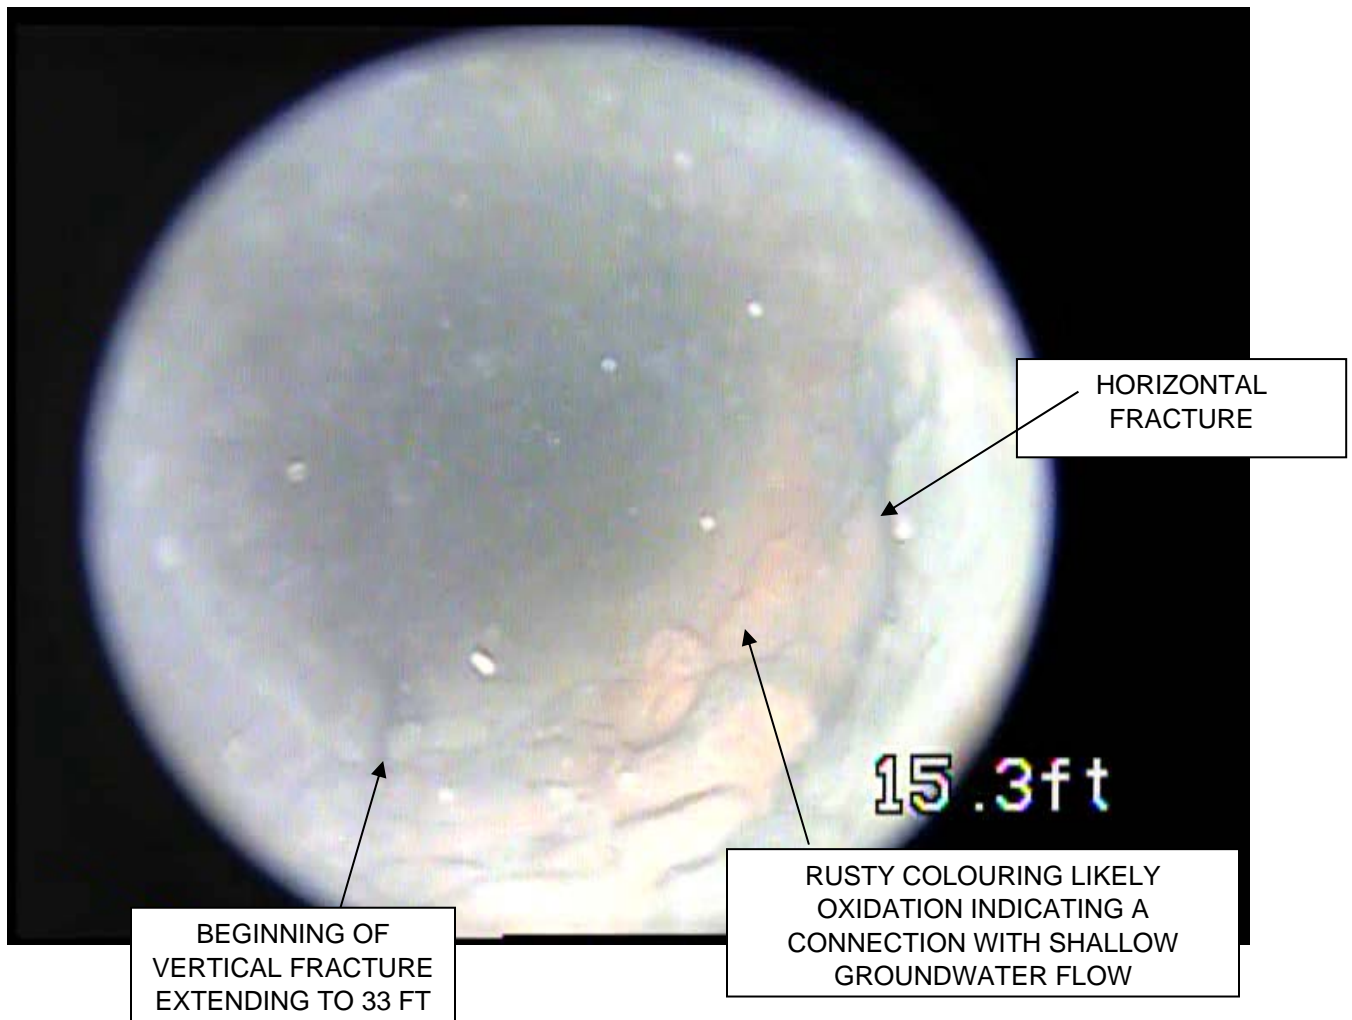
Well 16MW22B is located near the northeast corner of the MEL building about 140 metres from 16MW20 located on the IOL bulk plant property, in the direction of the wharf and several metres from the IOL underground gasoline transfer line and the FN water supply well that is constructed to 120 foot depth. The cobble and cave fractures appear to represent zones of significant fracturing and vertical fractures are evident that extend several metres, providing an interconnection with the two highly fractured zones in the bedrock, that show a downward dip from the IOL site toward the FN/MEL properties and the wharf.

Photo 3-19 Of Photo group 3-19 to 3-22 for Video Snapshots showing major fracturing from 15.4 ft. to 33 ft. at 16MW22B. Well 16MW22B is located near the northeast corner of the MEL building about 150 metres from 16MW20 located on the IOL bulk plant property, in the direction of the wharf and several metres from the IOL underground gasoline transfer line and the FN water supply well that is constructed to 120 foot depth. Photo also included in Appendix 72.

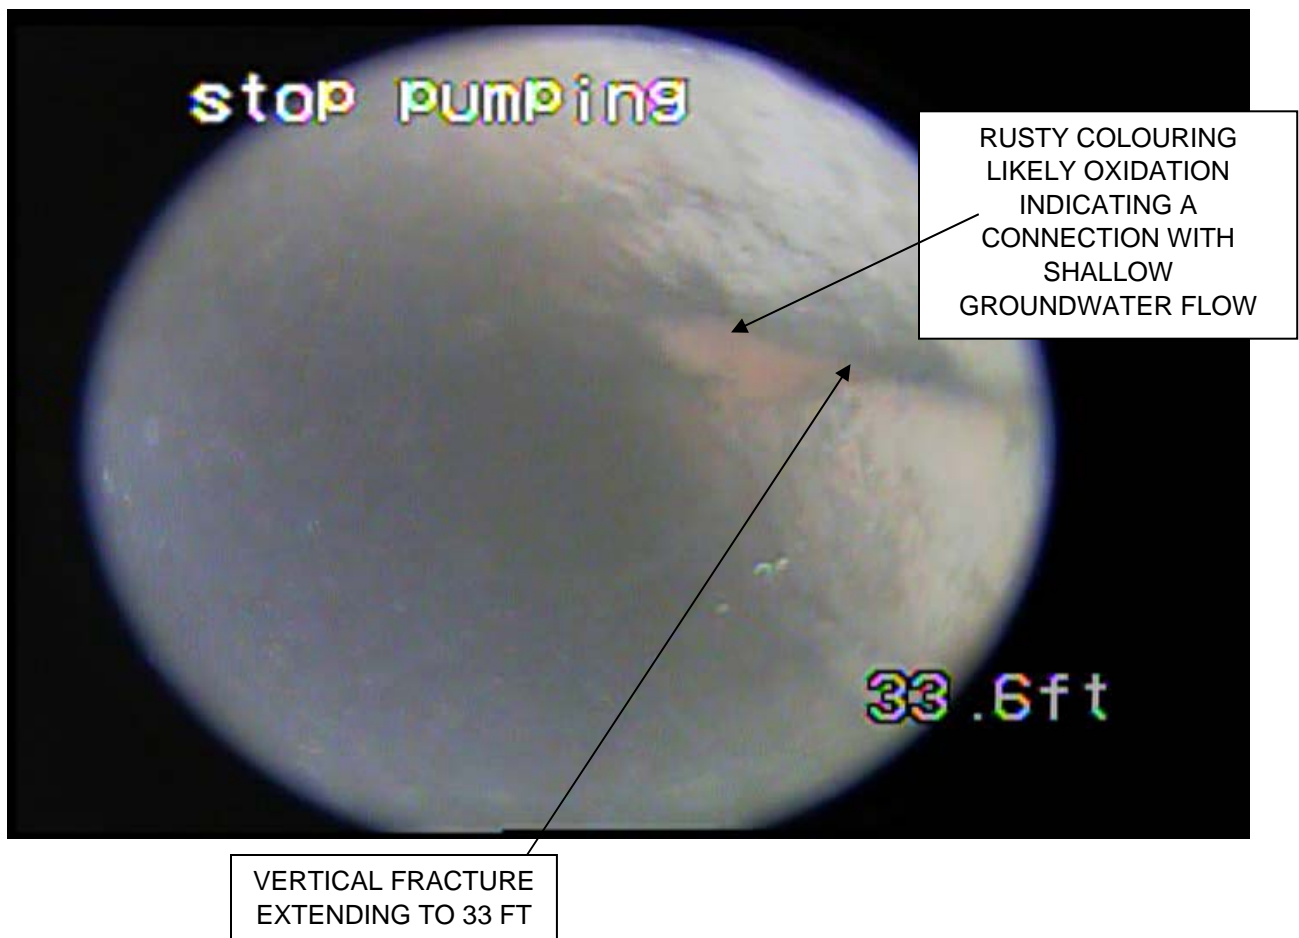
Photo 3-20 Of Photo group 3-19 to 3-22 for Video Snapshots showing major fracturing from 15.4 ft. to 33 ft. at 16MW22B. Well 16MW22B is located near the northeast corner of the MEL building about 150 metres from 16MW20 located on the IOL bulk plant property, in the direction of the wharf and several metres from the IOL underground gasoline transfer line and the FN water supply well that is constructed to 120 foot depth. Photo also included in Appendix 72.

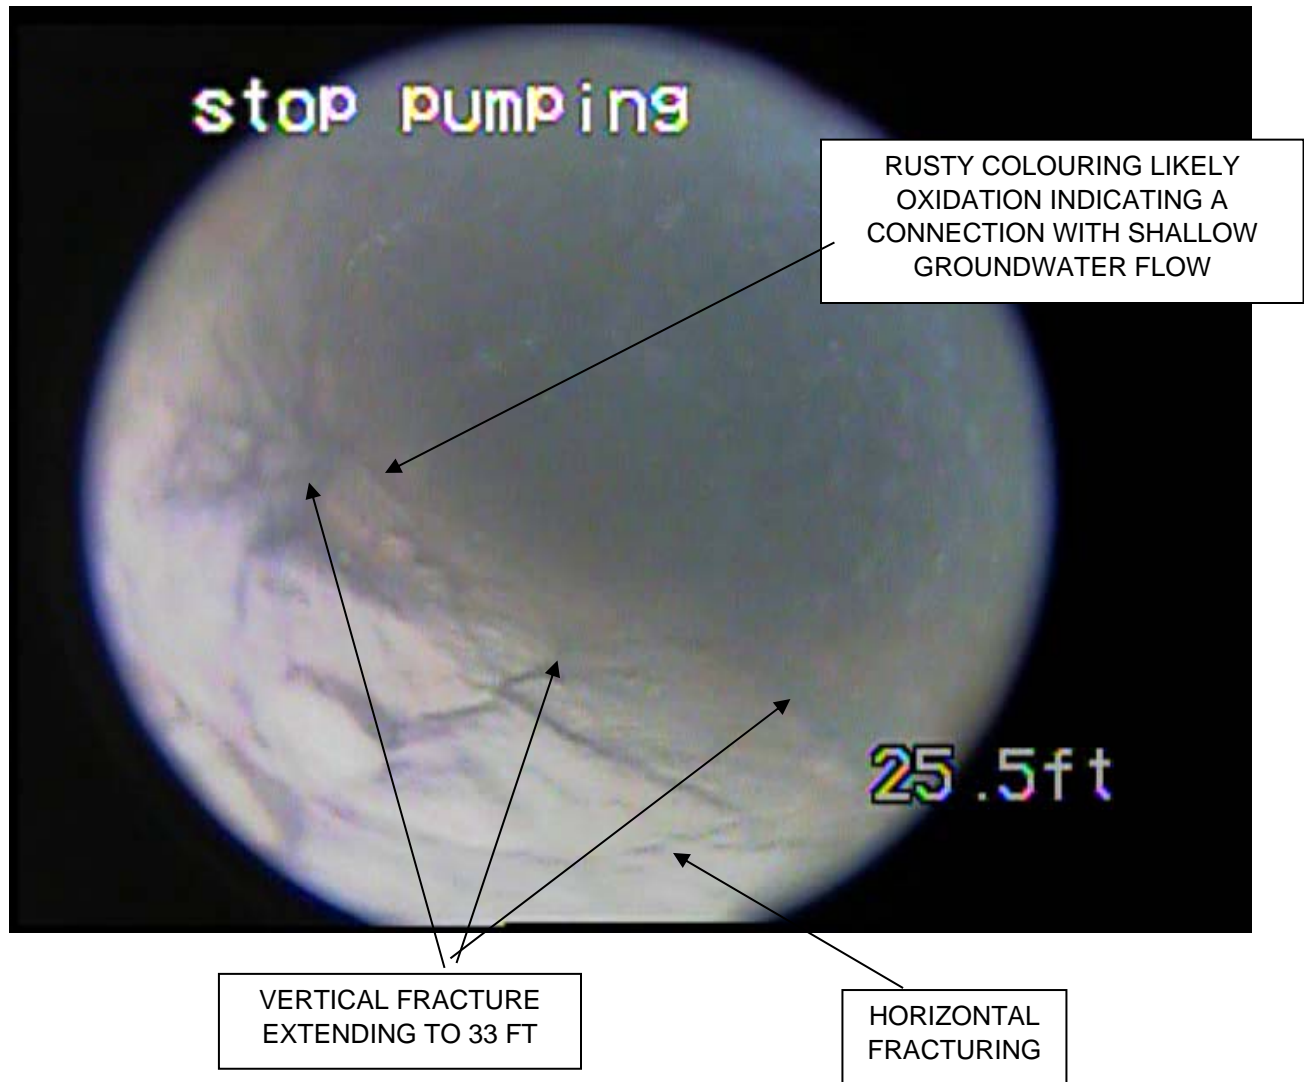
Photo 3-21 Of Photo group 3-19 to 3-22 for Video Snapshots showing major fracturing from 15.4 ft. to 33 ft. at 16MW22B. Well 16MW22B is located near the northeast corner of the MEL building about 150 metres from 16MW20 located on the IOL bulk plant property, in the direction of the wharf and several metres from the IOL underground gasoline transfer line and the FN water supply well that is constructed to 120 foot depth. Photo also included in Appendix 72.

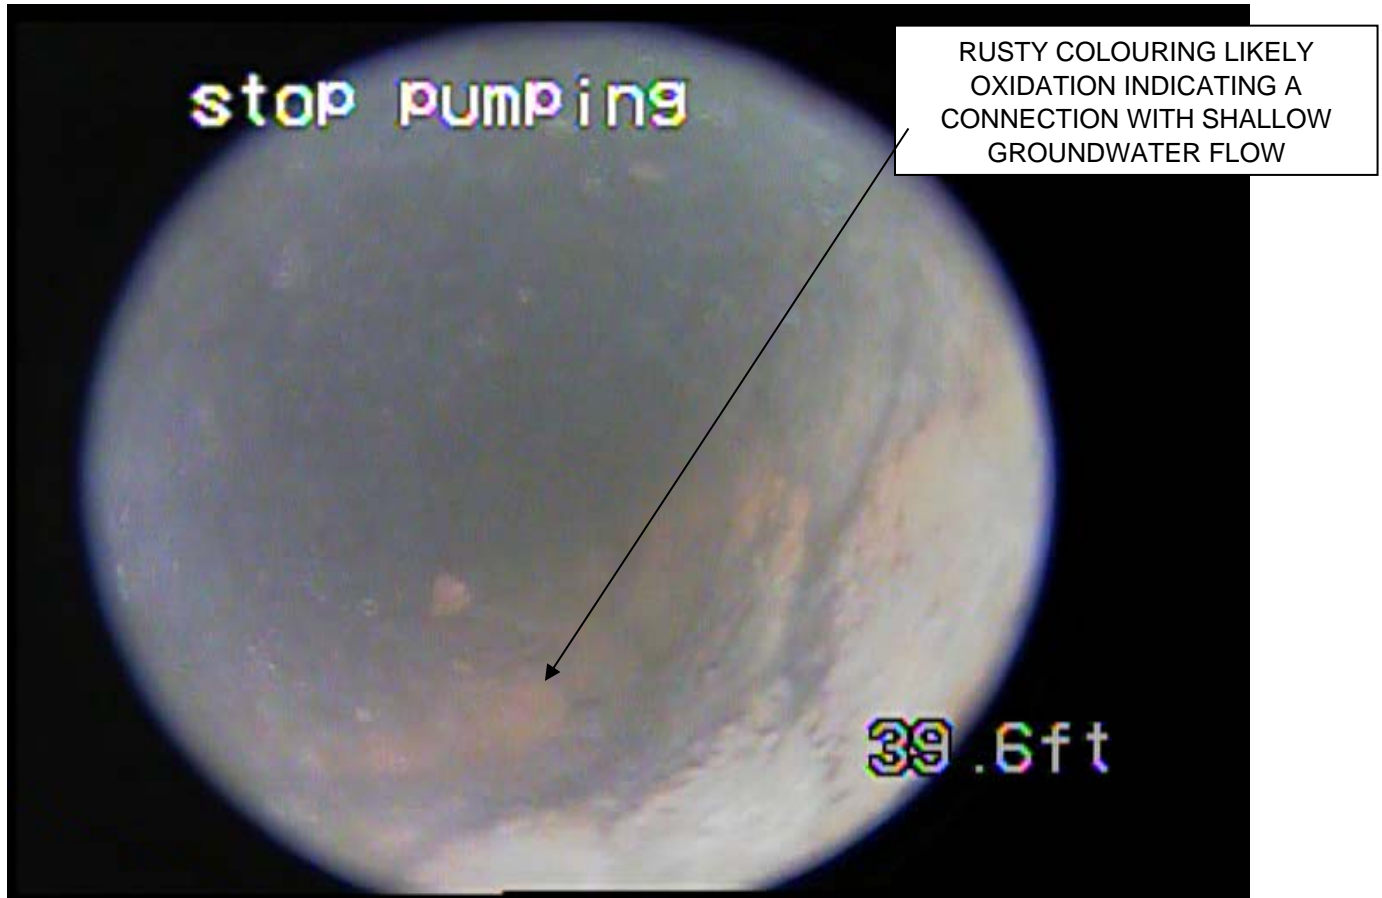
Photo 3-22 Of Photo group 3-19 to 3-22 for Video Snapshots showing major fracturing from 15.4 ft. to 33 ft. at 16MW22B. Well 16MW22B is located near the northeast corner of the MEL building about 150 metres from 16MW20 located on the IOL bulk plant property, in the direction of the wharf and several metres from the IOL underground gasoline transfer line and the FN water supply well that is constructed to 120 foot depth. Photo also included in Appendix 72.

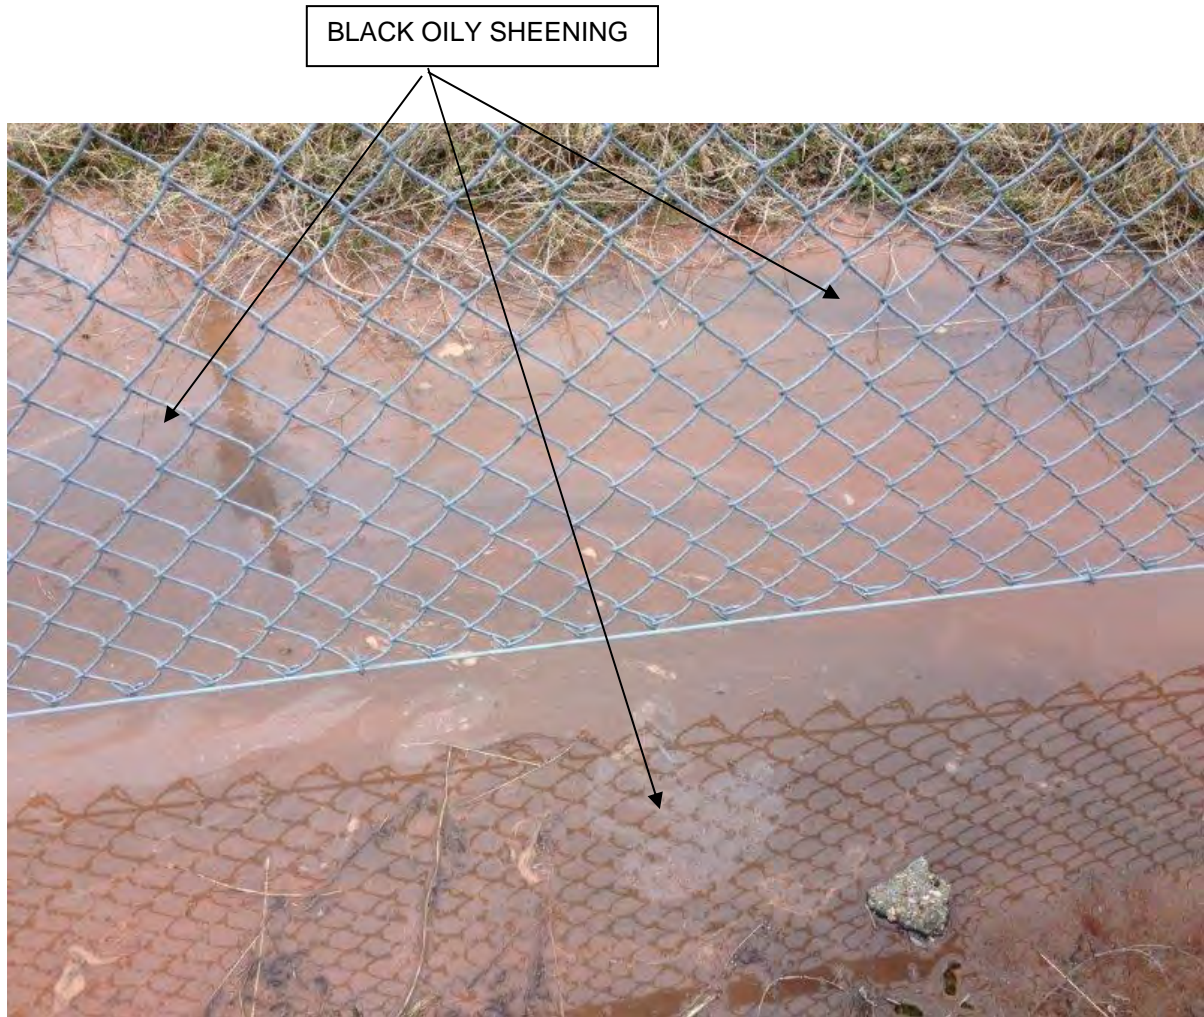
Photo 4-1 Petroleum sheening during air rotary drilling of 16MW20A and 16MW20B located on the IOL bulk plant property adjacent to 14<sup>th</sup> St.

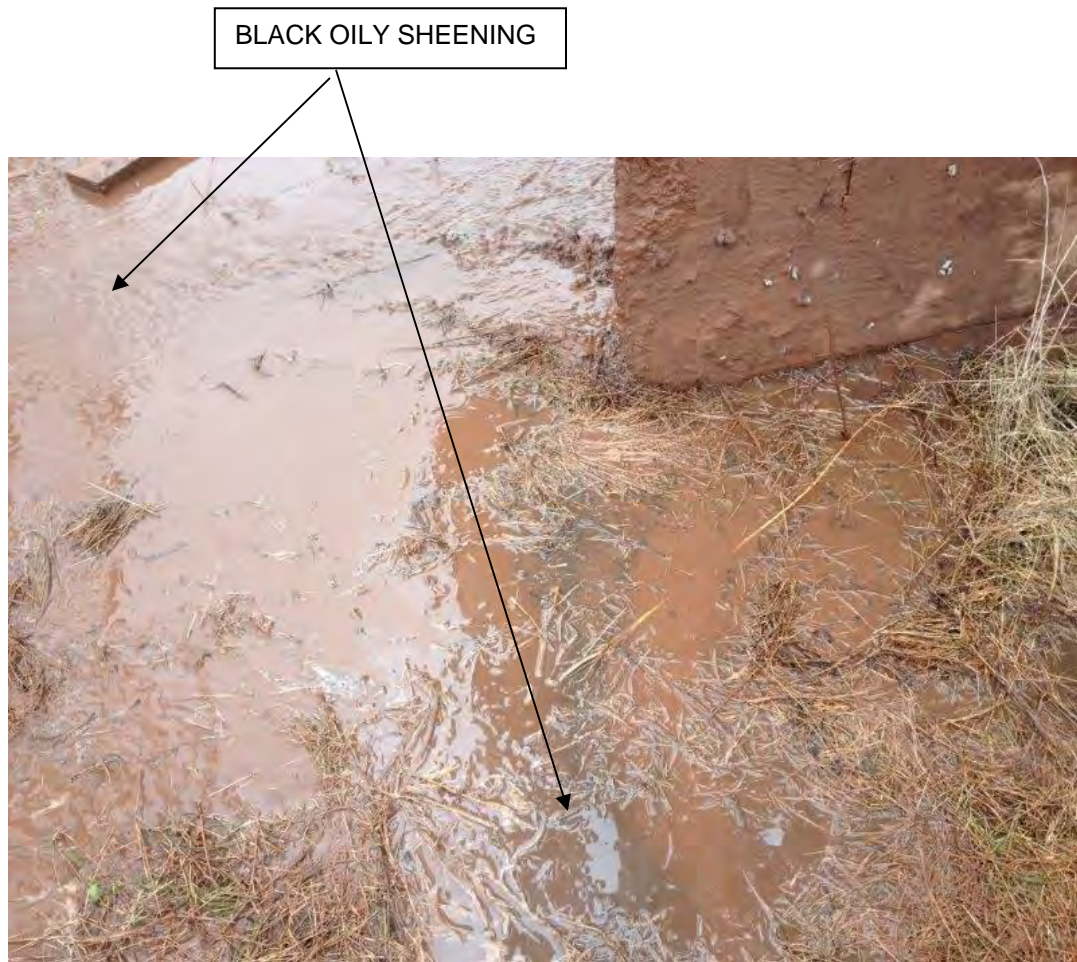
Photo 4-2 Petroleum sheening during air rotary drilling of 16MW20A and 16MW20B located on the IOL bulk plant property adjacent to 14<sup>th</sup> St. Evident for about 30 minutes of pumping to clear the well for downhole video.

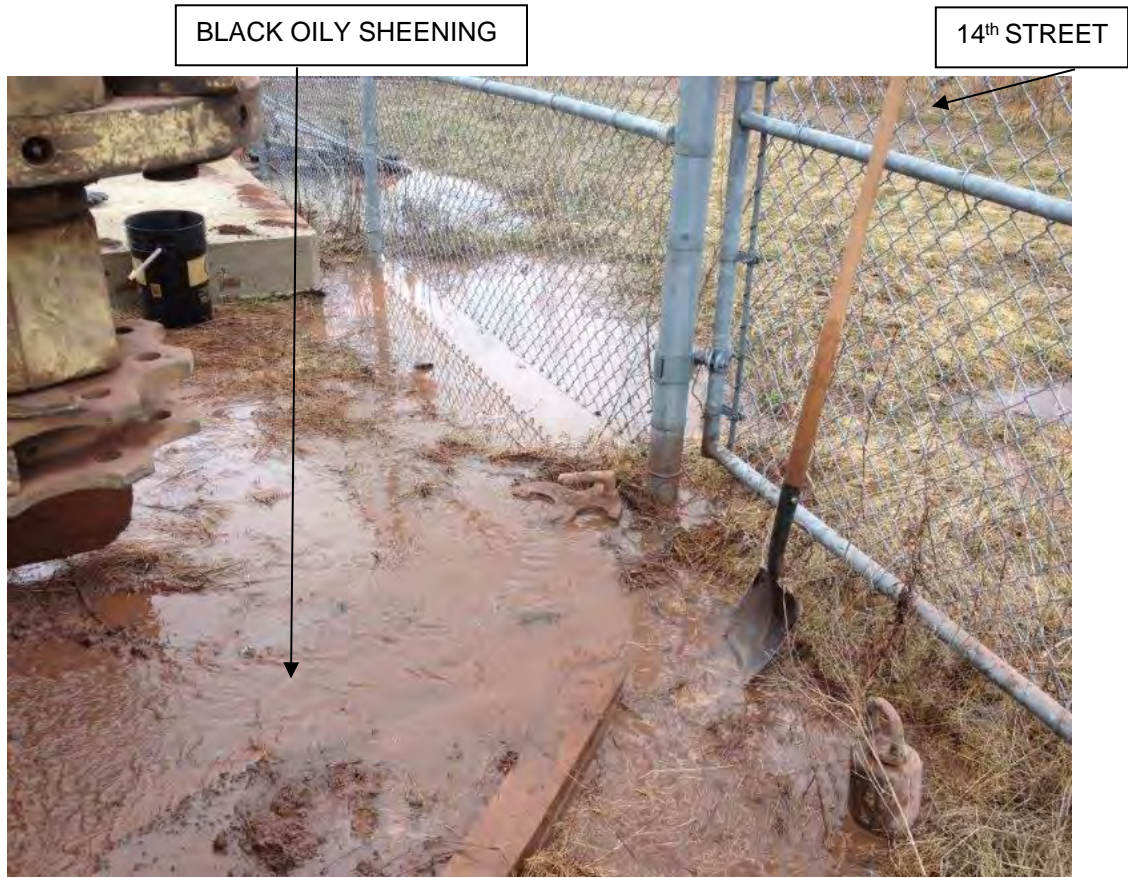
Photo 4-3 Petroleum sheening during air rotary drilling of 16MW20A and 16MW20B located on the IOL bulk plant property adjacent to 14<sup>th</sup> St. Photo also shows relative location of MW to bulk plant fence line adjacent to 14<sup>th</sup> St.

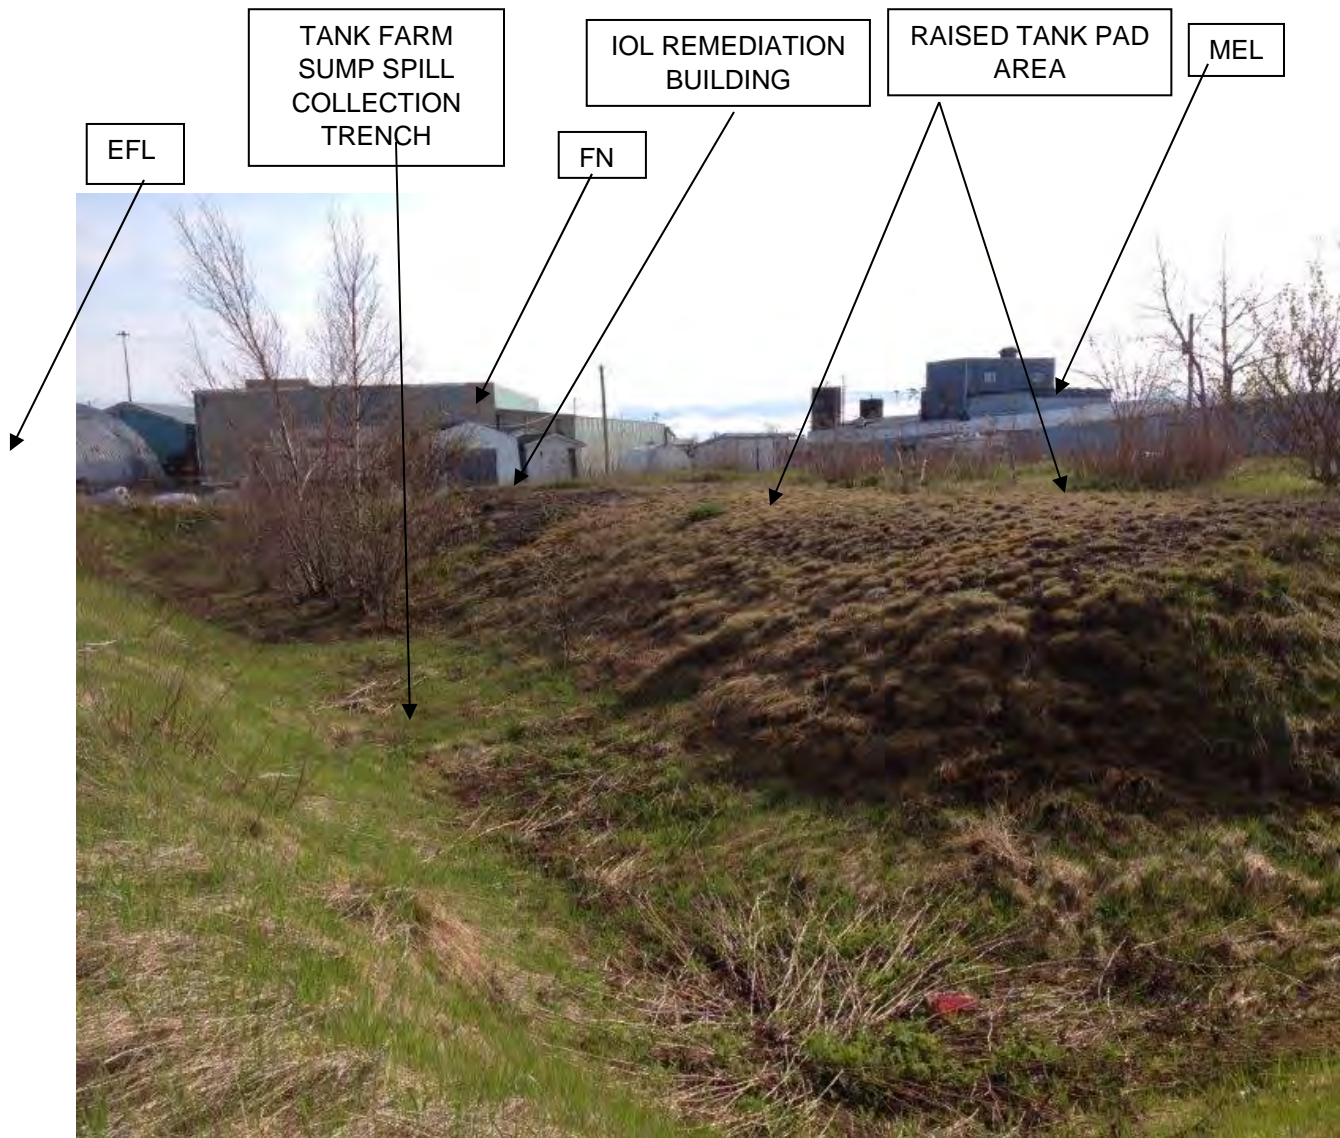
Photo 4-4 Sump area as low point for collection of liquids from the smaller tank farm diked area.
