FISH AND FISH HABITAT SURVEY

Fish and Fish Habitat Summary for:
One Small Unnamed Watercourse (North east)

Heveco Peat Bog (DNR # 524)

R.A. Currie Ltd
Biological Consultant

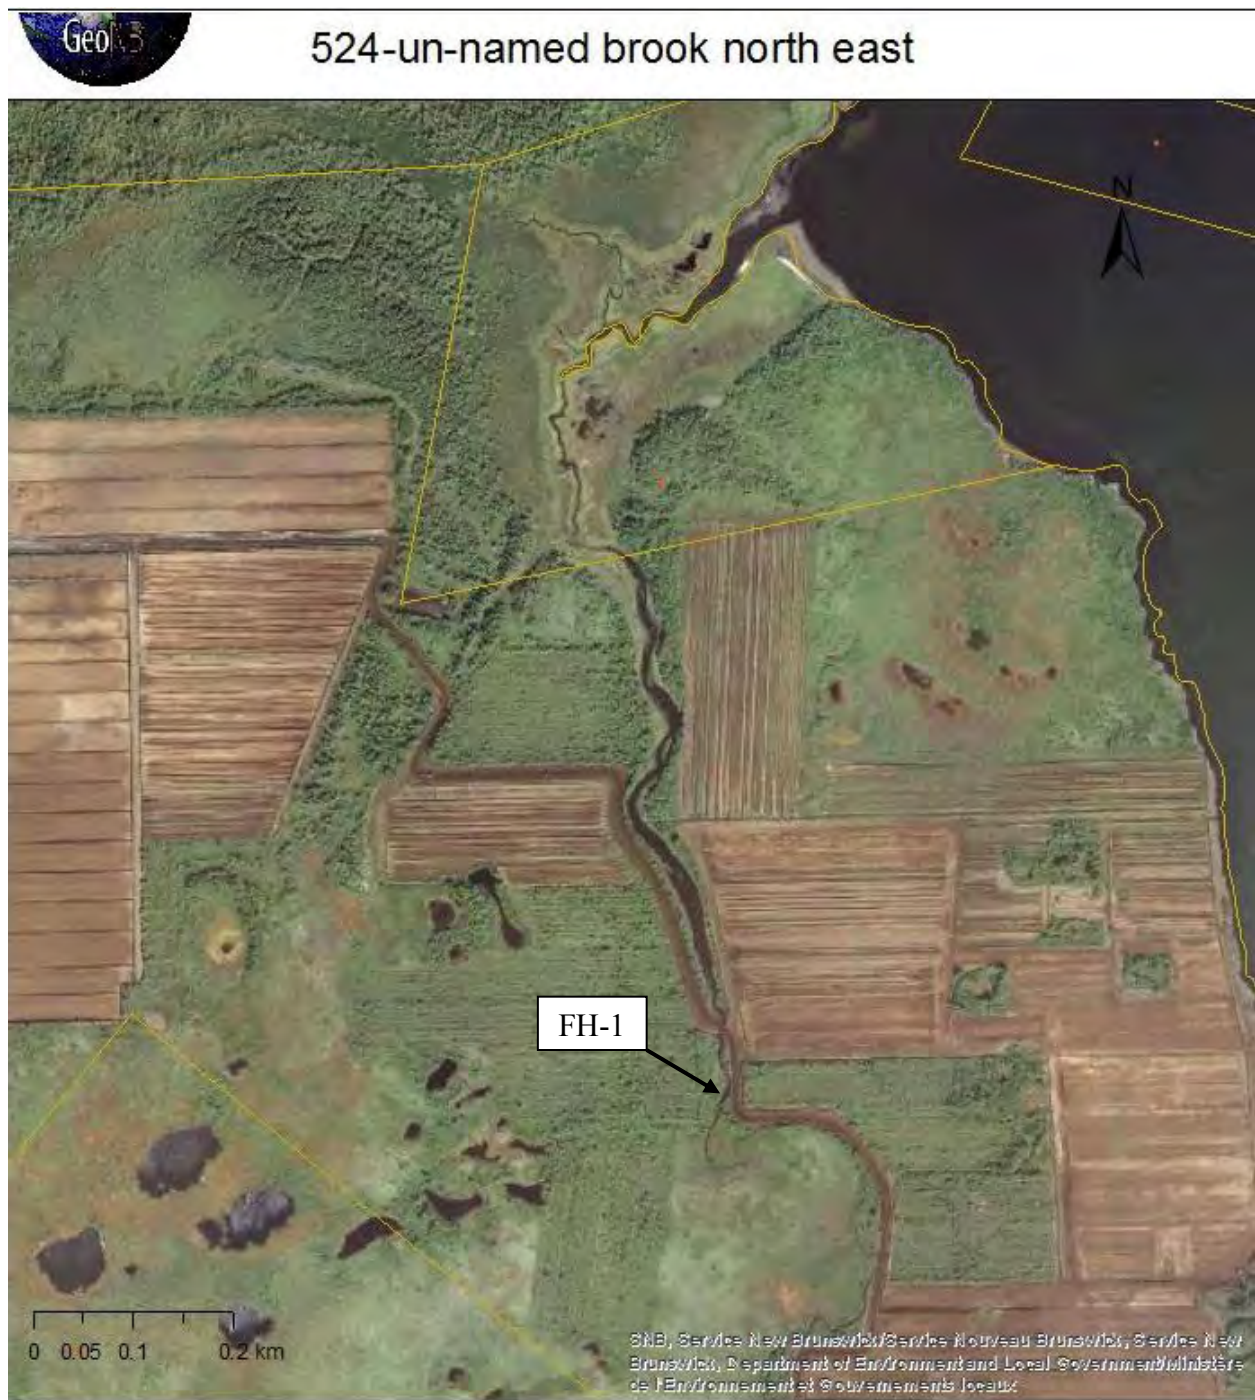
The unnamed stream referred to as Site 1 is relatively small. The area we viewed was quite close to the bay and this area of stream was influenced by tidal action. The average width in the area we viewed was approximately 1.5 m, and the average depth was 0.5 to 1 m. The water was stained deep brown due to the bog drainage and it was difficult to see more than 15-20 cm into the water. Probing with a stick determined the stream bottom was composed of deep, soft organic material, which was probably peat particles. The flow was very slow, and the direction of flow probably changed with each tidal cycle. A beaver had piled some sticks and debris in the stream at this location but the accumulated debris did not appear to impede the flow of water.

The small unnamed watercourse designated as Site 1 appears to be only bog drainage. It has a minor flow, colour and chemistry to support this opinion. The stream has an extremely low gradient and is influenced by tidal intrusion along much of its length.

The physical characteristics of this stream represent very poor fish habitat when compared to standard salmonid (salmon and trout) habitat metrics. The water is warm, unshaded, quite acidic and organic fines (peat particles) represent 100 percent of the streambed.

No fish were captured or observed through electrofishing and direct observation. If fish are present, they occur in very low numbers and would likely represent common coarse fish species such as stickleback, shiner, killifish etc. This stream does not represent salmonid habitat and it can be stated with certainty that salmon and trout do not inhabit this stream.

Figure 1: Unnamed watercourse in North-east part of Heveco bog.

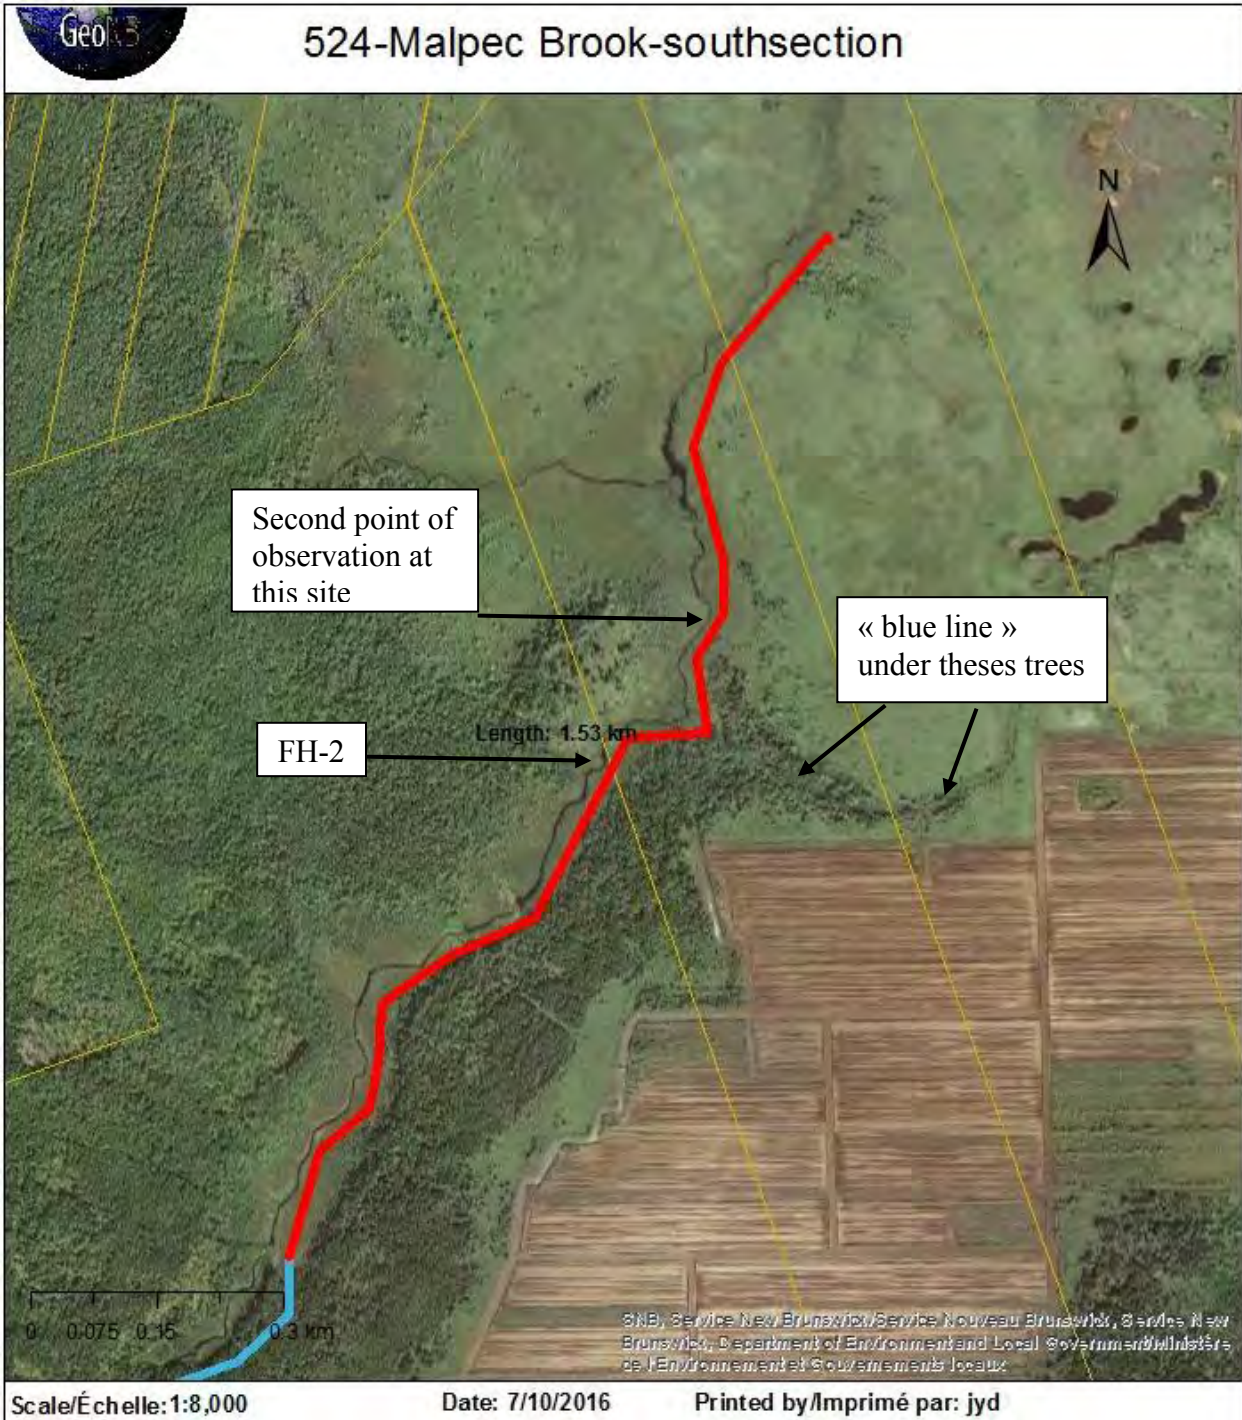
The section of stream on the bog shares many of the physical characteristics of the previously described stream. The water has a brown stain that is typical of bog drainage and the flow velocity is extremely slow. At this point, the stream has an open water width of approximately 2 m and a depth of 0.5 to 1 m. Unlike the first watercourse, the stream banks are very unstable and do not allow an observer to get to the water's edge. The stream banks are fully vegetated with grass and shrub vegetation that is typical of peat bogs, however, a wide zone of vegetation near the stream is flooded with water that ranges from 0.3 to 0.5 m in depth. A water sample was recovered from this location for basic chemical analysis. The unstable stream banks did not permit us to walk along the stream so we retreated into the trees and looped around further upstream to view the stream closer to the two domes that dominate the southern side of the bog. During the process of walking through the trees, we came across the small tributary. This appears as a distinct tributary on the map (Figure 2) but in the field it was confirmed to be only a wet drainage swale and has no permanent channel features and does not represent fish habitat. We viewed the stream in the vicinity of the peat domes and confirmed the stream displayed the same characteristics previously described. The open water channel was narrower (1 to 1.5 m wide) but the stream flooded riparian shrub vegetation. The flow rate was extremely slow and the water was dark and deep.

Figure 2: Observations at on-bog portion of Malpec Brook in South-west part of Heveco bog.

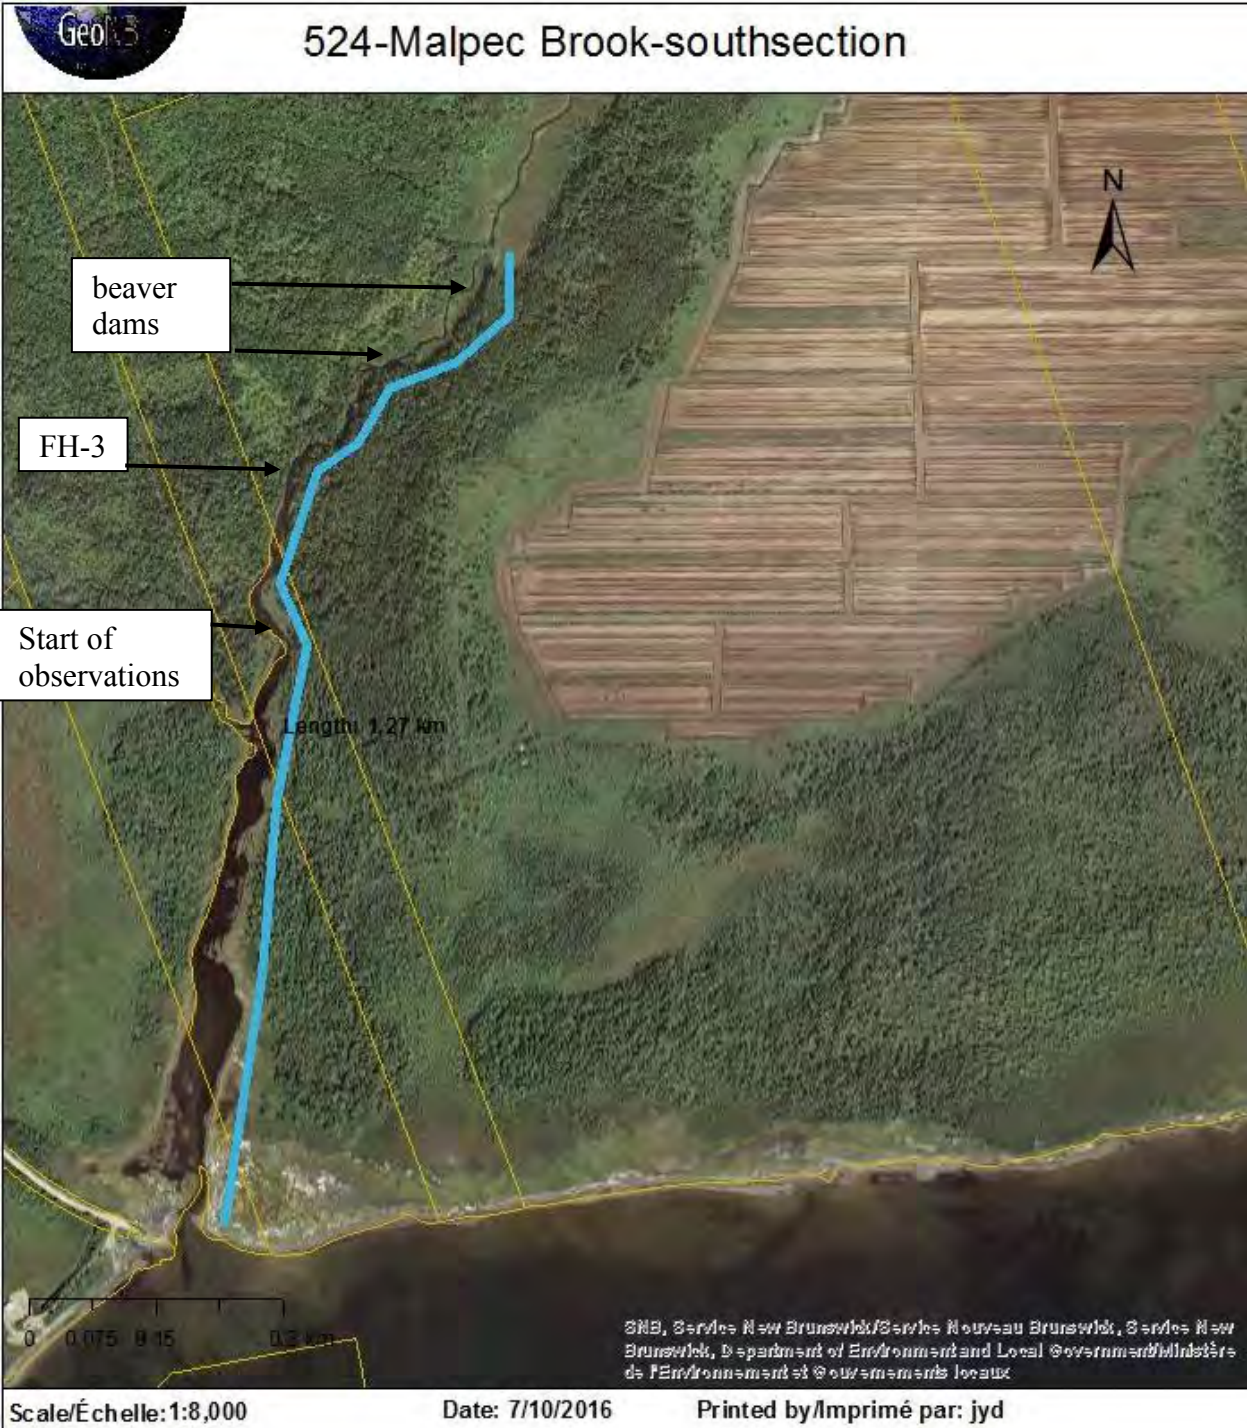
The next spot we viewed was much further downstream (Figure 3). We walked through the woods to access this location and discovered the stream was much wider and shallower at this location and was flowing at a moderate velocity. The stream was obviously under tidal influence at this location and the streambed contained sand and fines. We then followed the stream upstream to the extent of tidal influence. At this point the stream was narrower and there was more gravel in the streambed. Trees and shrubs occupied the stream banks and the banks appeared stable. A short distance upstream from this point, two beaver dams occurred in the stream. The first was an old structure that was in disrepair, the second dam occurred a short distance further upstream. At this point, the character of the stream changed dramatically. The water became impounded and shrub vegetation typically of what we observed on the bog further upstream fully occupied the stream banks. These conditions appeared to extend from this point all the way upstream to the bog and the headwaters of this stream.

Figure 3: Observations at the off-bog portion of Malpec Brook in South-west part of Heveco bog.
