Parlee Beach Water Quality

Shediac, New Brunswick

Final Report

April 2018

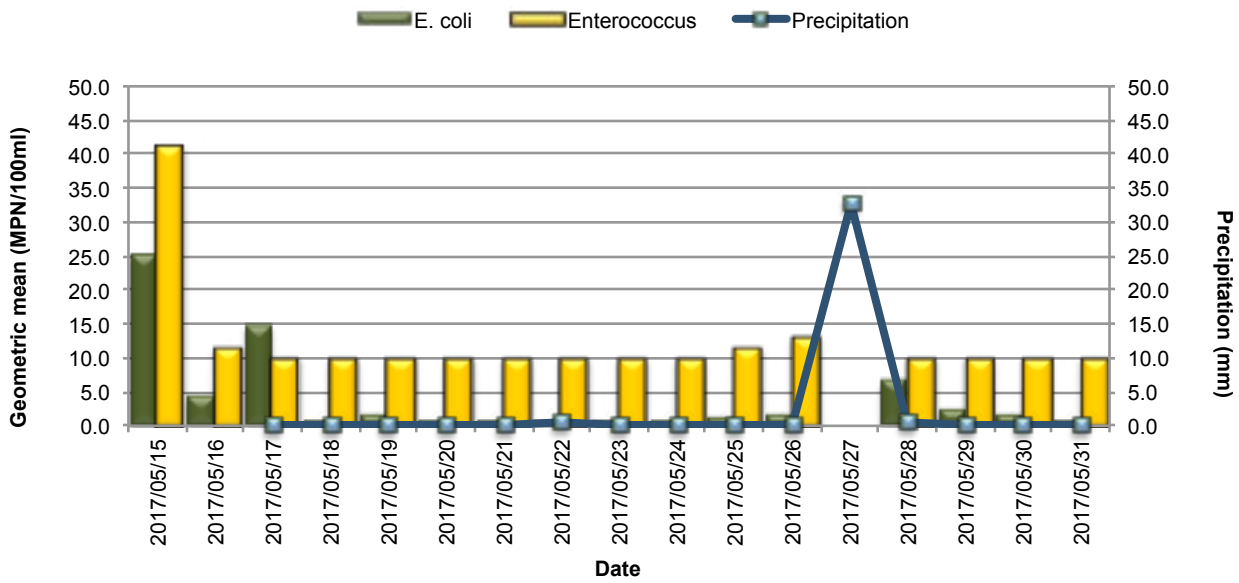
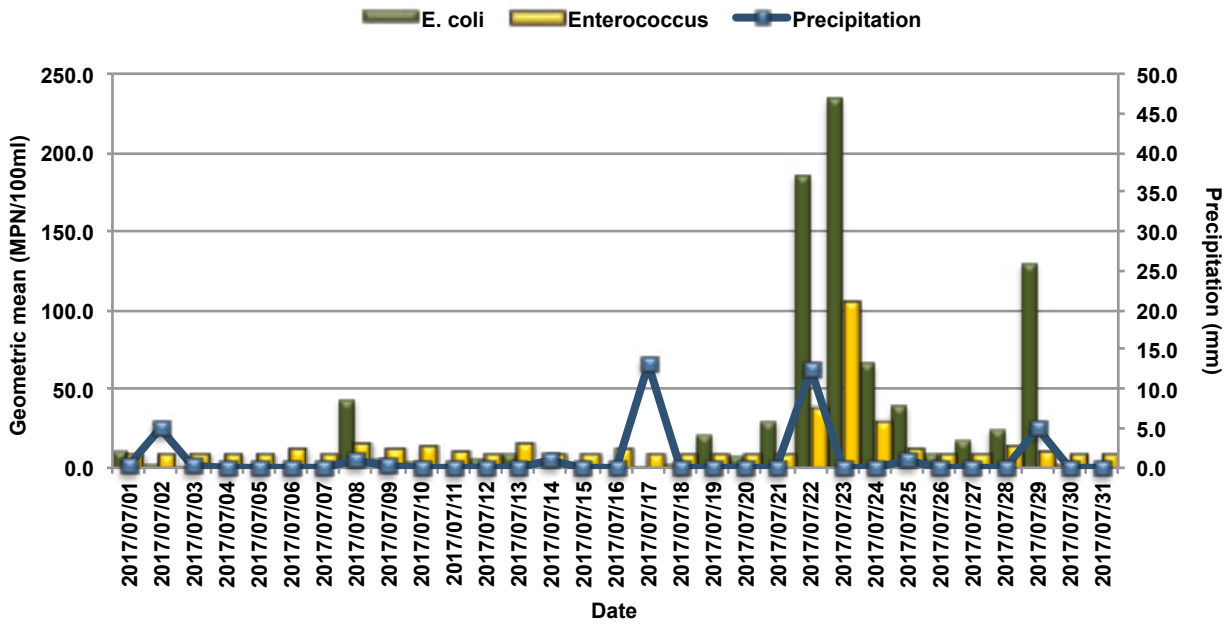
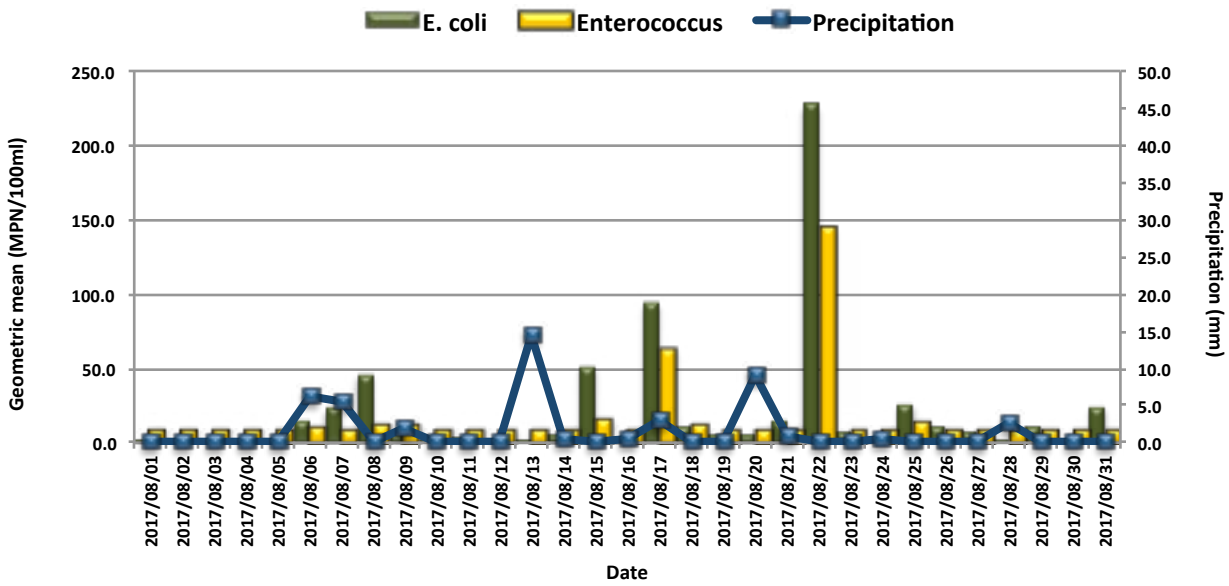
Figure 3.4a - Precipitation and Geometric Mean – May

A review of the literature suggests that intense rainfall events increase surface water runoff, which may negatively affect water quality at swimming beaches. Figures 3.4a to 3.4f illustrate the relationship between rainfall and the geometric mean of bacteria counts from June to the first nine days of October 2017. There is no consistent correlation between these parameters.

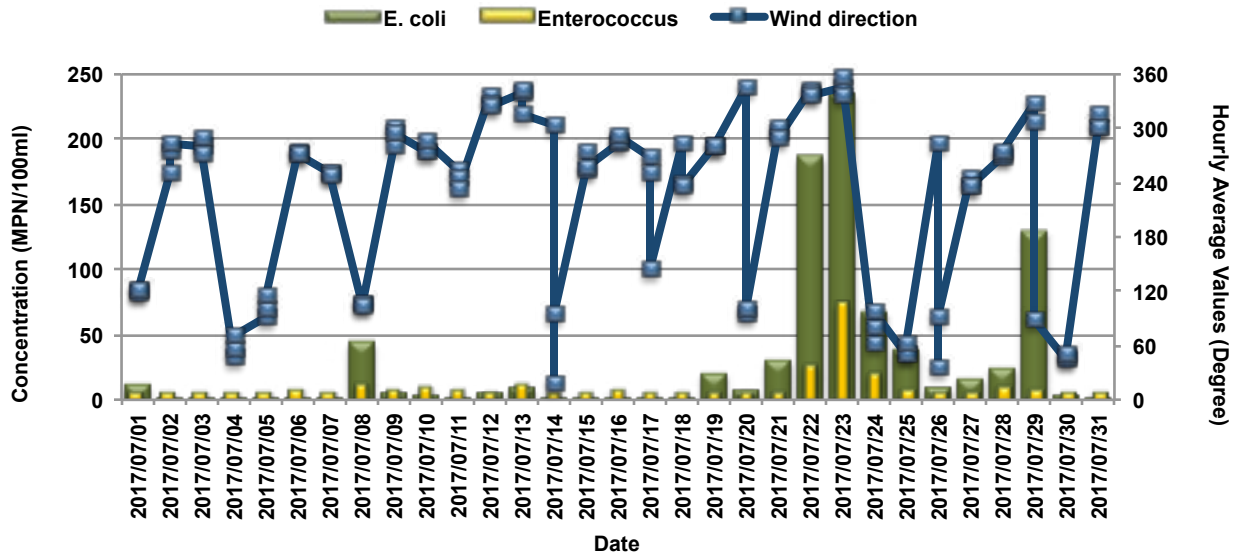
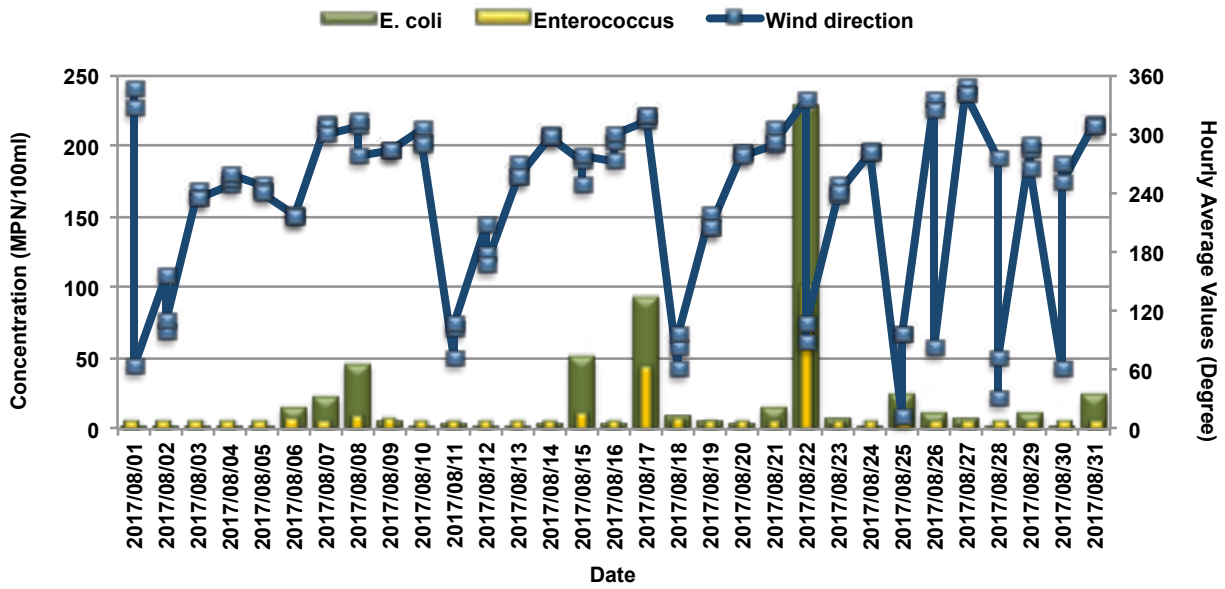
Figure 3.5b - Wind Direction and Geometric Mean – June

Figures 3.5b to 3.5f illustrate the relationship between wind direction and the geometric mean of bacteria counts from June to the first nine days of October 2017. There appears to be a relatively consistent correlation between these parameters. These data suggest that when the wind is blowing from the southwest (between 180 and 270 degrees), water quality at Parlee Beach is acceptable. But when the wind shifts to the northwest (between 270 and 360 degrees) there is often an increase in test values.

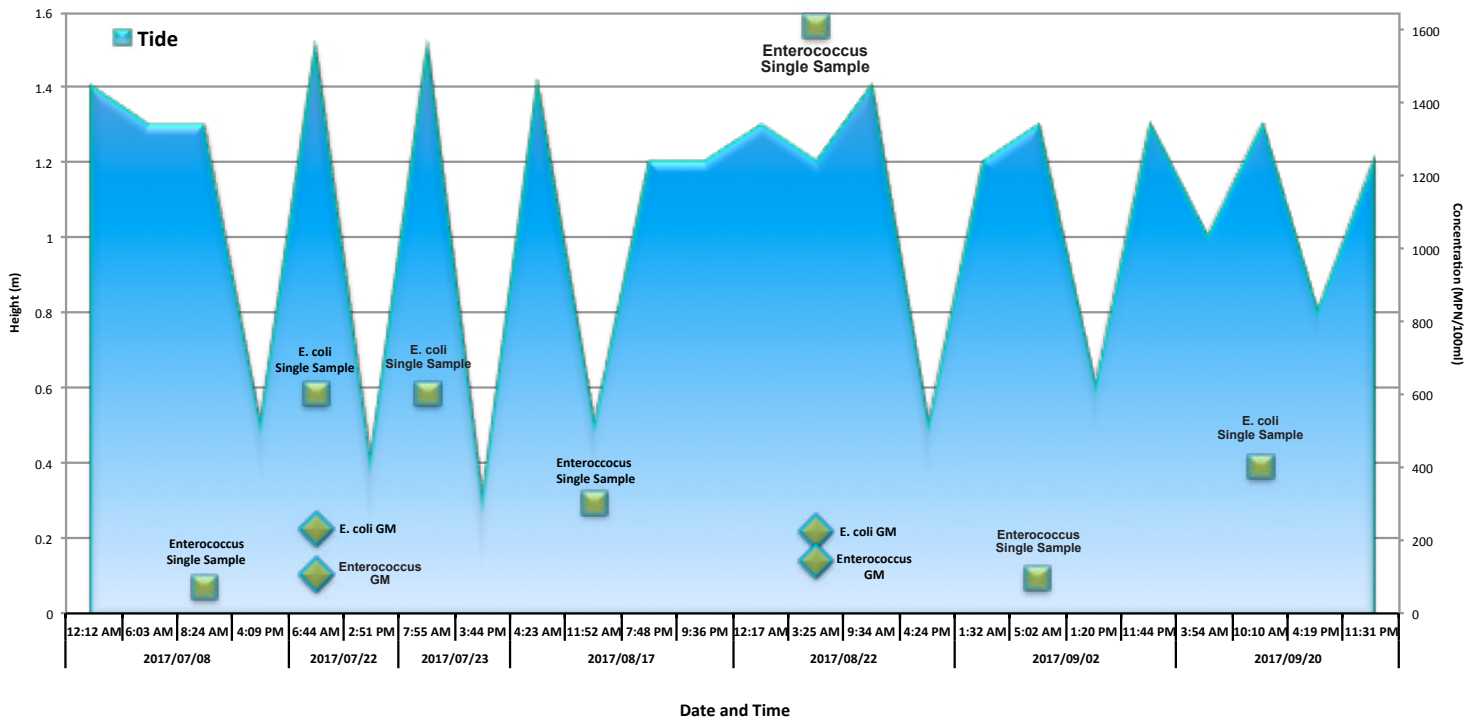
Figure 3.5g - Tidal Height and Single-Sample Maximum

Figure 5.5g shows an example of the relationship between tide height and bacteria for a selected seven days spread over July to September. The graph is not a continuous sequence of chronological days. In addition, the sample time does not match the time on the graph; it matches the day only.

Exceedances of the guideline value geometric mean of bacteria counts were noted on July 22 and August 22. The July 22 sample was collected on an ebbing tide; the August 22 sample was collected on a rising tide, as samples were collected at 10:30-11:00 am each day. Exceedances of the guideline value single-sample maximum occurred during each selected day; sometimes associated with sample collection time on a rising tide and sometimes on an ebbing tide. These are the only days during which the guideline values single-sample maximum or geometric mean were exceeded. For the other 140 days when samples were collected, many during high tide conditions, guidelines values were not exceeded. There is insufficient data to determine a conclusive relationship.

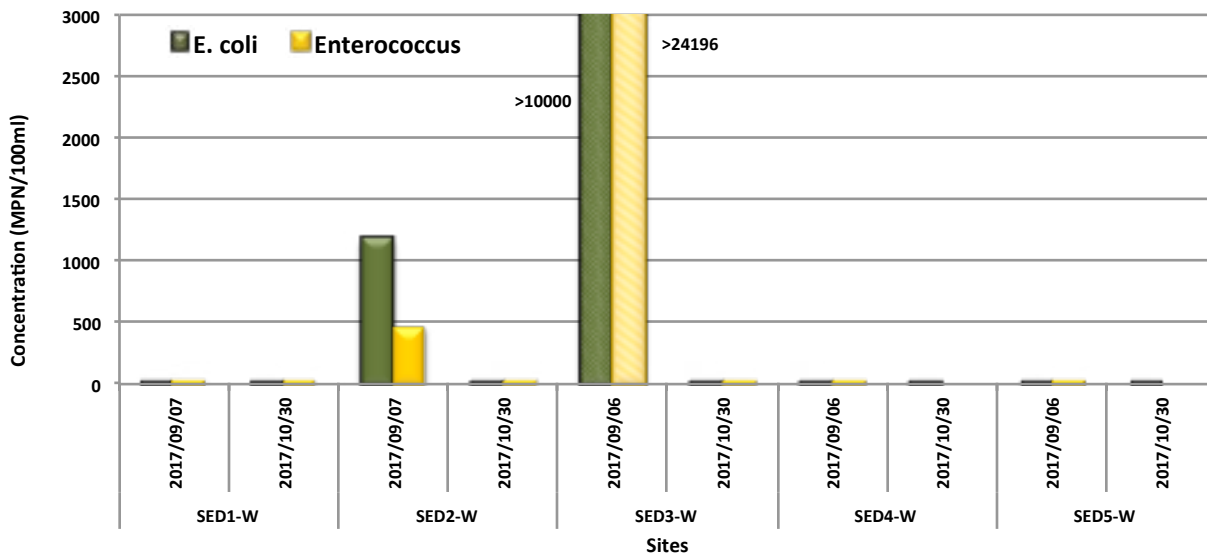
Figure 4.3d - Water at Sediment Sites

The test results for the five water samples collected at the Sediment sites are shown at Figure 4.3d. Data was collected in September and October, 2017. Two *E. coli* samples exceed the single-sample maximum guideline value of 400: SED2 at 1,174 MPN/100ml on September 7; and, SED3 (“pond” in Parlee Beach Provincial Park) at >10,000 MPN/100ml on September 6. For enterococcus, two samples exceeded the single-sample maximum guideline value of 70 MPN/100ml: SED2 at 450 MPN/100ml on September 7; and, SED3 at >24,196 MPN/100ml on September 6 (coincident with precipitation event).

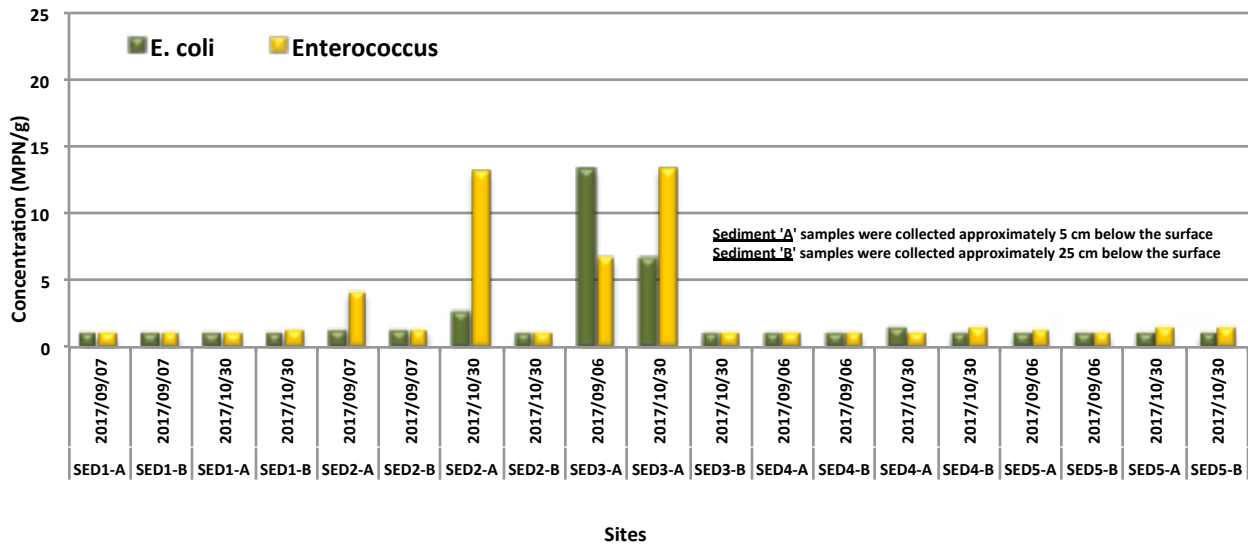
Figure 4.3e - Sediment at Sediment Sites

The test results for the five sediment samples collected at Sediment sites are shown at Figure 4.3e. Data were collected in September and October. The A samples were collected 5 cm below the surface; the B samples were collected 25 cm below the surface. A majority of the 25 cm samples exhibit concentrations less than 2 MPN/g. Elevated *E. coli* values were exhibited at SED2 on October 30 and SED3 (“pond” in Parlee Beach Provincial Park) on September 6 and October 30 for 5 cm samples. For enterococcus, there were two concentrations of 13 MPN/g for 5 cm samples at SED2 and SED3 on October 30.

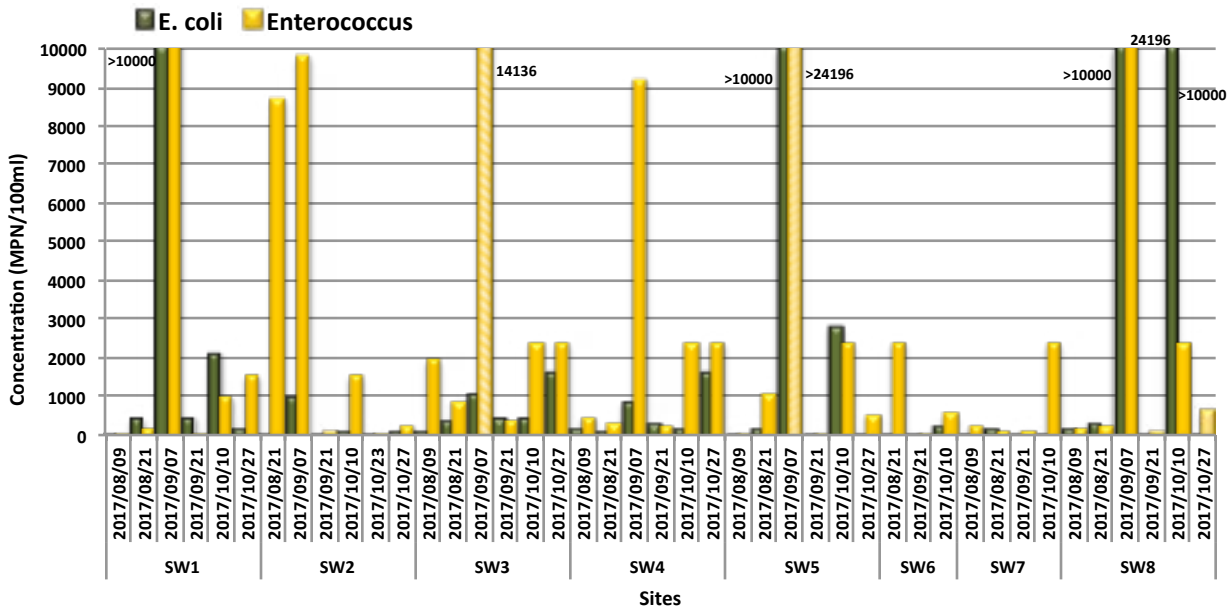
Figure 4.3g - Stormwater Sites

The test results for the eight Stormwater sites are shown at Figure 4.3g. Data were collected between August and October, 2017. The single-sample maximum guideline value of 400 MPN/100ml for *E. coli* was exceeded for some sampling events at all sites except SW6 and SW7. High values exceeding 10,000 MPN/100ml are exhibited at SW1, SW5, and SW8. For enterococcus, some samples at all sites exceeded the single-sample-maximum guideline value of 70 MPN/100ml. Very high values ranging from 10,000 MPN/100ml to 24,196 MPN/100ml are exhibited at all sites except SW6 and SW7. Many high values occurred on September 7 which coincided with a period of approximately 28 mm of precipitation on September 6 to 7. This suggests high bacterial counts are related to surface water runoff.

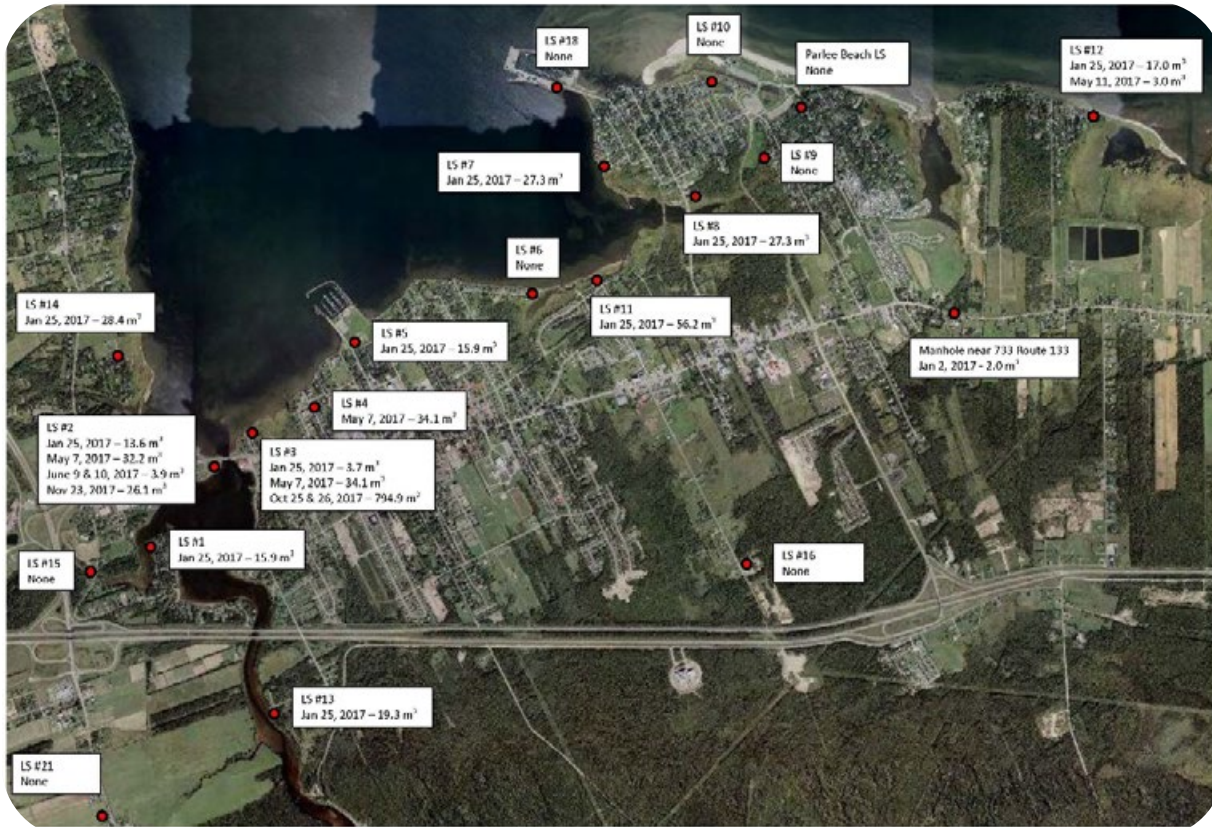
Figure 4.3k - GSSC Lift Station Overflows - 2017

Due to the relatively flat terrain in the Shediac and Pointe-du-Chêne area, the Greater Shediac Sewage Commission (GSSC) operates 24 lift stations to service the sewers in its jurisdiction. Occasionally these lift stations overflow during periods of intense precipitation or power outages. When this happens, the overflow pipes discharge directly into the environment and it is possible that diluted sewage reaches local creeks and swales, and, eventually enters Shediac Bay.

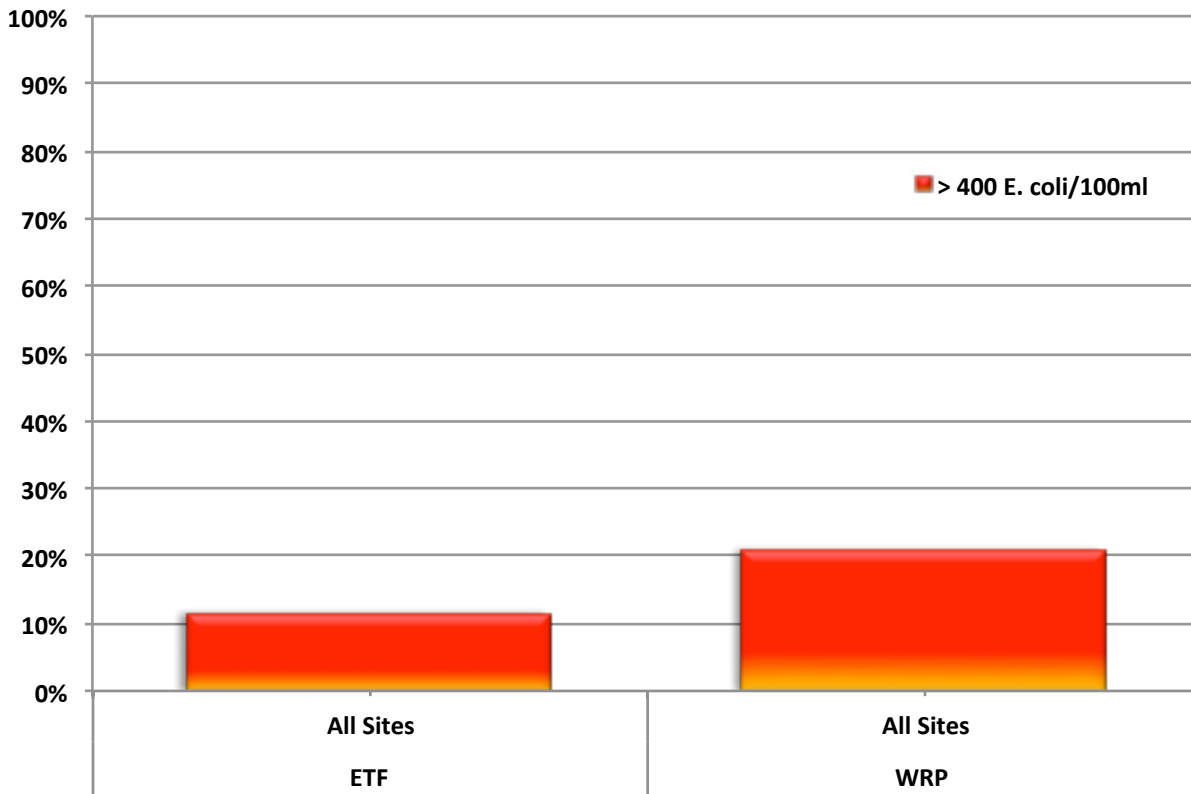
Figure 4.3I - Exceedances of Guideline Values

Figure 4.3l presents the exceedances for the single-sample maximum values identified by the Guidelines for Canadian Recreational Water Quality for the ETF, and WRP sampling sites for *E. coli*. Exceedances occurred at about 12 per cent of the ETF sites, and about 20 per cent of the WRP sites. This indicates there are sources of bacteria distributed throughout the watershed.

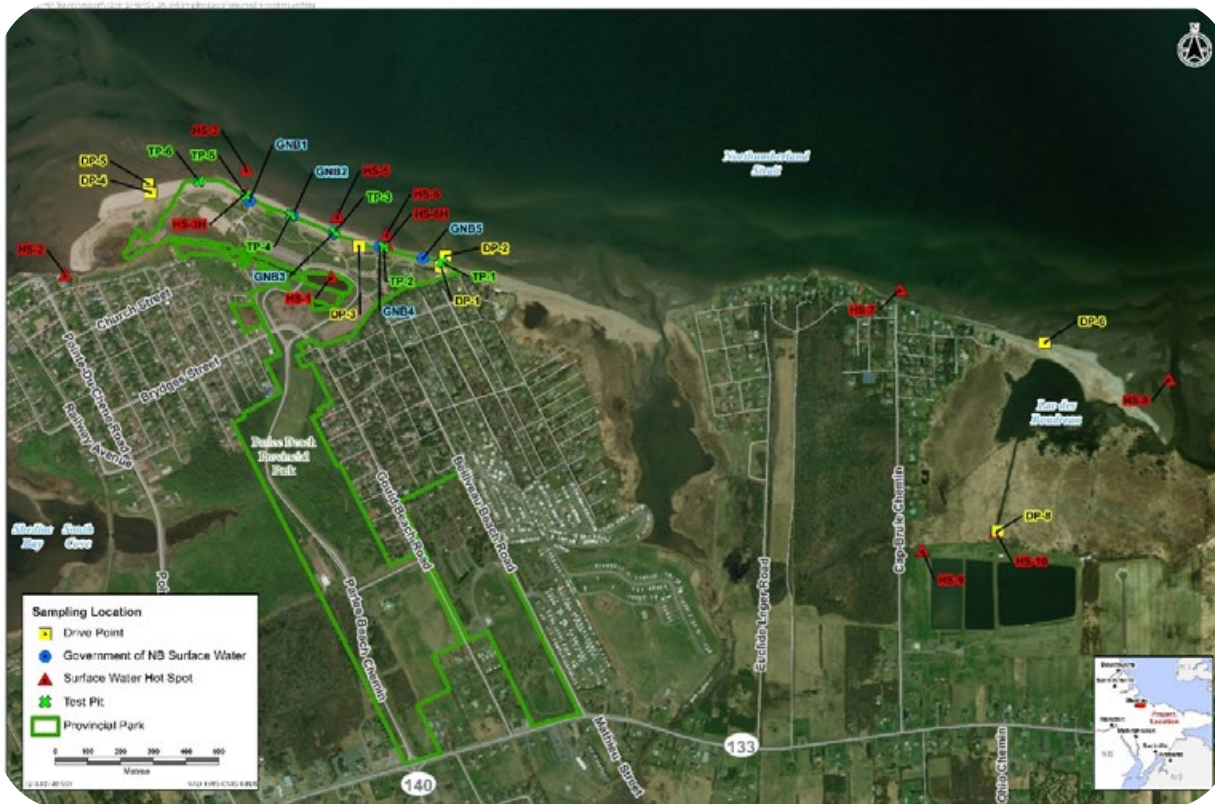
Figure 5.1 - Sampling Locations

Sampling for bacteria in beach sand and the associated pore water was completed using the “careful excavation” method. Six test pits were excavated at locations indicated by TP-1 to TP-6 at Figure 5.1. A total of nine surface water locations, indicated by HS-1 to HS-10, were sampled in both dry (August 30 to September 1, 2017) and wet (October 10, 2017) conditions.

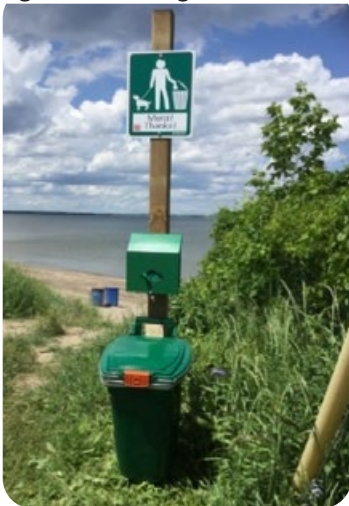
Figure 6.1a - Dog Waste Station

- 12 dog waste stations were installed, including signage, litter containers, and dog waste bag dispensers (Figure 6.1a), located throughout Pointe-du-Chêne LSD and the wharf (Figure 6.1b).
- 1200 letters were mailed to Pointe-du-Chêne residents.
- 6,800 bags were distributed.
- 11,674 lbs. of waste (may include some beach trash) were collected.

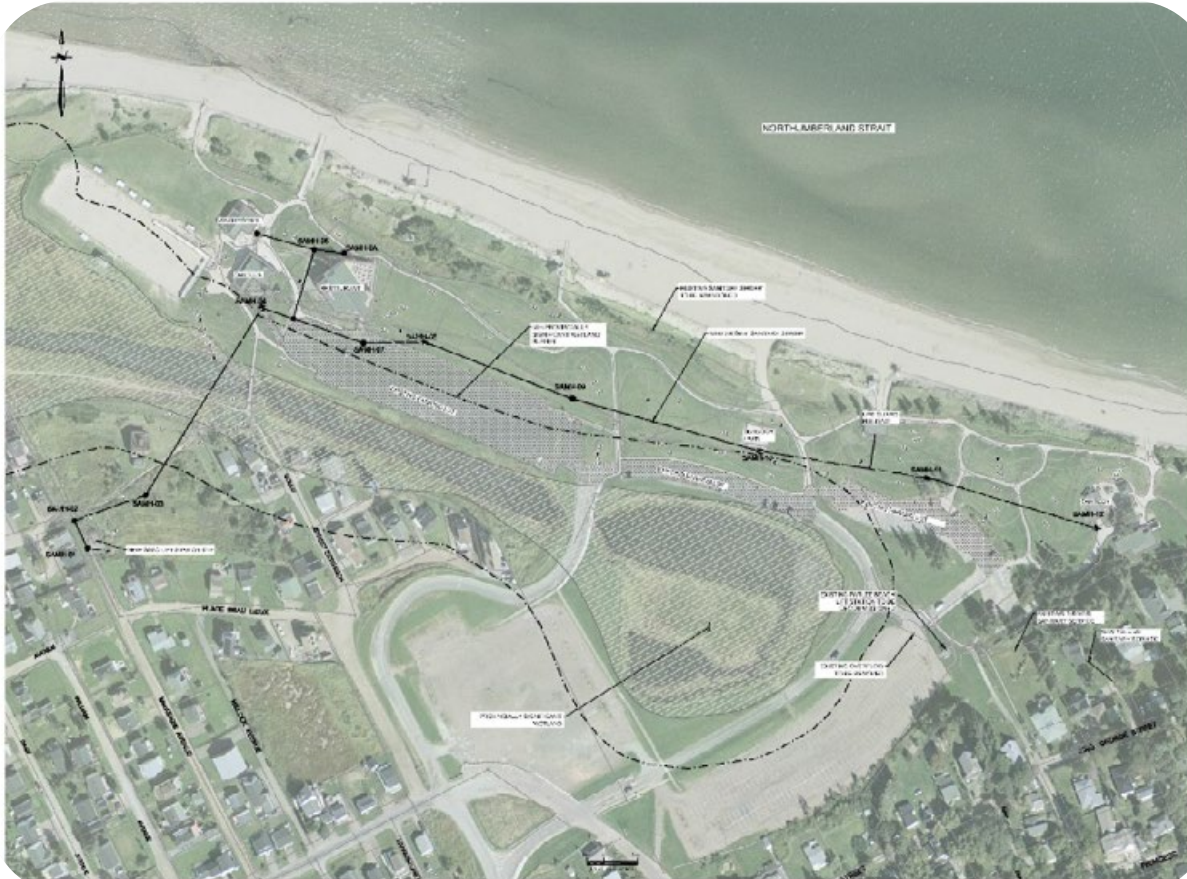
Figure 6.3 - Parlee Beach Sewage System Replacement

An initiative to replace the Parlee Beach waste water collection system (restaurant, washrooms, showers), and to decommission the seasonally operated Parlee Beach Provincial Park lift station at the western extremity of the park was planned in 2017. This project will result in all Provincial park sewage being diverted to an upgraded GSSC lift station #10 (Figure 6.3) and treated at the GSSC treatment plant.

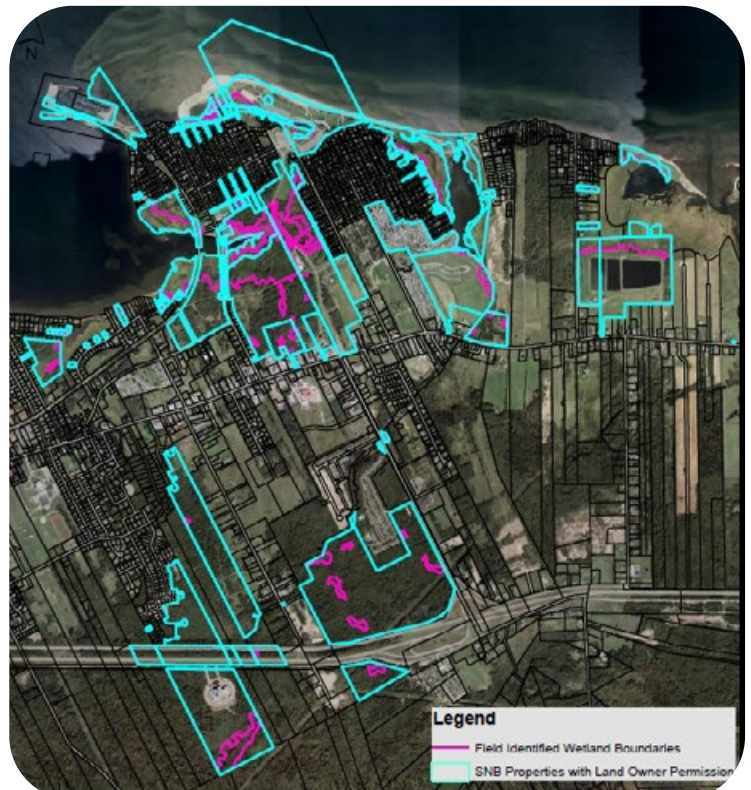
Figure 6.4 - Additional Wetland Delineation

The study documented more wetland than is currently represented on GeoNB wetland layer. Figure 6.4 illustrates additional wetland delineations (pink lines).
