**"RECEIVING WATER CHARACTERIZATION STUDY
FOR A FUTURE OUTFALL OF THE
BURNT CHURCH WASTEWATER TREATMENT PLANT"**

**Receiving Water Characterization Study
for a Future Outfall of the
Burnt Church Wastewater Treatment Plant**

Prepared by: **NATECH Environmental Services Inc.**
2492 Route 640
Hanwell, N.B.
E3E 2C2

Date: **June 30, 2014**

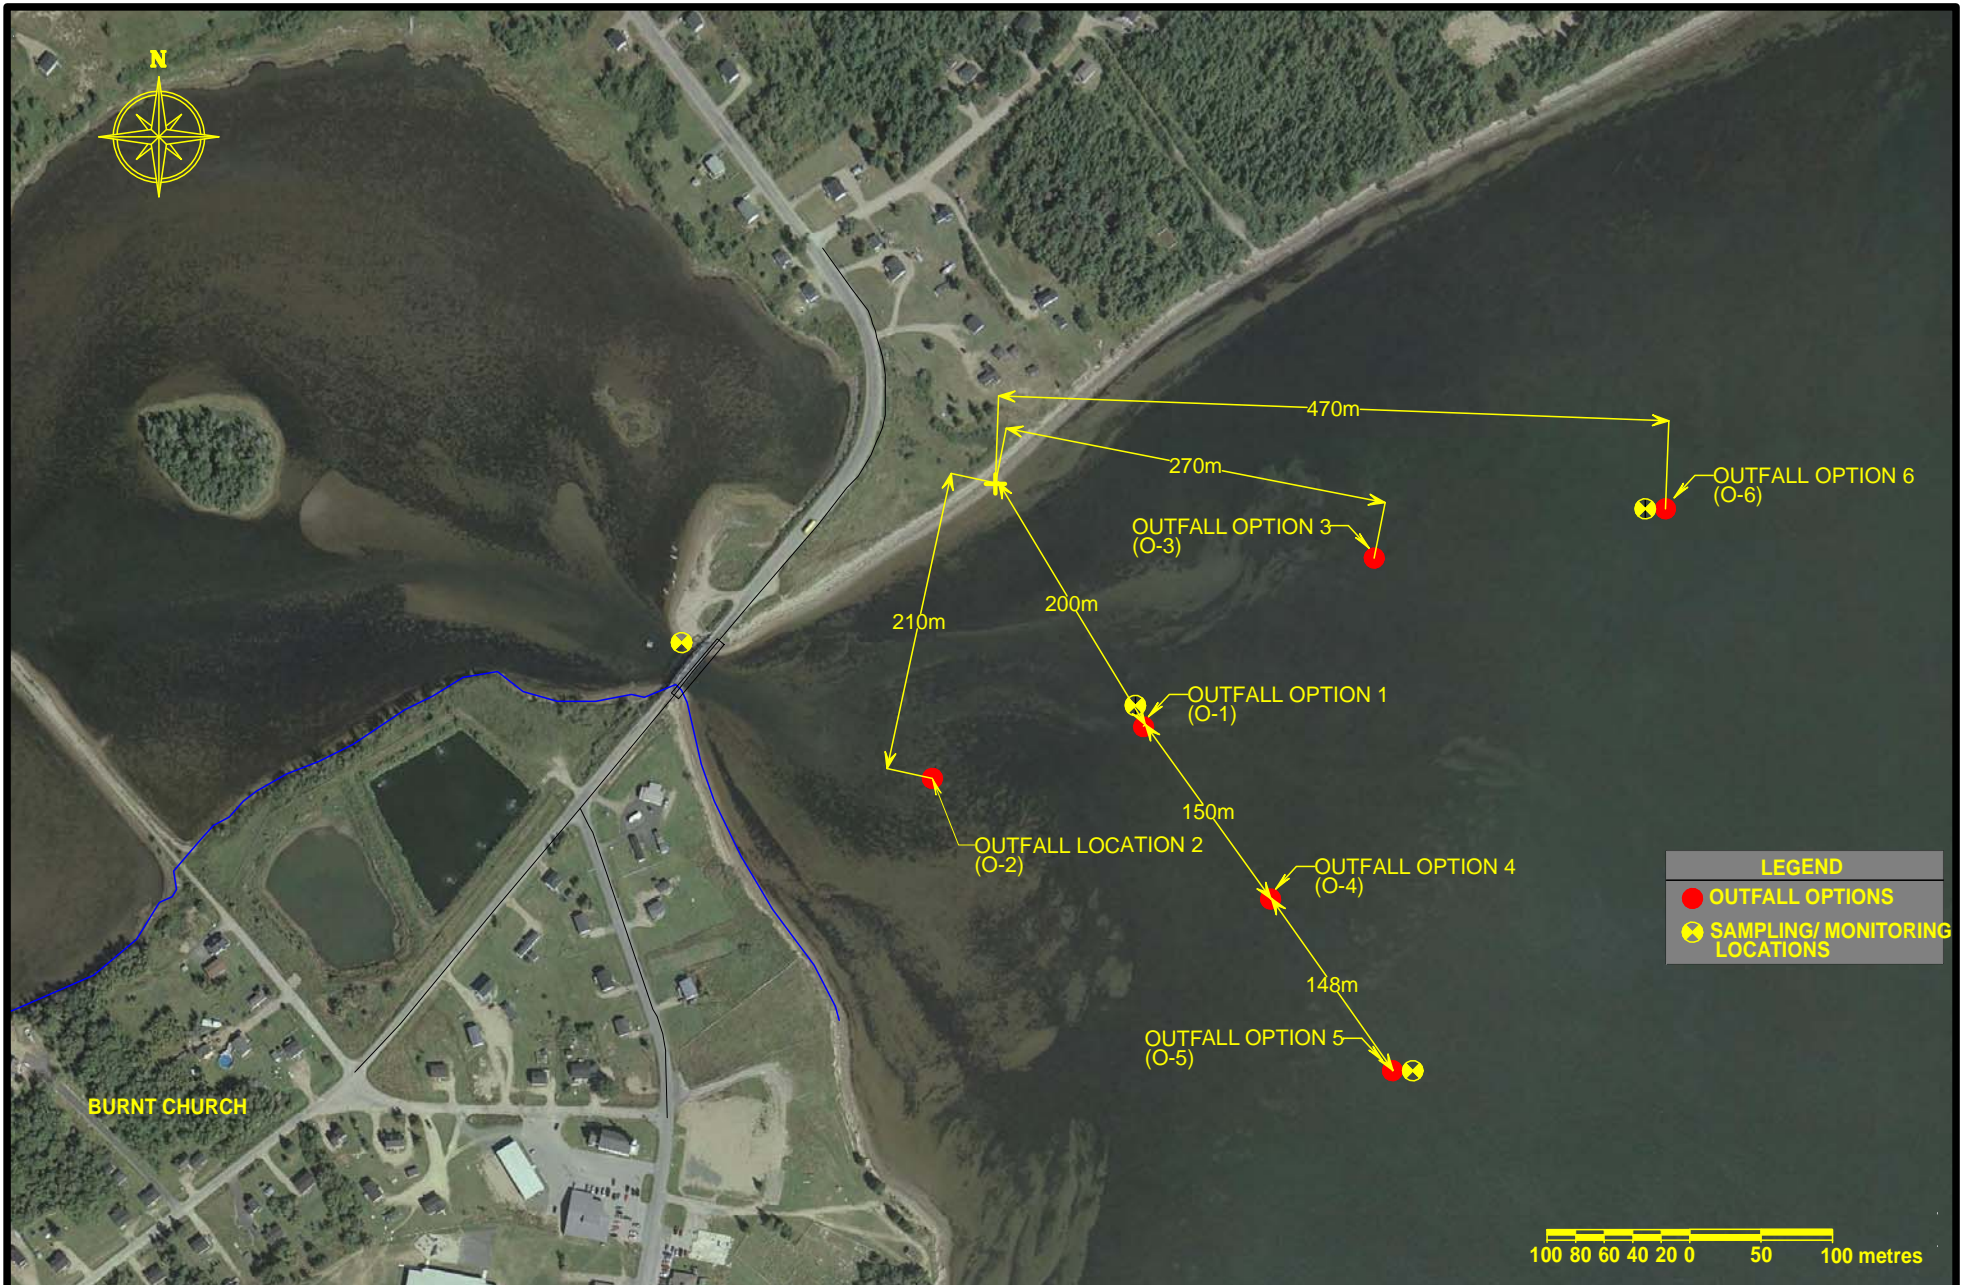
Date: 2014/05/23	Date:	Project No.: CBC-14-01	Nº du projet
Scale: AS SHOWN	Echelle:	Sheet No.: 1-2	Nº de la feuille:

Receiving Water Characterization Study
 Burnt Church
 Potential Outfall Locations
 & Water Sampling Locations

The water quality testing locations are shown on Figure 1-2. Table 3.4 lists the water quality measurements carried out in the field, and the laboratory analyses. The laboratory reports are attached in Appendix B. Figures 3-9 to 3-11 detail temperature/salinity/density profiles. Figures 3-12 to 3-15 show variations in temperature and conductivity over time and depth.

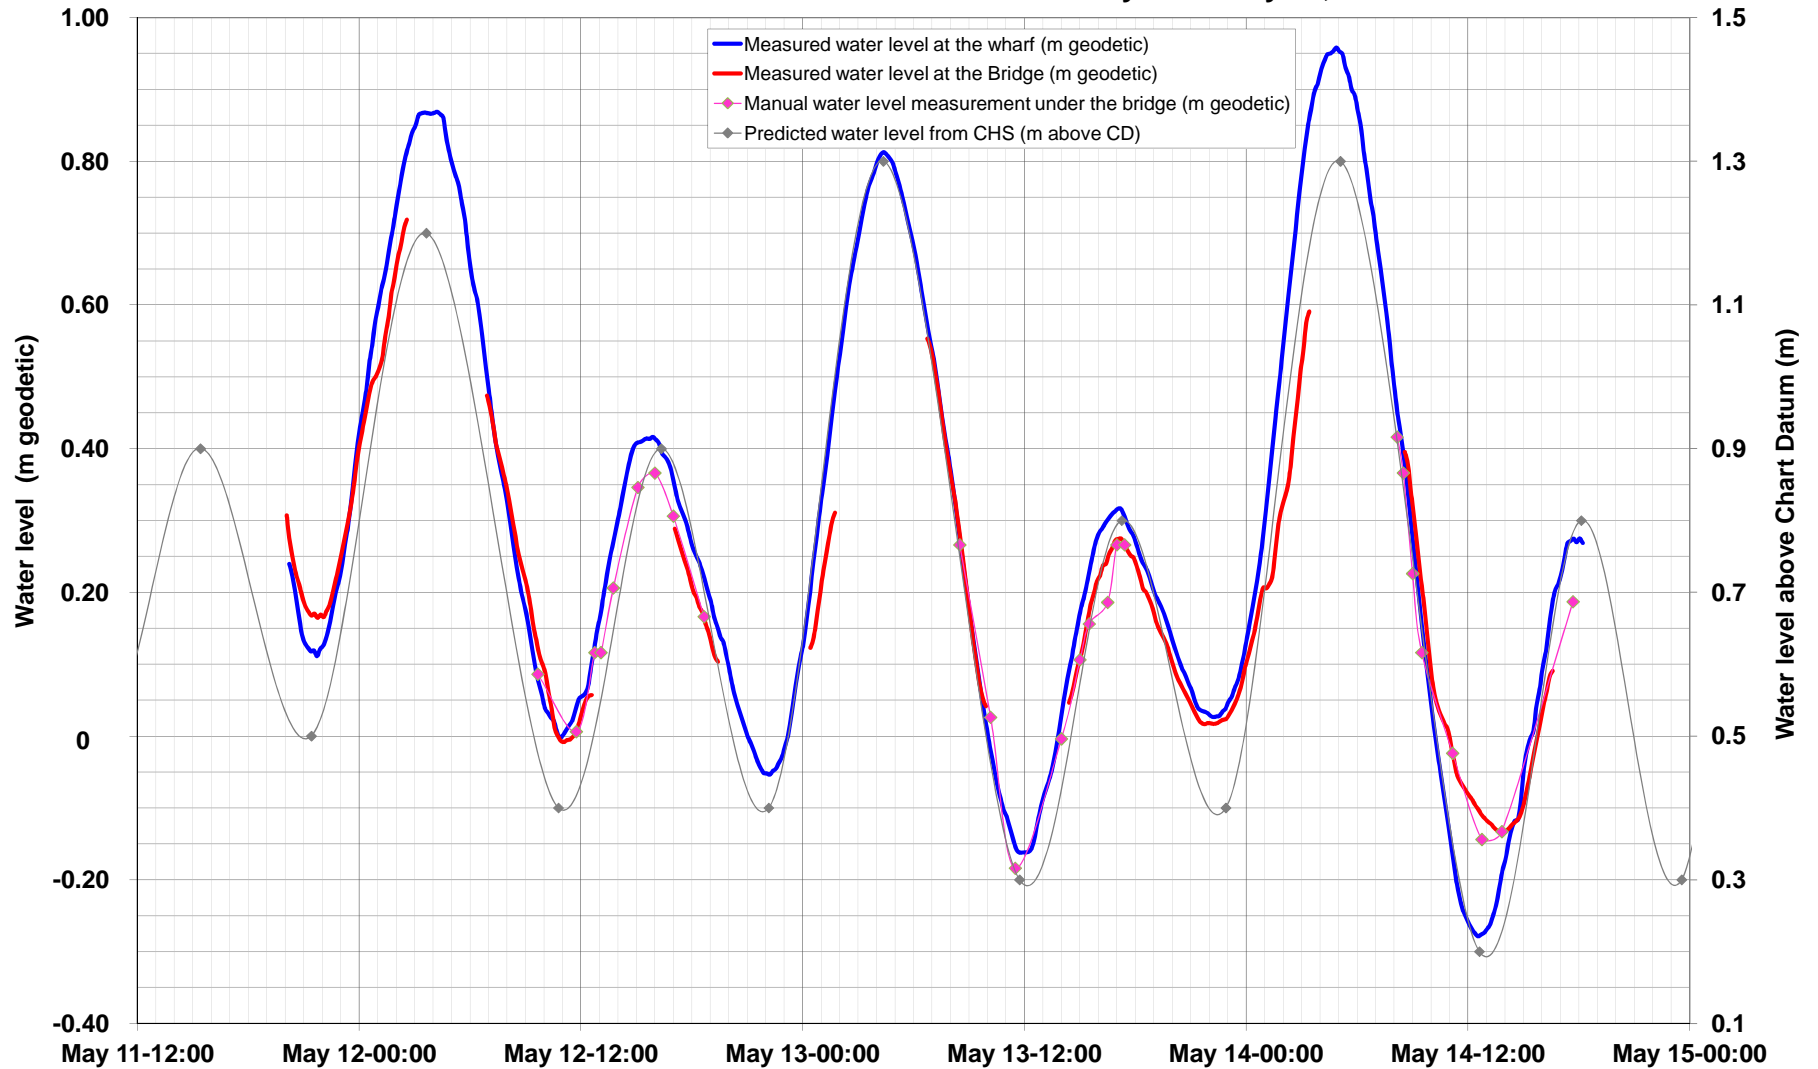
FIGURE: 3-1

Burnt Church - Water Level Variations from May 11 to May 15, 2014

Water Level Variations

The water level records during the survey are displayed on Figure 3-1, as well as tidal predictions for the area from the Canadian Hydrographic Service. Table 3.2 shows the typical water levels expected in Burnt Church obtained from the local hydrographic chart.

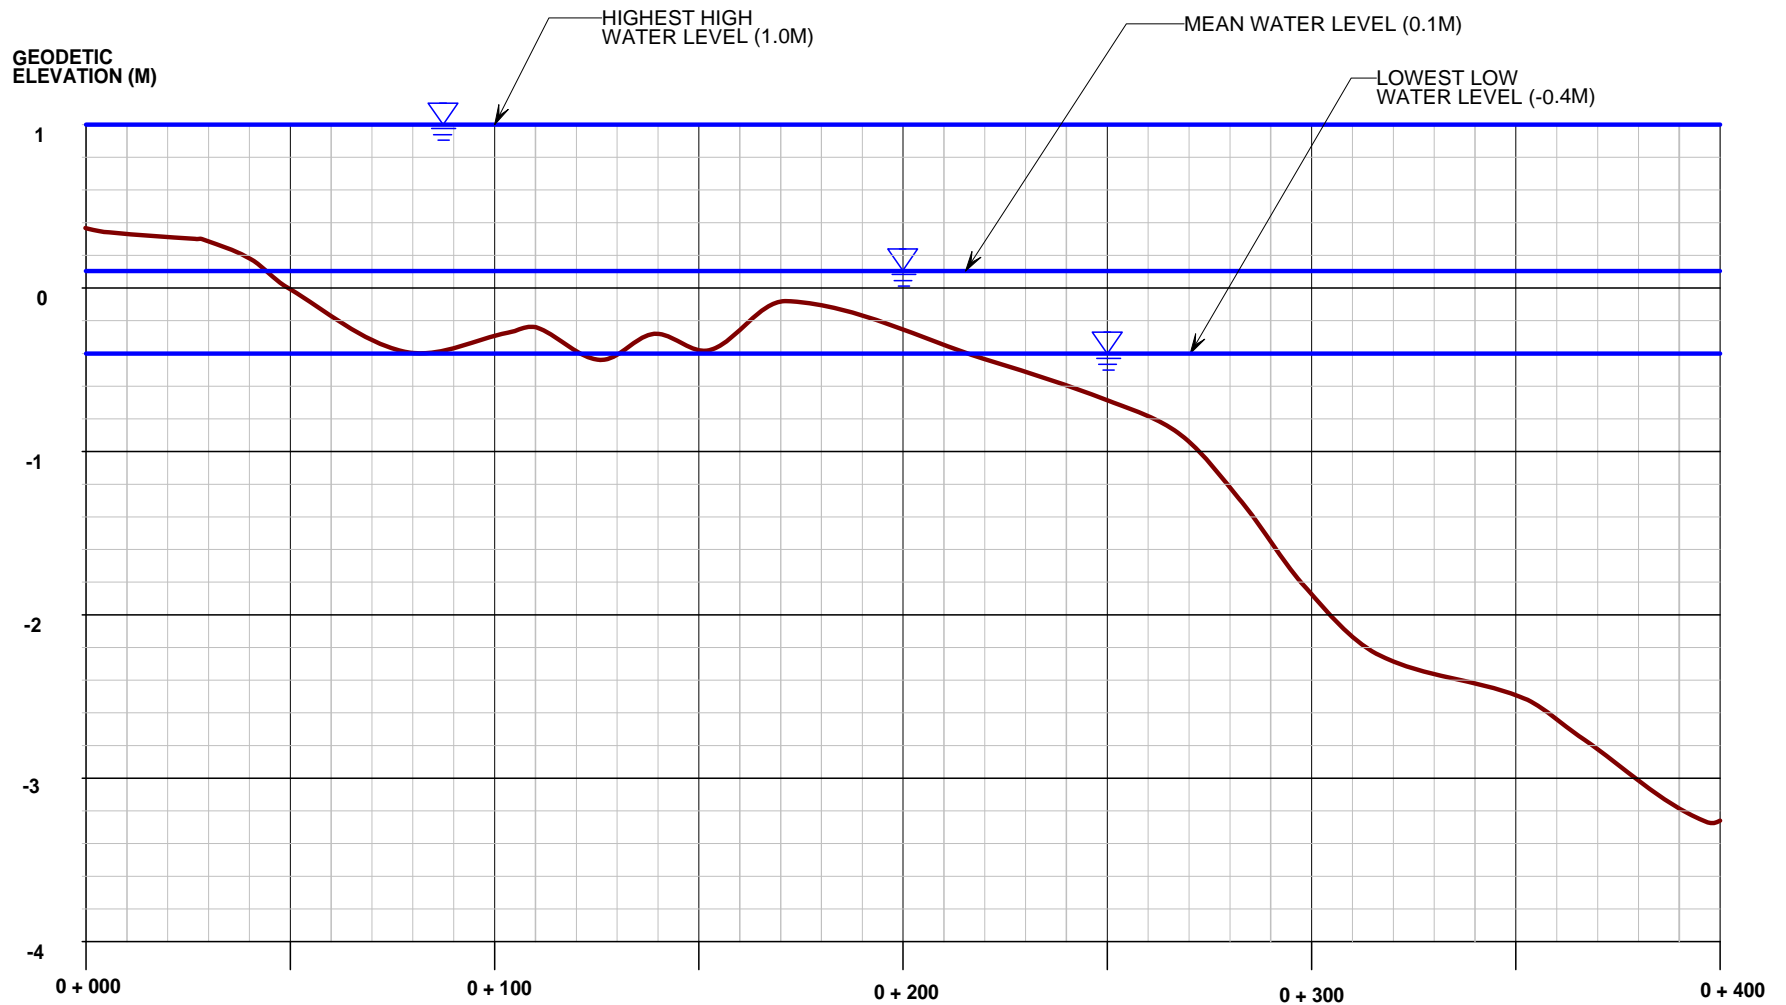
Figure: 3-4

Mixing Zone Investigation
 Burnt Church
 Cross Section Through Locations O1, O4, O5

Figures 3-2 and 3-3 depict the surveyed bathymetry in the outfall area. Figure 3-2 is a 3D perspective, rotated to better show the river channel. Figure 3-3 is a plan view (or looking straight down with the Y-axis pointing North). A cross-section of inner Miramichi Bay along the anticipated outfall pipeline is presented on Figure 3-4.

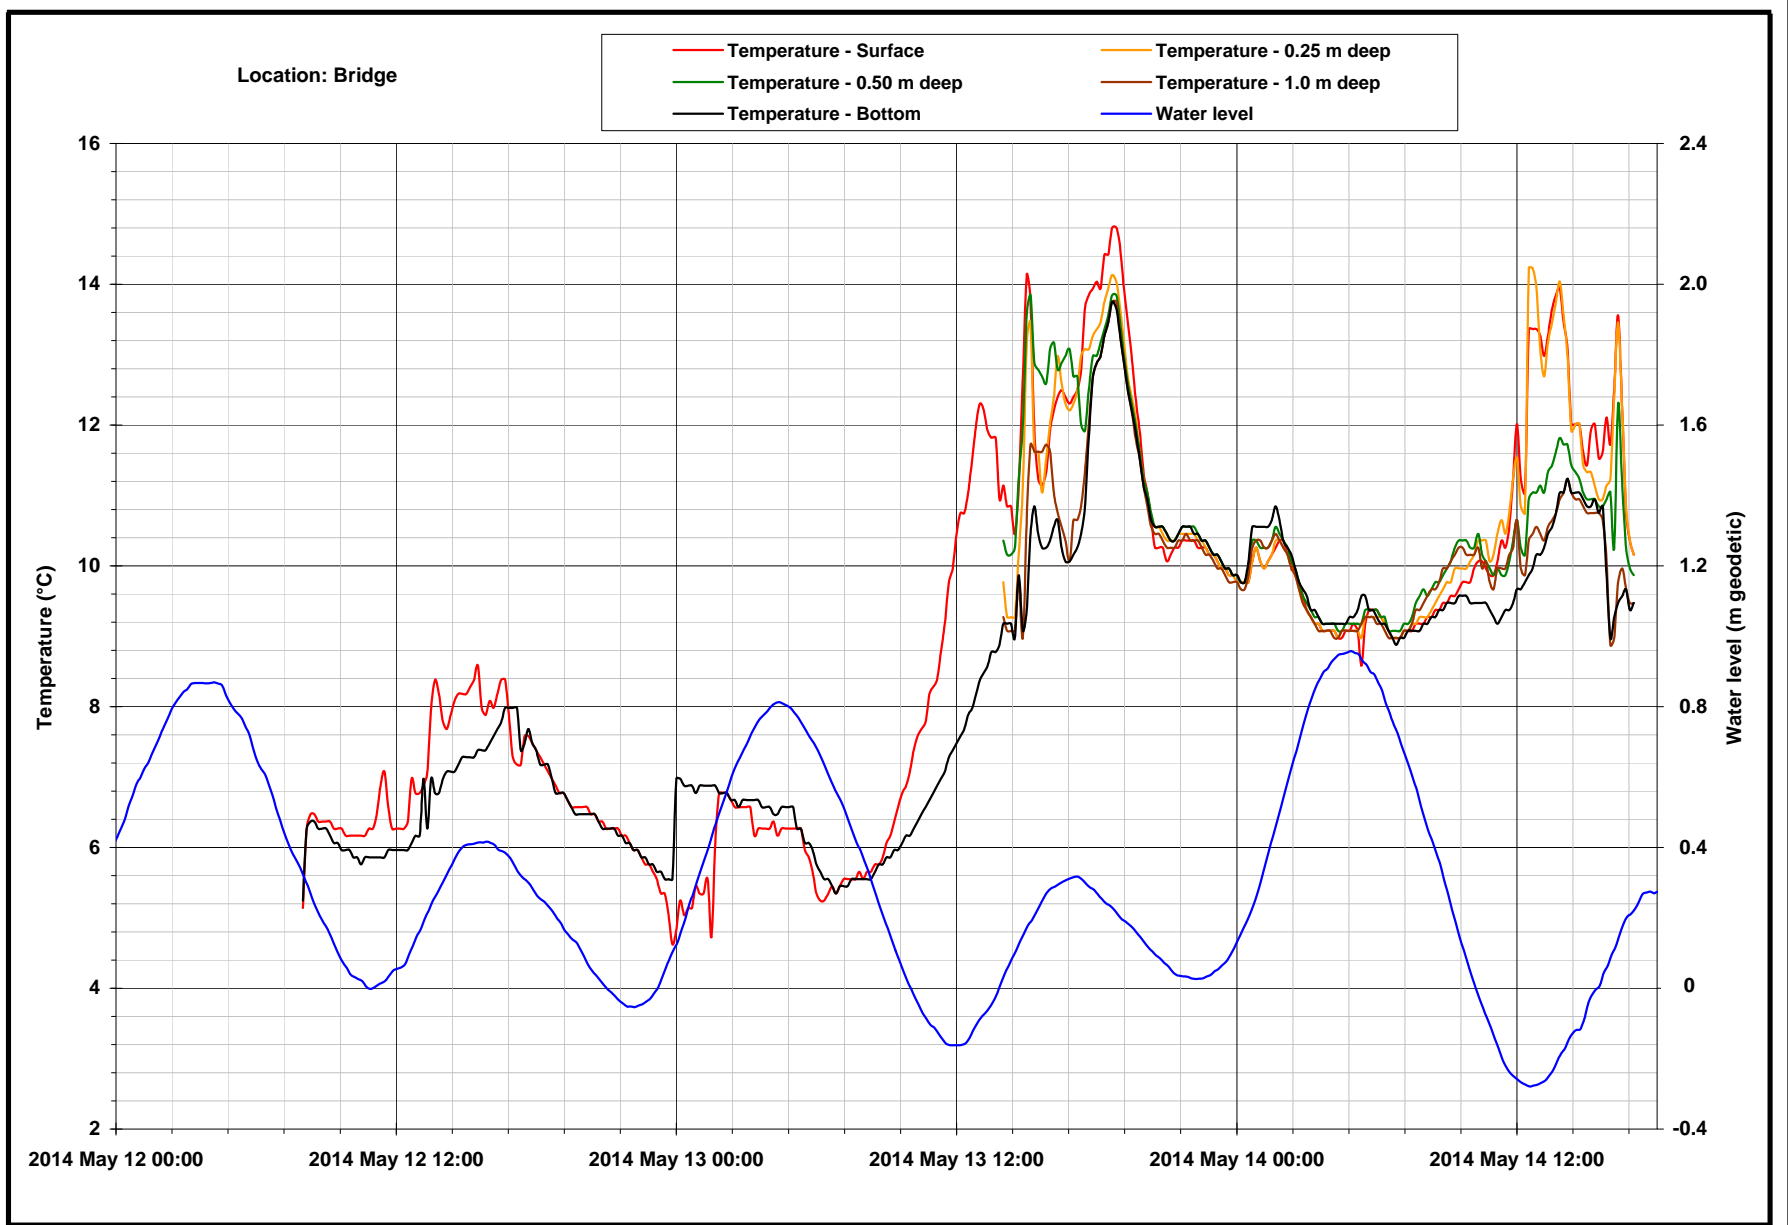
FIGURE: 3-12

Receiving Water Characterization Study
 Burnt Church
 Water Temperature Variations - At Bridge

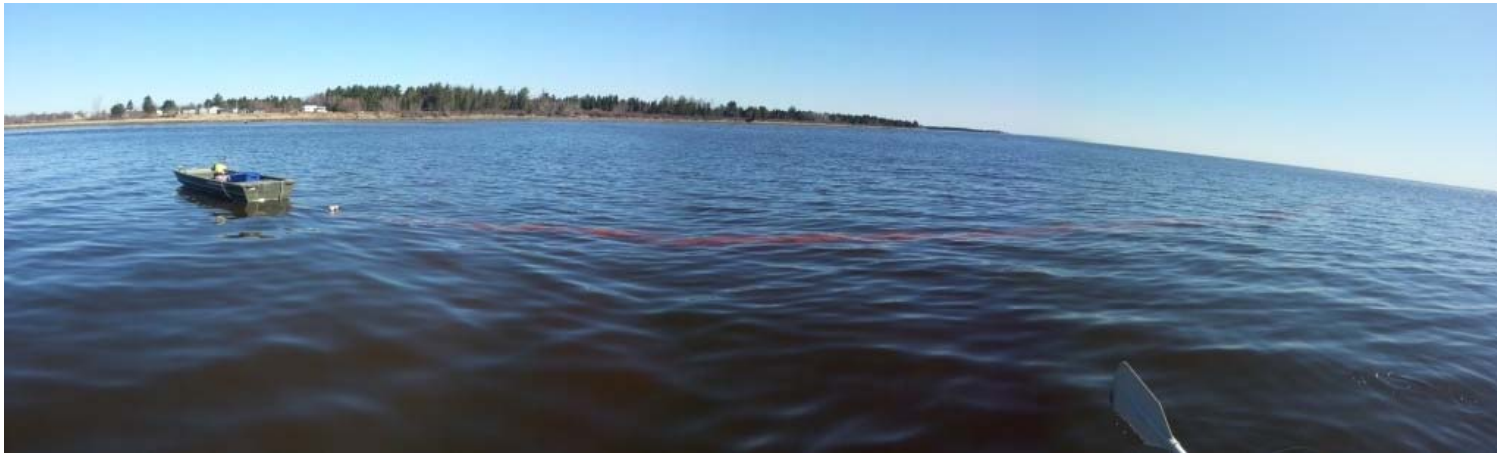
Dye plume flowing away from the shore

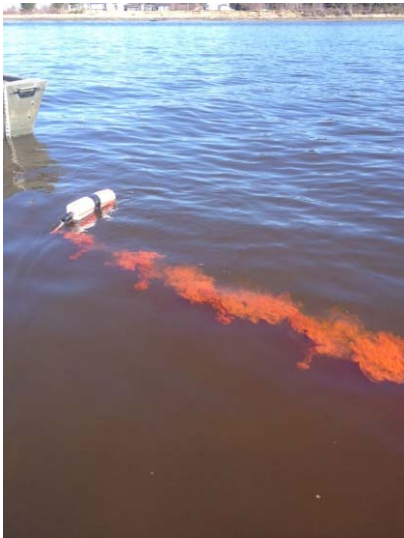
Dye injection setup

The mixing regime in the receiving environment was measured by injecting Rhodamine WT dye as a tracer at several locations into Inner Miramichi Bay. The dye was released at the surface as the WWTP effluent is anticipated to be buoyant. Dye sensor readings along with corresponding GPS position and time were documented. Visual observations were sketched and the plume boundary shape was traced in the field using GPS tracking.

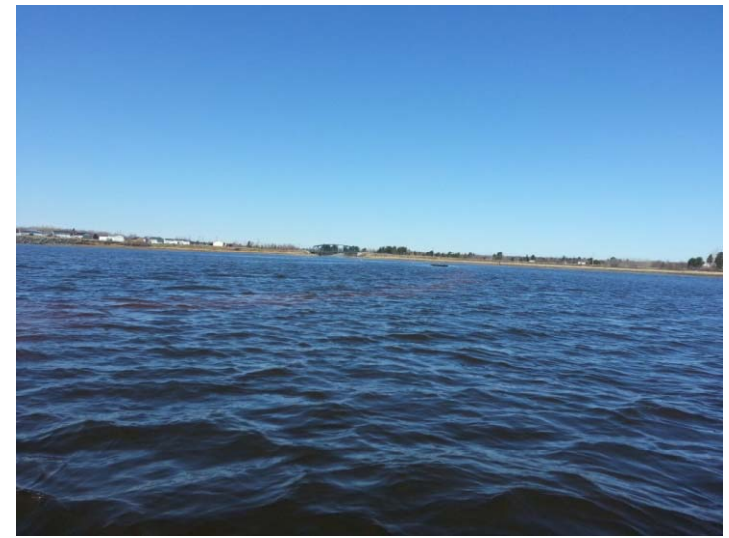
Long and narrow dye plume
