PRELIMINARY ENVIRONMENTAL ASSESSMENT REGISTRATION

SAINTE-CÉCILE LOBSTER AND CRAB PLANT

SAINTE-CÉCILE, NB

February 2018

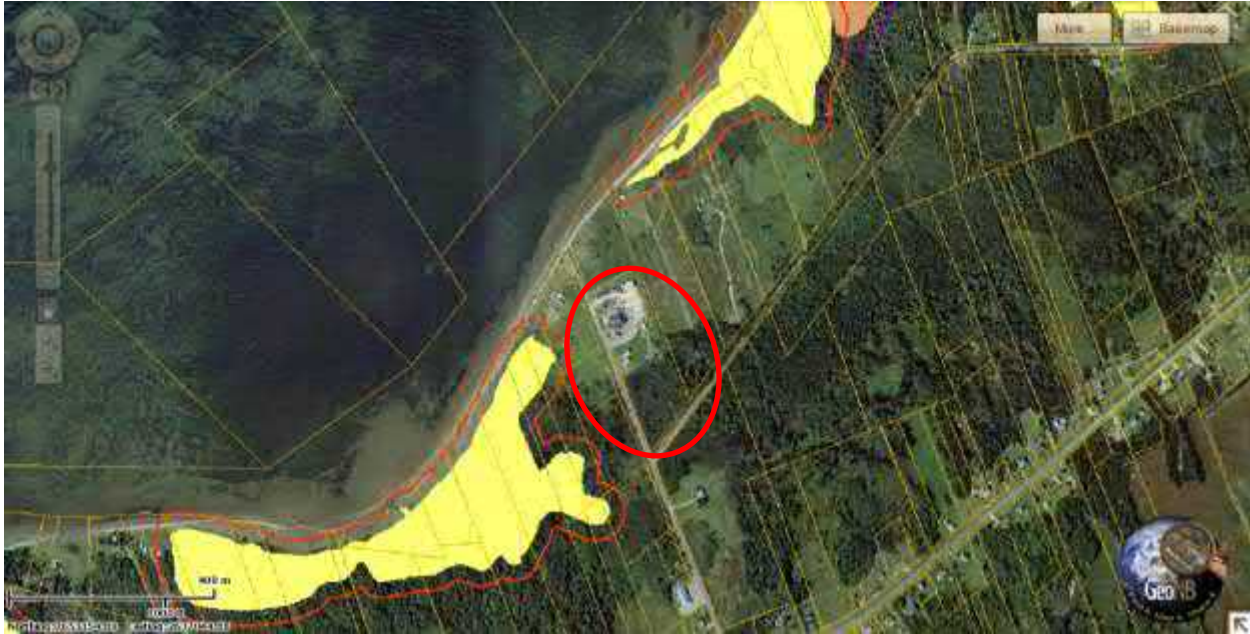
Figure No. 5: Regulated Wetlands in Proximity to the Subject Site (GeoNB)

A coastal Provincially Significant Wetland (PSW) is located approximately 100m to the west of the subject site. A second PSW coastal wetland is located approximately 230m north of the site (200m to the buffer), along the coast. No other regulated wetlands are located in the area, and none are identified within the subject site (Figure 5).

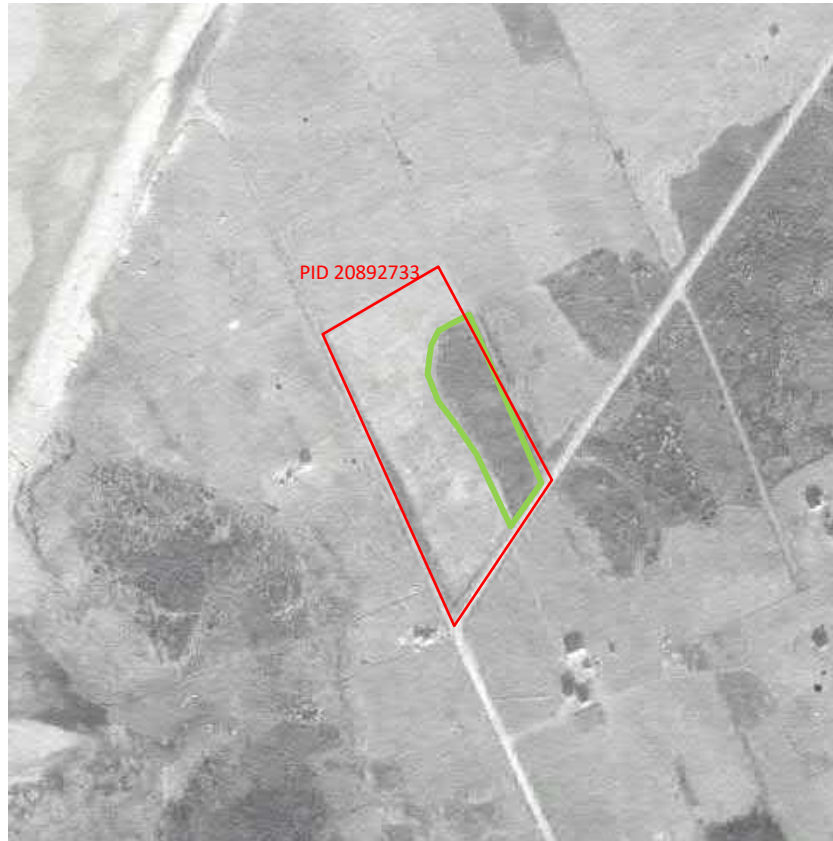
Figure No. 7: 1944 Aerial Photo of Site (Wetland Area in Green)

ERD aerial photos from 1944, 1955, 1963, 1974, 1985, 2002 and 2012 were reviewed. Based on this review, the area consisted of agricultural fields with some forest patches dating back to at least 1944. In all photos, forest patches not cleared for agriculture can be observed which correspond to wetland areas mapped on GeoNB or observed in the field. Figure 7 highlights such an area in PID 20892733.

Based on this review and the results of the limited soil profiles obtained, it is reasonable to conclude that a portion of the cleared field on PID 20892733 is an unmapped wetland approximately 300 square metres in size. Given the physical distance and separation from the coast, it is unlikely this wetland would be considered a coastal wetland (i.e. a PSW).

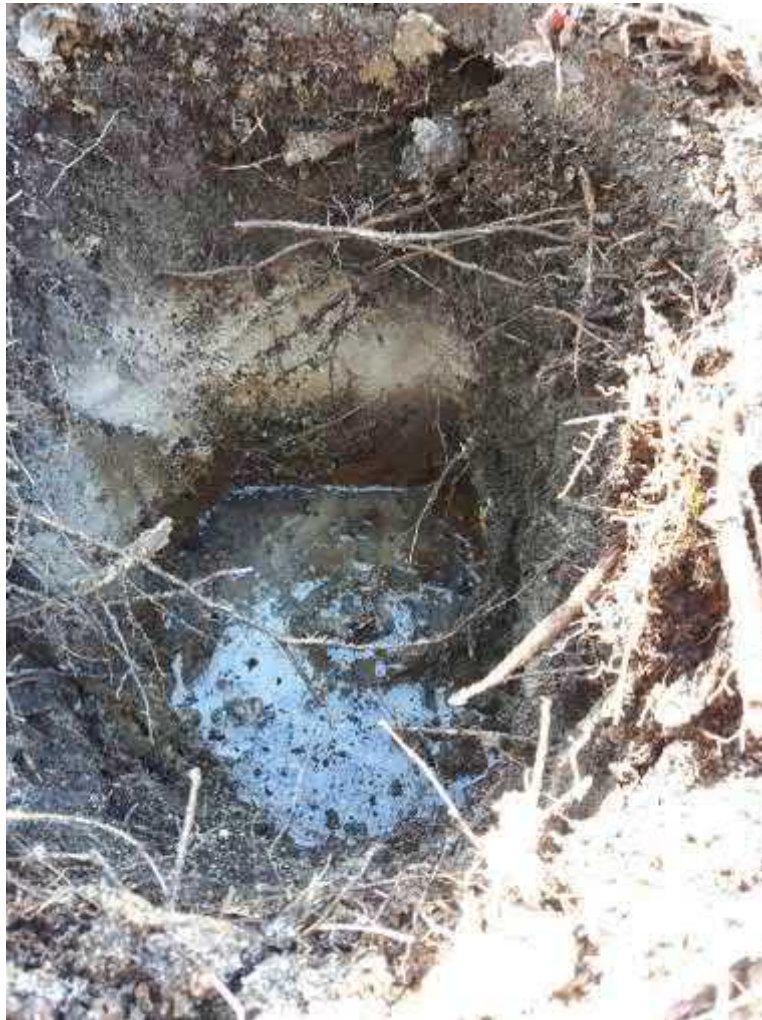
Photo No. 5: Soil Test Pit

An attempt to dig test pits by hand within the proposed project footprint was not possible due to the frozen ground; however, two pits were able to be dug by hand along the eastern property boundary. Soil horizons in each pit were identical.
