Wetland Delineation Report

Standard Wetland Delineation Report: Grand Harbour, Grand Manan, NB

PID 15185465

June 16, 2018

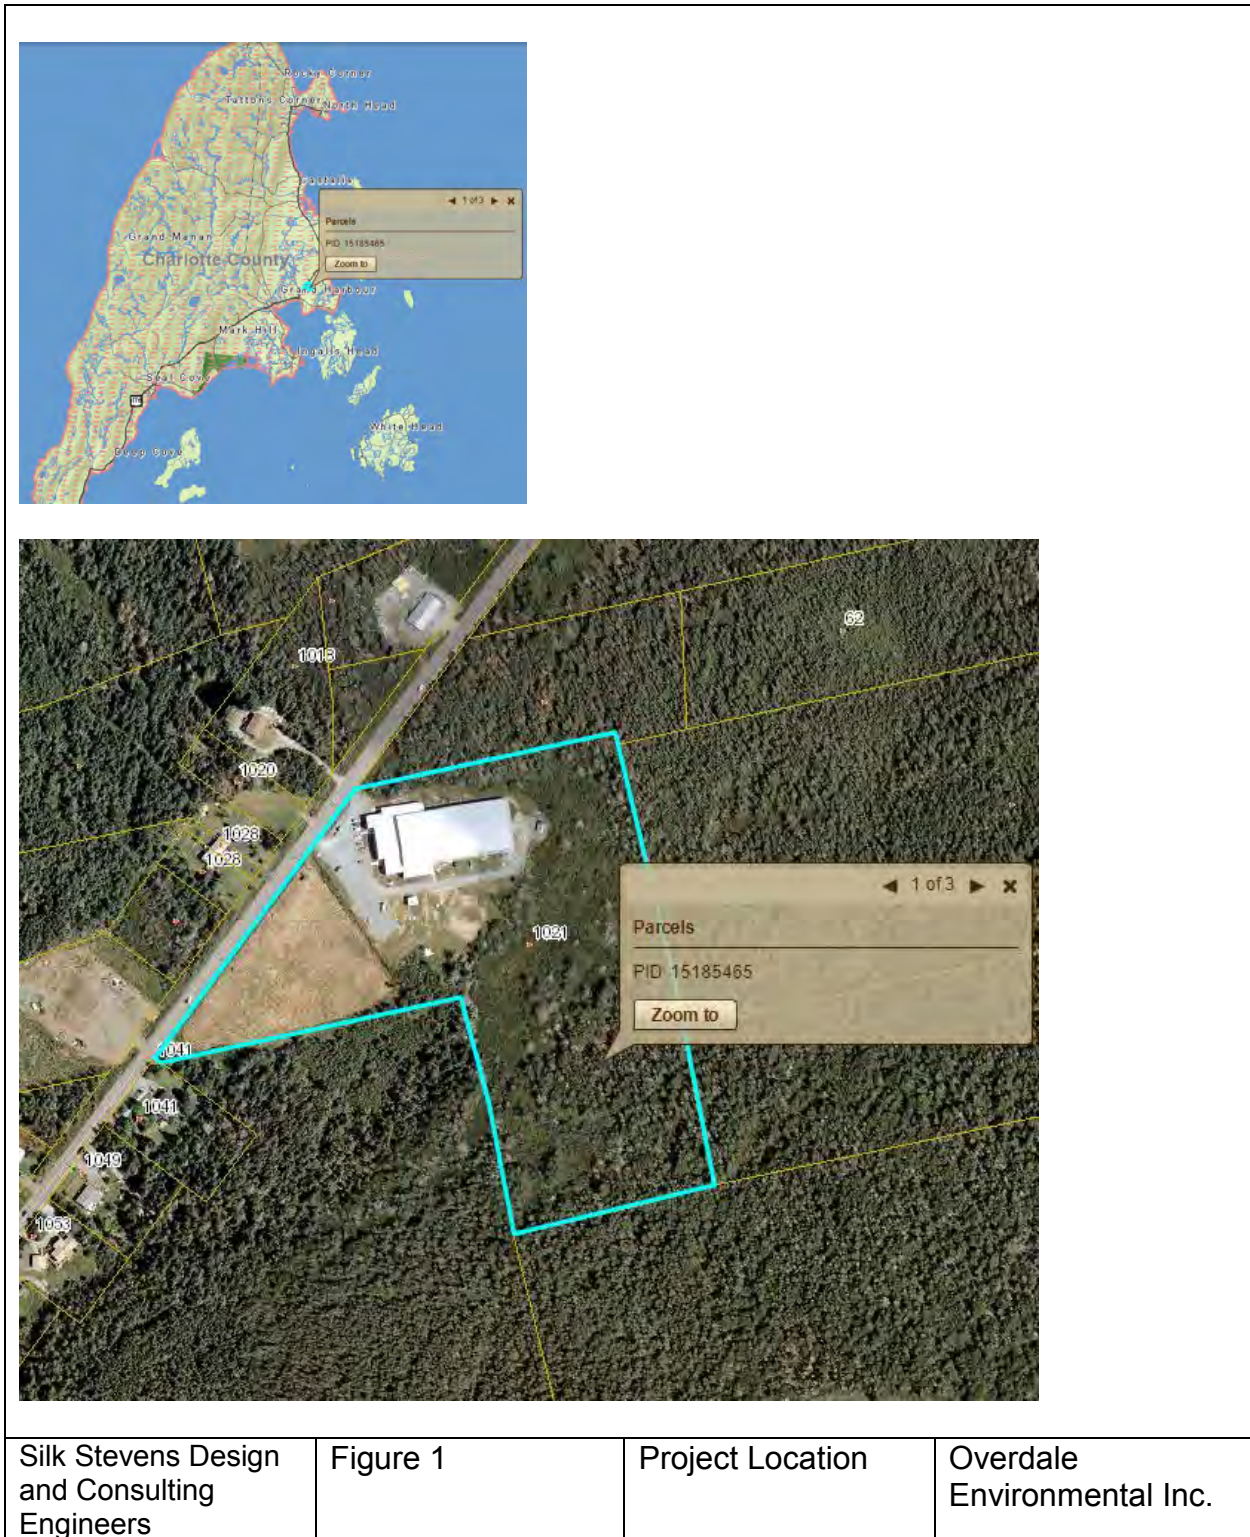
Figure 1. Survey Area

A Standard Wetland Delineation was conducted by Theo Popma, a recognized Delineator at Overdale Environmental Inc. The property (PID 15185465) is located on Grand Manan Island near Grand Harbour, NB (Figure 1, Appendix A). The western boundary of the PID is adjacent to the parking lot for the local Arena. Wetland is shown to exist on the site according to the map layer at SNB GeoNB (Figure 2). The delineation was conducted in accordance with the NB Wetland Conservation Policy and the Clean Environment Act.

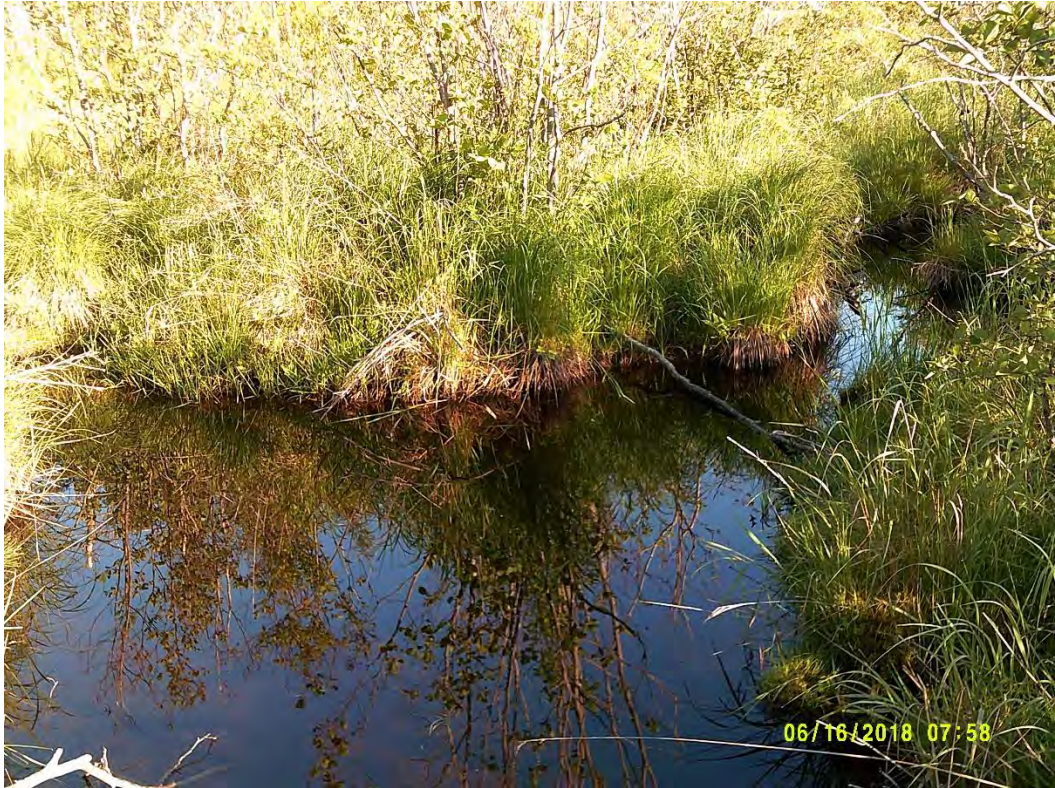
The site consists of a dried-down wetland with an open transition zone dominated by shrubs and a variety of grasses. Previous beaver activity in the area likely affected drainage of this wetland which used to be much larger. Ditching and development at the nearby arena also may account for this. The wetland itself has been reduced to a Shrub Swamp with some Marsh characteristics occupying the lowest poorly drained regions. Some open water is present as well as channeling. Microtopographical relief defined much of the wetland boundary.

Open water in
Shrub Swamp
Wetland

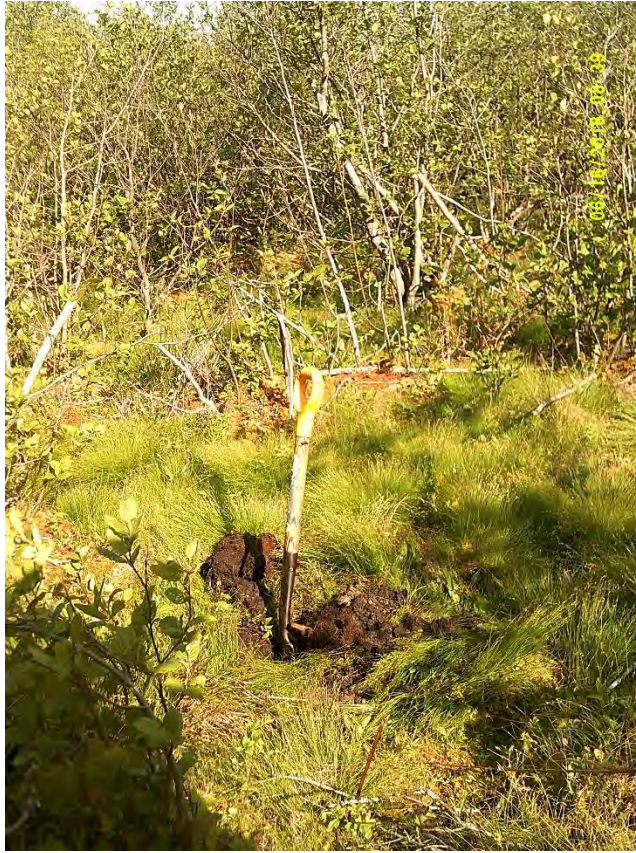
Datapoint 2

DP 2: Wetland

This region is slightly upslope from the main stream channel which feeds wetland on this PID. DP2 borders on the adjacent PID where open meadow habitat still contains wetland indicators such as water-saturated soils.

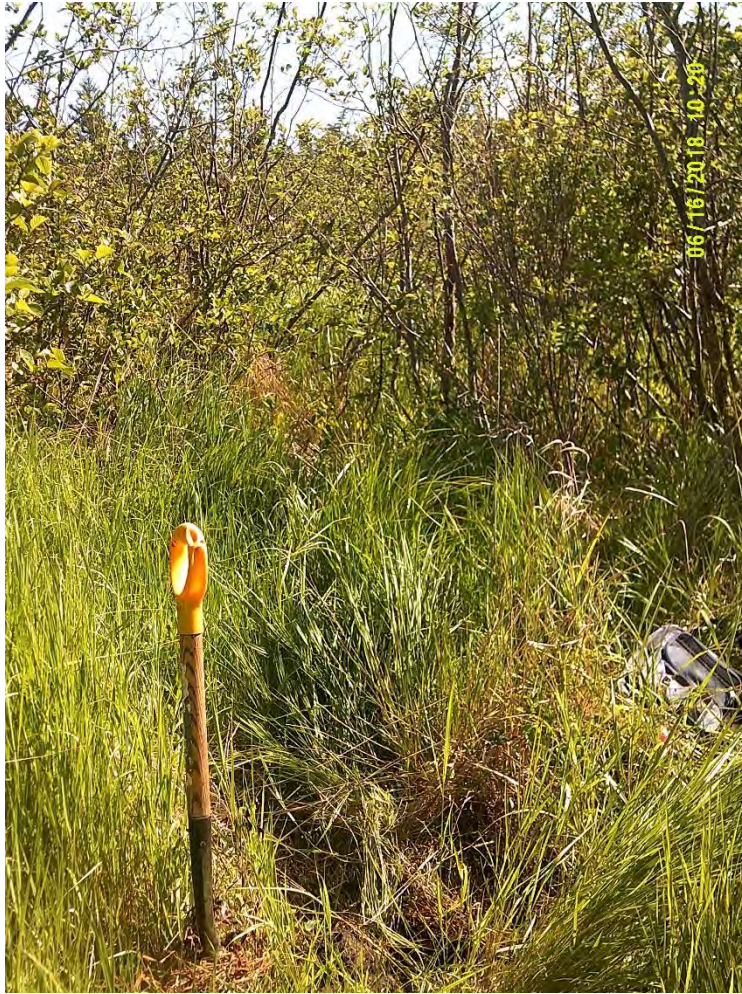
Datapoint 5

DP5: Wetland

This sample point represents the area nearest to the arena and is defined by the presence of Hydrogen Sulfide gas in the sediments and presence of high water table. Channels are nearby as well as open water pools. Some microtopographical relief is present along this edge of the wetland boundary.
