# EIA REGISTRATION

## **Village of Grand Manan Aquatic Centre and Wellness Facility**

# EIA Registration

SSL Project: 17-10-004

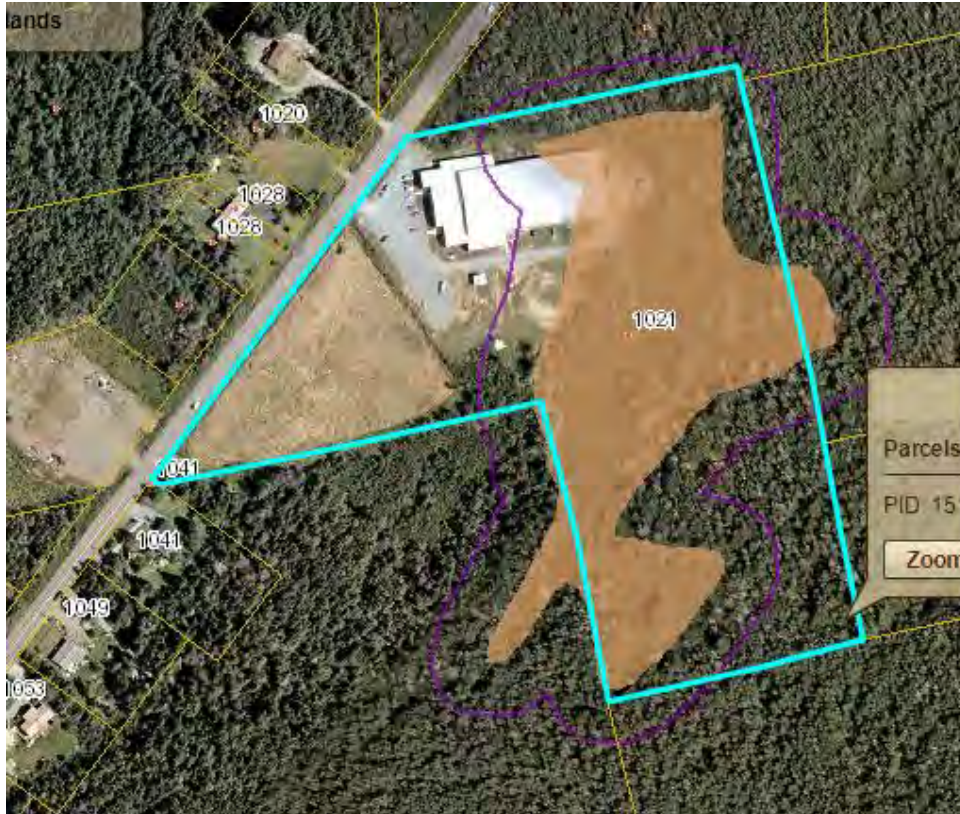
Figure 3-1: Regulated Wetland GeoNB

The wetland in proximity to the proposed project location was found to be approximately 2.93 hectares based off the GeoNB Regulated Wetland Map dated 2011-01-03, Figure 3-1, which would trigger an EIA as described below:

According to current GeoNB mapping, there is a wetland of size 2.93 hectares (7.24 acres) near and on the site, this map is illustrated on drawing C-03 in Appendix B. Silk Stevens Limited had retained a Wetland Delineator to assess the site as there were some discrepancies between what is mapped and the actual conditions. The wetland delineation report confirmed the wetland is much smaller than mapped and the new boundary is shown on drawing C-04 in Appendix B and the full report can be found in Appendix I. The new wetland delineation has been accepted by the Department of Environment and Local Government as of July 17, 2018. The proposed Aquatic Centre and Wellness will be required to be constructed within the wetland and/or its setbacks.

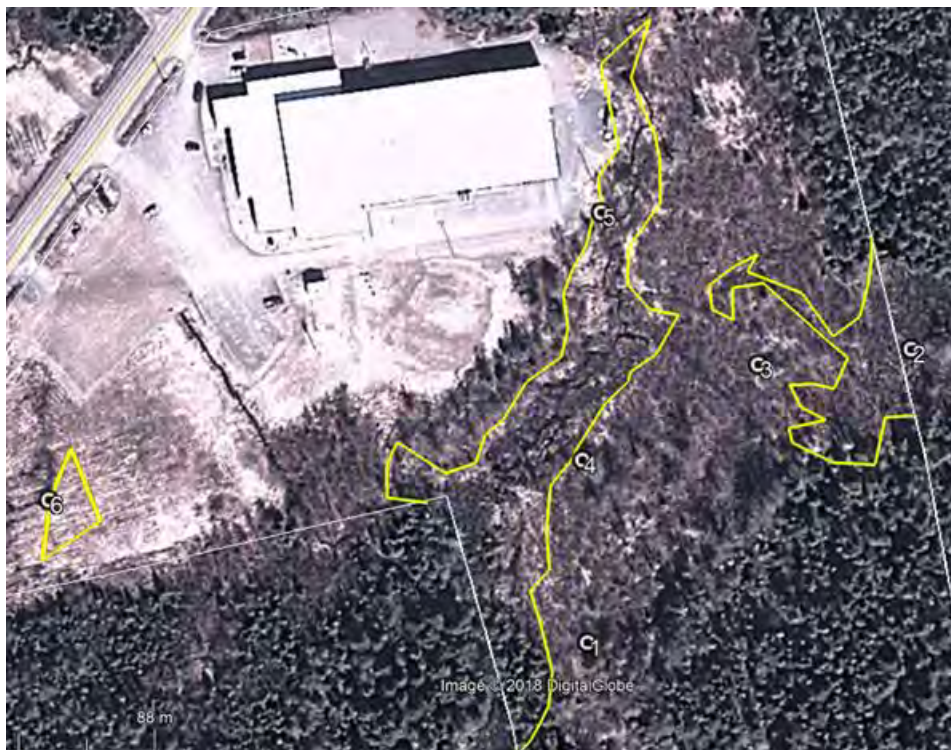
Figure 3-2: Delineated Wetland and Data Points

Overdale Environmental Inc. was hired to confirm the size of the wetland and delineate if required. The full Wetland Delineation Report is included in Appendix I. The resulting size of the wetland was found to be 0.65 ha in two distinct but connected lobes and a small (less than 0.1 ha) marshy wetland area near the clearing by parking lot (Popma, 2018). Interpretation of aerial photos, Figure 3-2, indicates that the total size of this wetland (both on and off this PID) is approximately 1 ha in total; it is noted that this is considered to be an Atypical Area where human impacts affect analysis of wetland indicators, and that it is a Problem Area where natural events such as beaver activity also affect indicators (Popma, 2018).

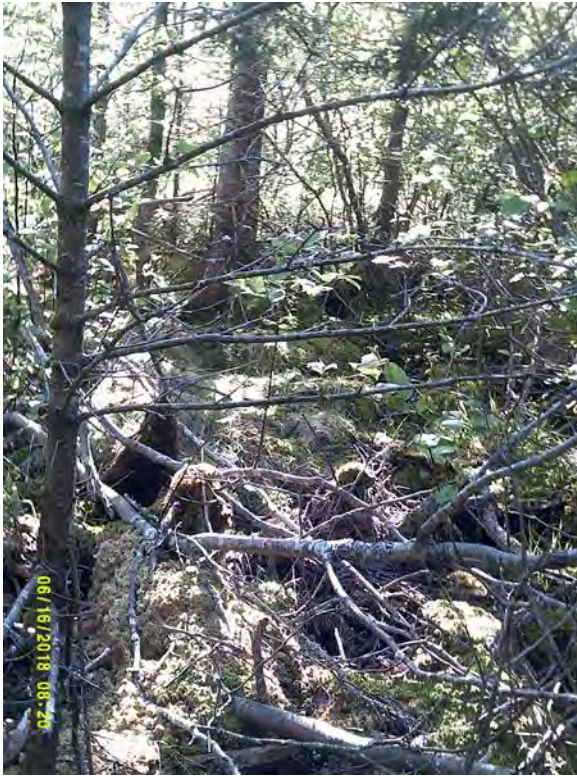
*Figure 3-4: Forested Wetland (Popma, 2018)*

Figure/Habitat Type	Description
Figure 3-4: Forested Wetland	A small patch of Forested Wetland was identified along the southwestern edge of the PID. This habitat is near the wetland boundary and near small microtopographical incline of about 4 feet. Deeply pitted and hummocked mossy ground was relatively open and interspersed with ferns and shrubs. No channeling was observed, but this habitat was found to be similar to where Shrub Wetland narrows to form a channel beneath the forest canopy at the northern edge of the PID. (Popma, 2018)
Figure 3-5: Shrub Wetland	This is the dominant wetland type on the PID. Speckled Alders dominate but sedge-dominated graminoid cover is also abundant. Smaller microhabitats such as bare-ground muddy depressions, open water, channels and upland inclusions were also present. Two 3 primary lobes of shrub wetland were present and found to be joined by a narrow (less than 5m) hydrological connection. (Popma, 2018)

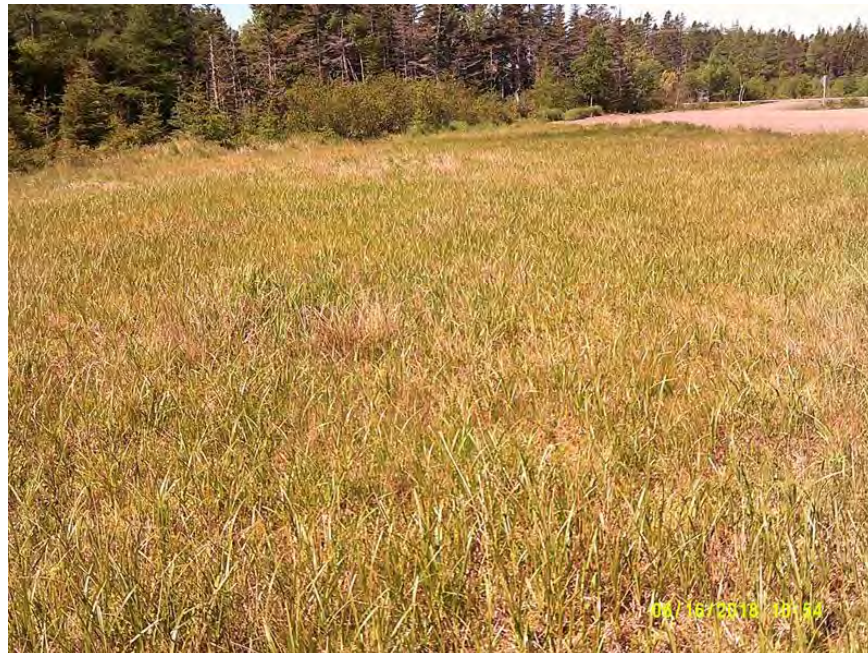
*Figure 3-6: Field/Marsh (Popma, 2018)*

Figure 3-6: Field/Marsh	This area is likely mowed infrequently to keep shrub vegetation down, but some natural characteristics still persist. Part of this region was identified as wetland according to standard wetland delineation protocols. Poor drainage has led to a small marshy graminoid-dominated depression within the field. Exotics such as Tufted Vetch and Vernal Grass were common as well. (Popma, 2018)
Figure 3-7: Lawn and Meadow	Lawn grasses allowed to grow freely occupy the edge of the parking area next to the slope leading to the nearby wetland. Canada Blue-Joint is also present. Virtually no shrubs are present here. (Popma, 2018)
Figure 3-8: Dried Down Transition Zone	This is a relatively large area which apparently used to be wetland but has since dried down likely due to the presence/absence of beaver activity. Soils sampling and hydrological indicators show that this is not wetland, but the vast majority of vegetation is still hydrophytic. A slight slope also helps drain this region creating suitable habitat for upland species of grasses and even some large White Spruce. (Popma, 2018)

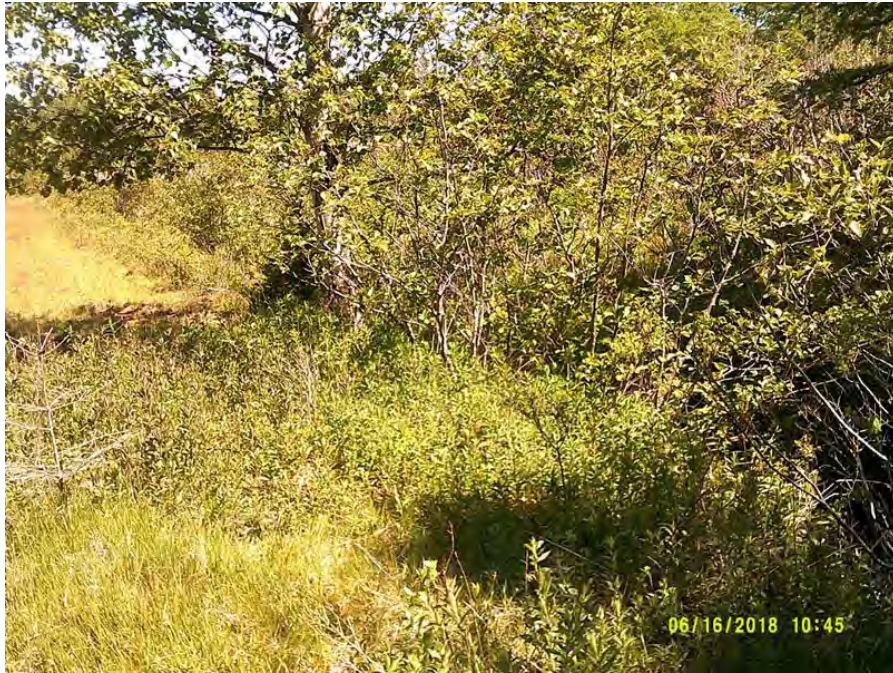
*Figure 3-9: Disturbed Forest Edge (Popma, 2018)*

Figure 3-9: Disturbed Forest Edge	Invasive herbaceous species dominate the understory of this habitat which is adjacent to the arena parking area. Young White Birch, Serviceberry and Speckled Alder are also present as shrubs and saplings. (Popma, 2018)
Figure 3-10: Mixed Upland Forest	The Forest surrounding the wetland transition zone is moderate-aged to mature and consists of a mixture of coniferous and deciduous species such as White Spruce and White Birch. The understory is relatively empty and dominated by bryophytes as is typical of boreal forests. A substantial amount of blowdown is present especially around the edge near the open transitional zone. (Popma, 2018)

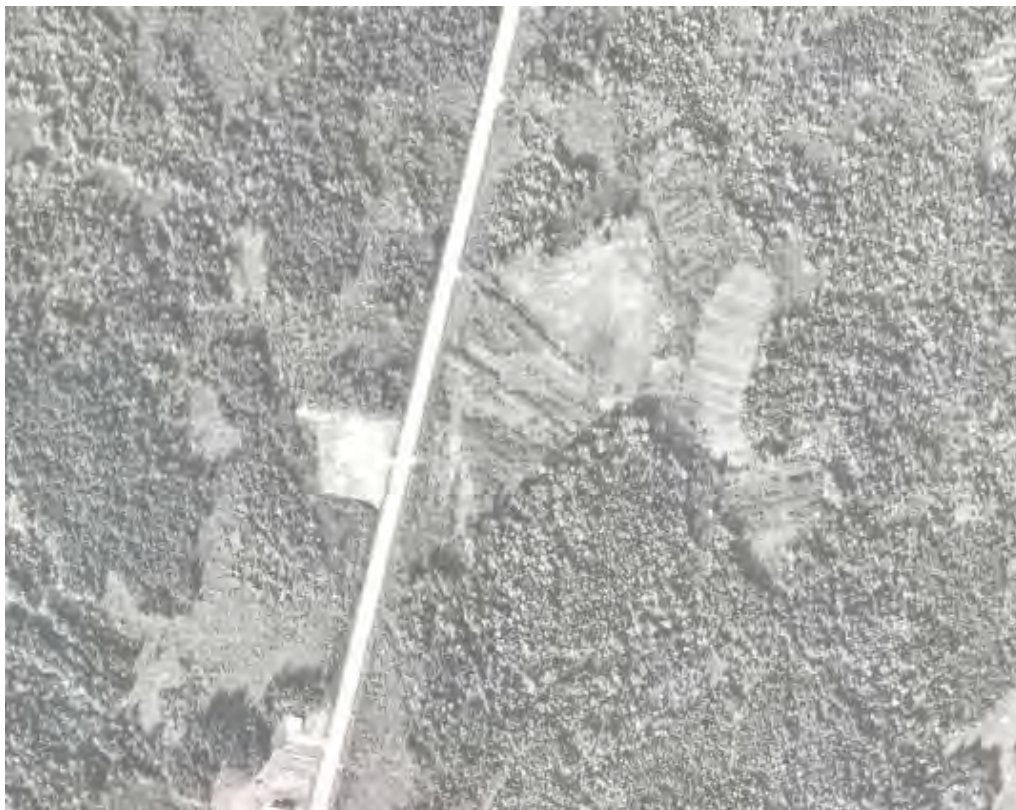
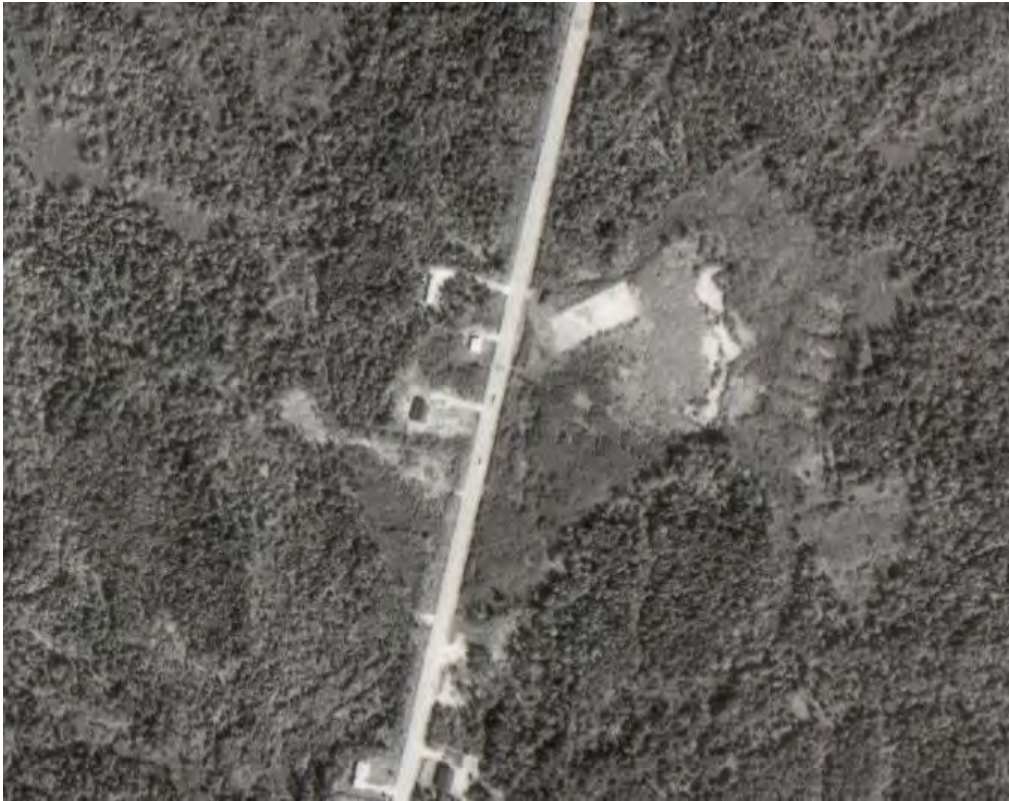
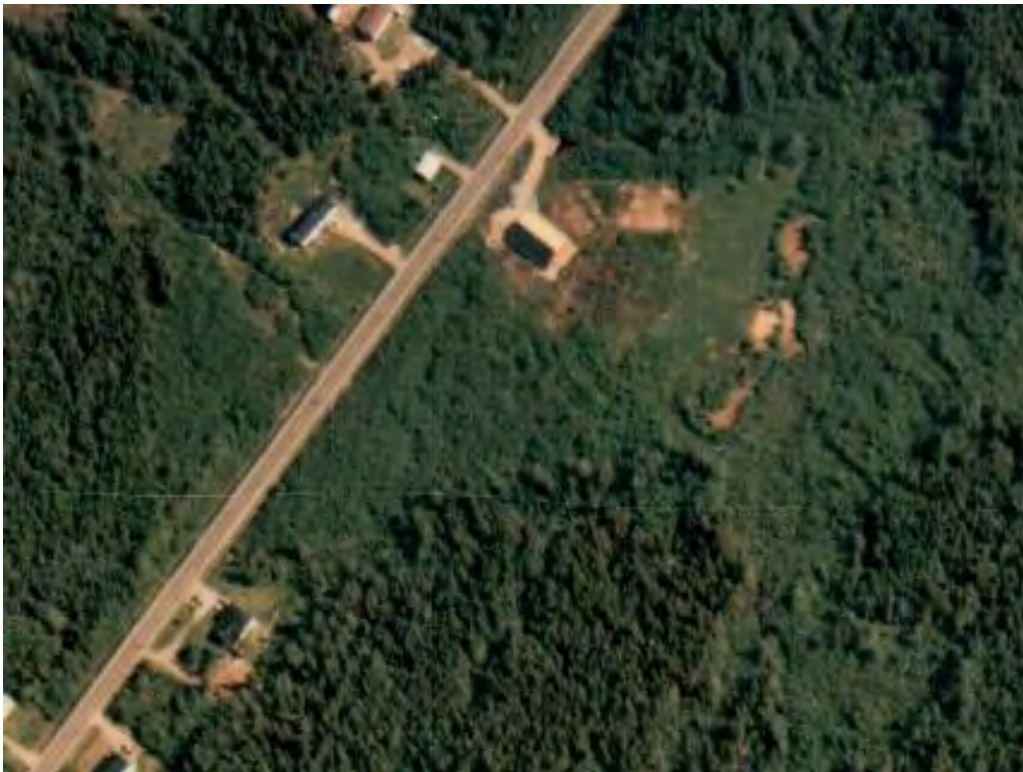
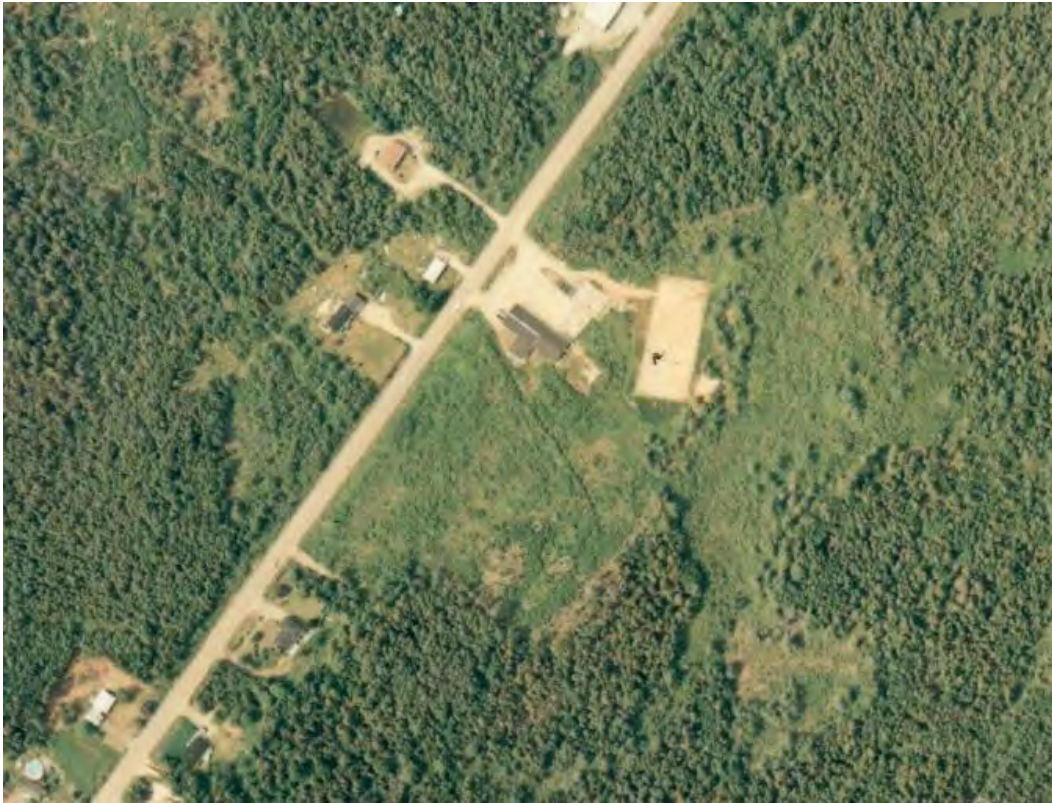
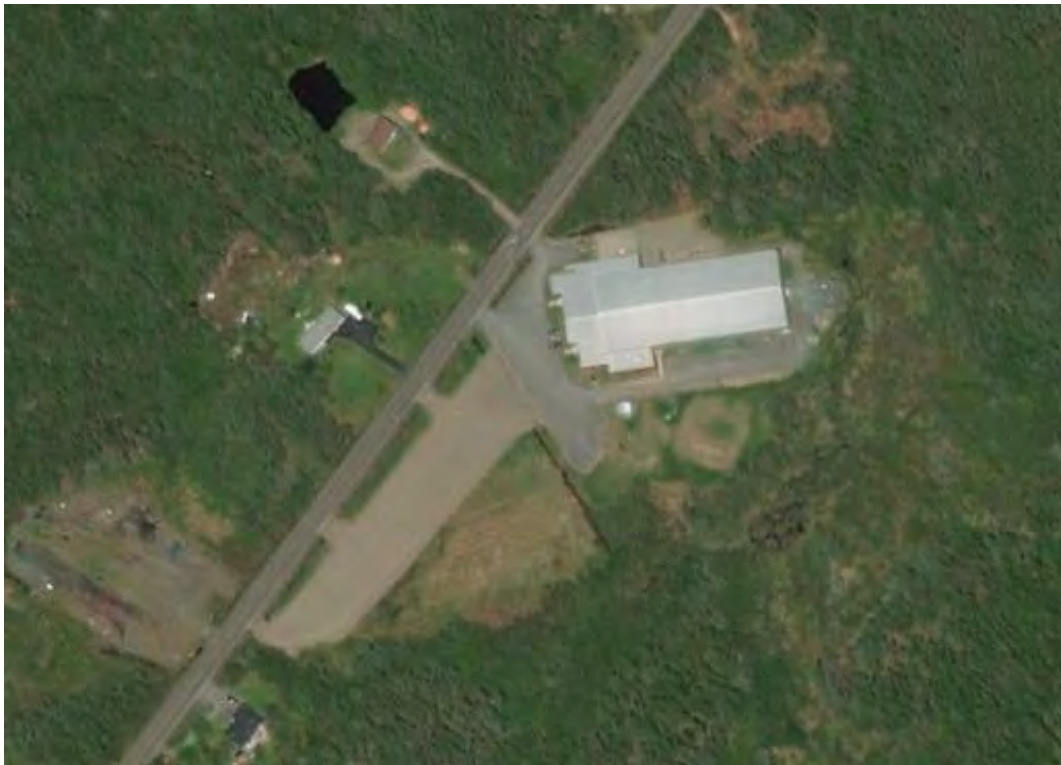
The following aerial photographs taken between 1962 until 2011 show the development of the parcel of land where the Aquatic Centre and Wellness Facility will be constructed. The aerial photography was provided by the Government of New Brunswick (GNB) Energy and Resource Development department or obtained from Ducks Unlimited Canada. In Figure 3-11, dated in 1962, the land appears to have been cleared/accessed however there were no building developments. In 1976, as shown in Figure 3-12, a portion of the land was cleared and prepared for the building which is visible in Figure 3-13 in 1984. The building shown in 1984-1999 was a Boys and Girls Club which was demolished and replaced by the current Community Centre. In 1999, in addition to the Boys and Girls Club there was an outdoor rink and basketball court on the land, see Figure 3-14. In 2011, the Community Centre was built to replace the old facilities and remains there to date as can be seen Figure 3-15. Refer to Appendix F for full size images.
