## **EIA Registration – McAdam Wellfield Expansion Project**

*Village of McAdam*

EIA Registration – McAdam Wellfield Expansion Project, McAdam, NB

Appendix B –  
Abbreviated Municipal Groundwater Supply Source Investigation

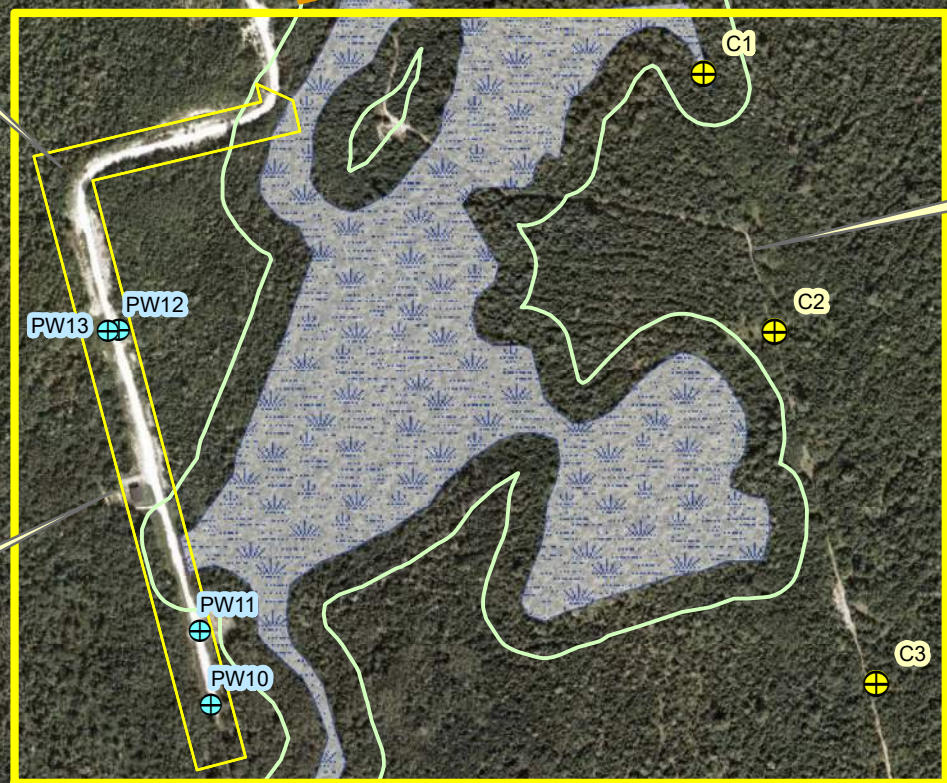
- Municipal Boundary
- Drill Targets
- McAdam Wells
- NBHN Watercourses
- Property Parcels
- Delineated WetLand 30m buffer
- Delineated WetLand (14.5 ha)

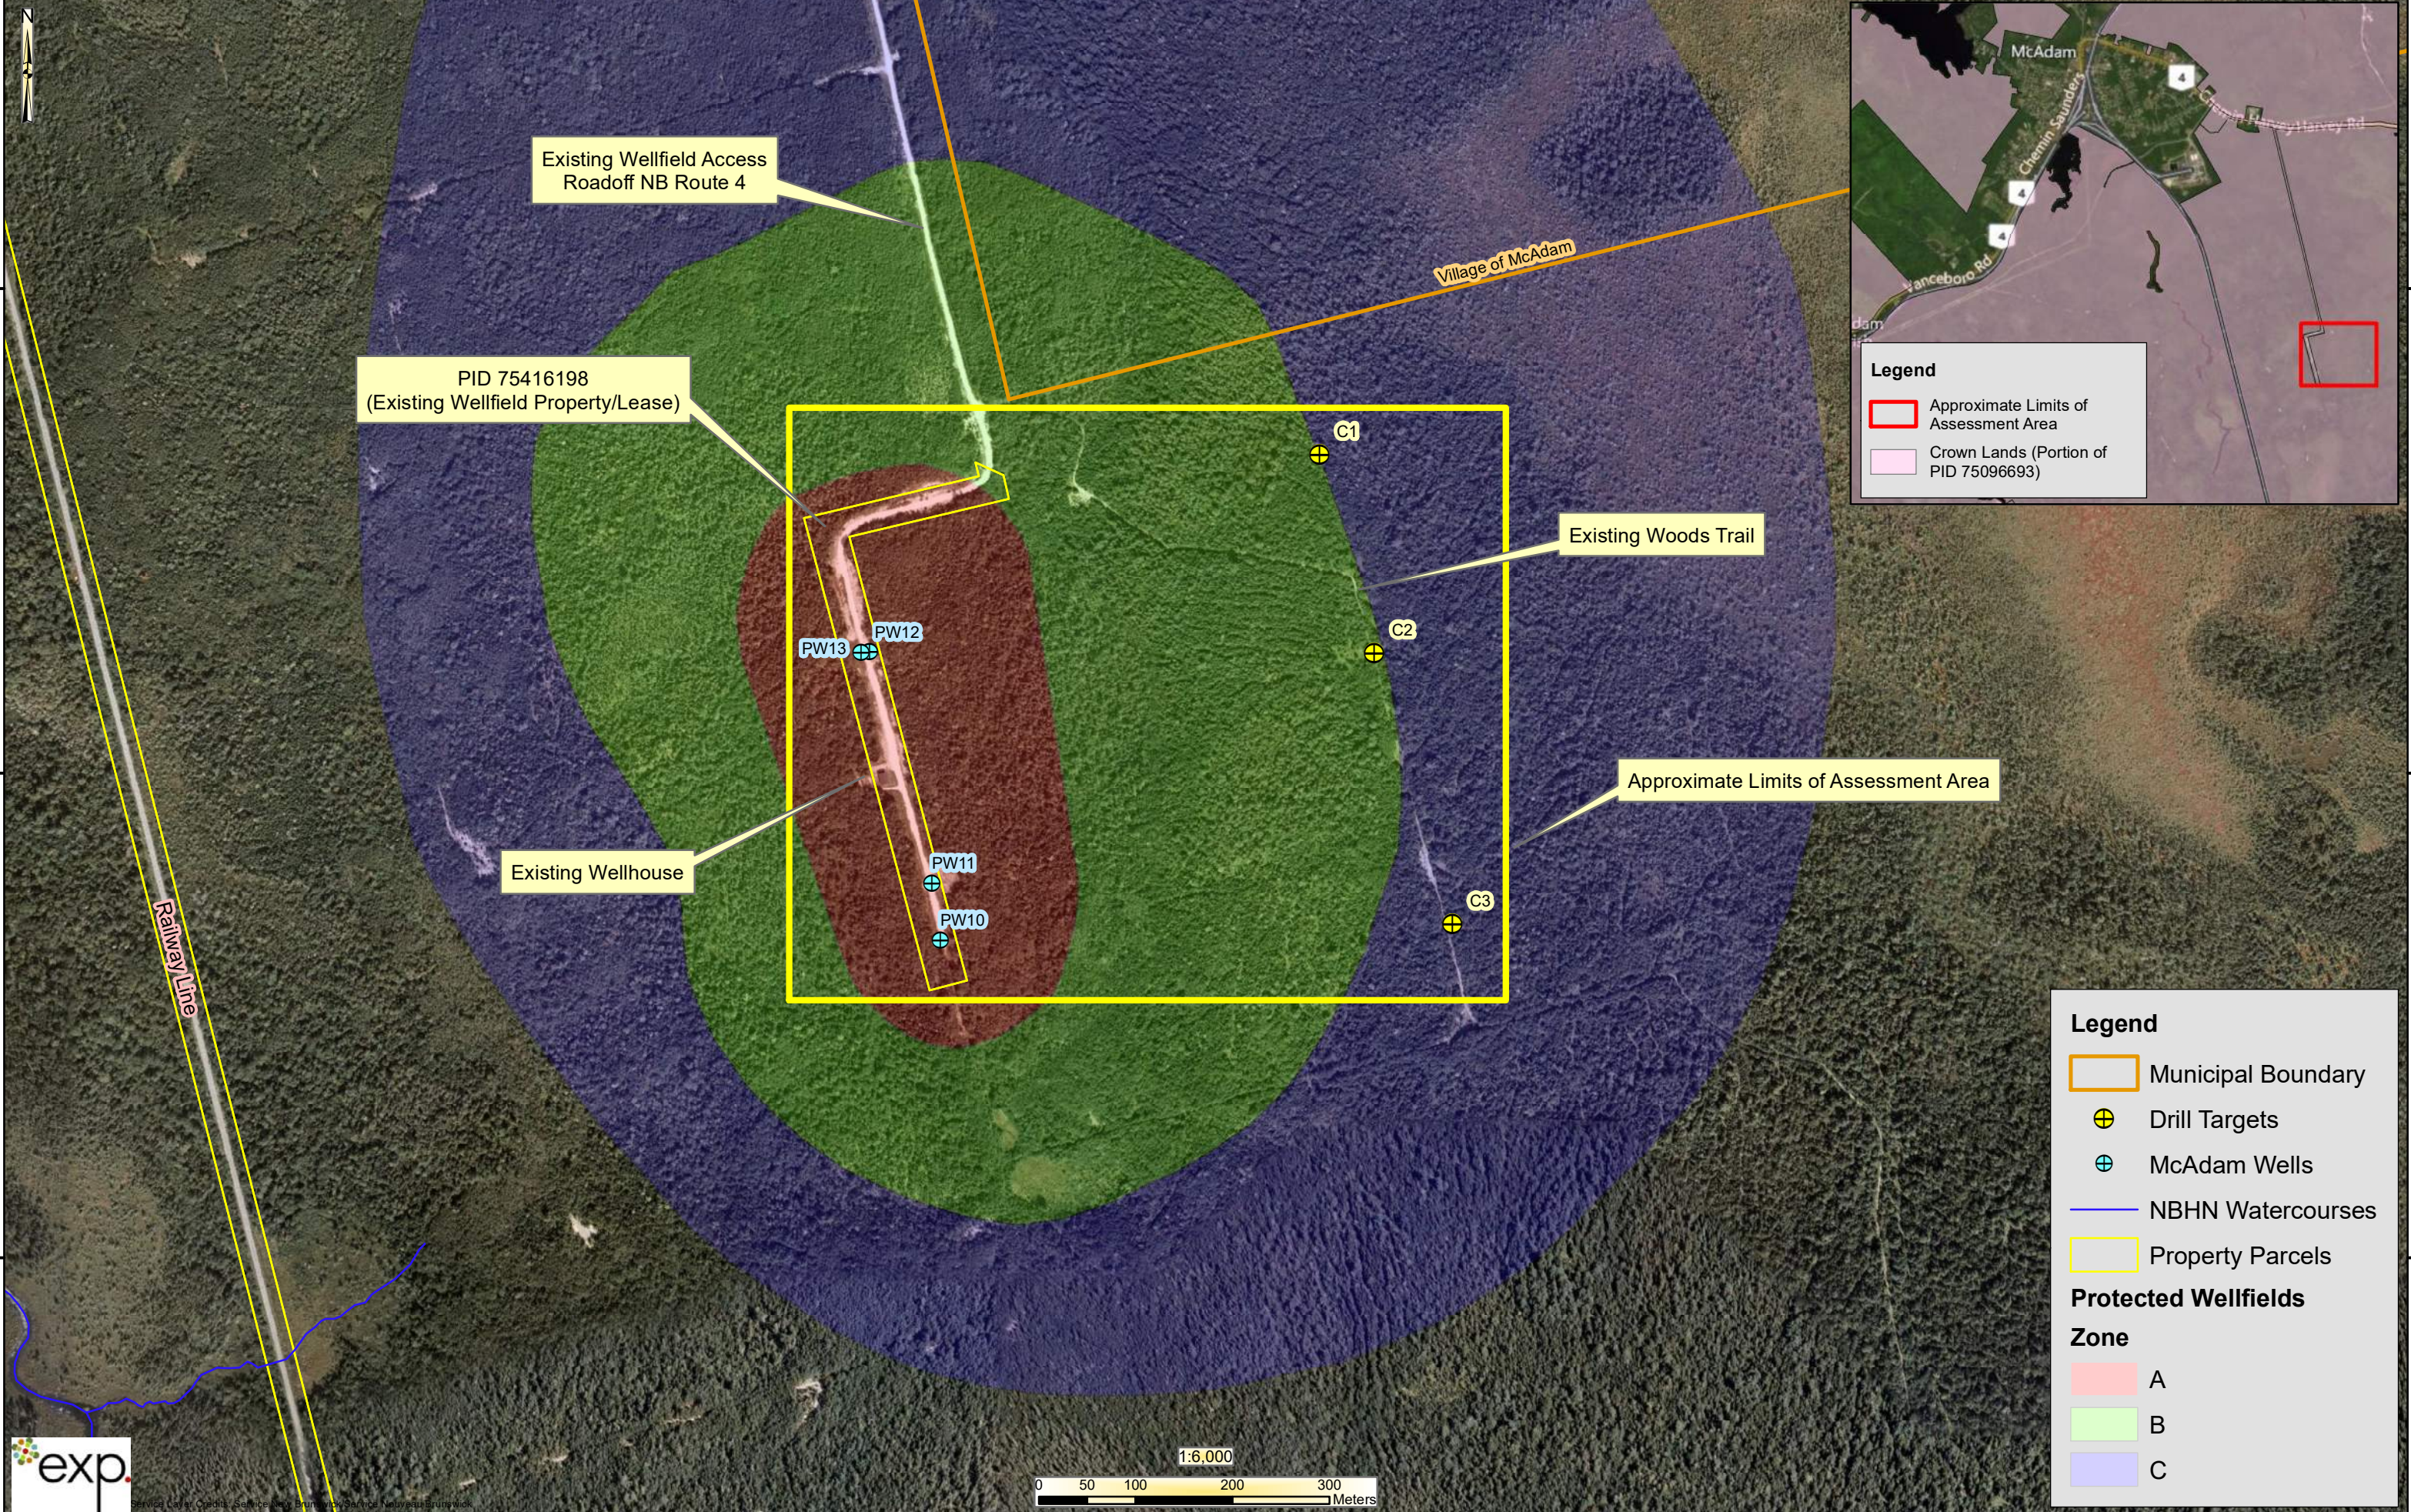
Existing Wellfield Access Roadoff NB Route 4

PID 75416198 (Existing Wellfield Property/Lease)
