# Environmental Impact Assessment

Closure of the CertainTeed Canada, Inc.  
McAdam Gypsum Wallboard Plant  
McAdam, NB

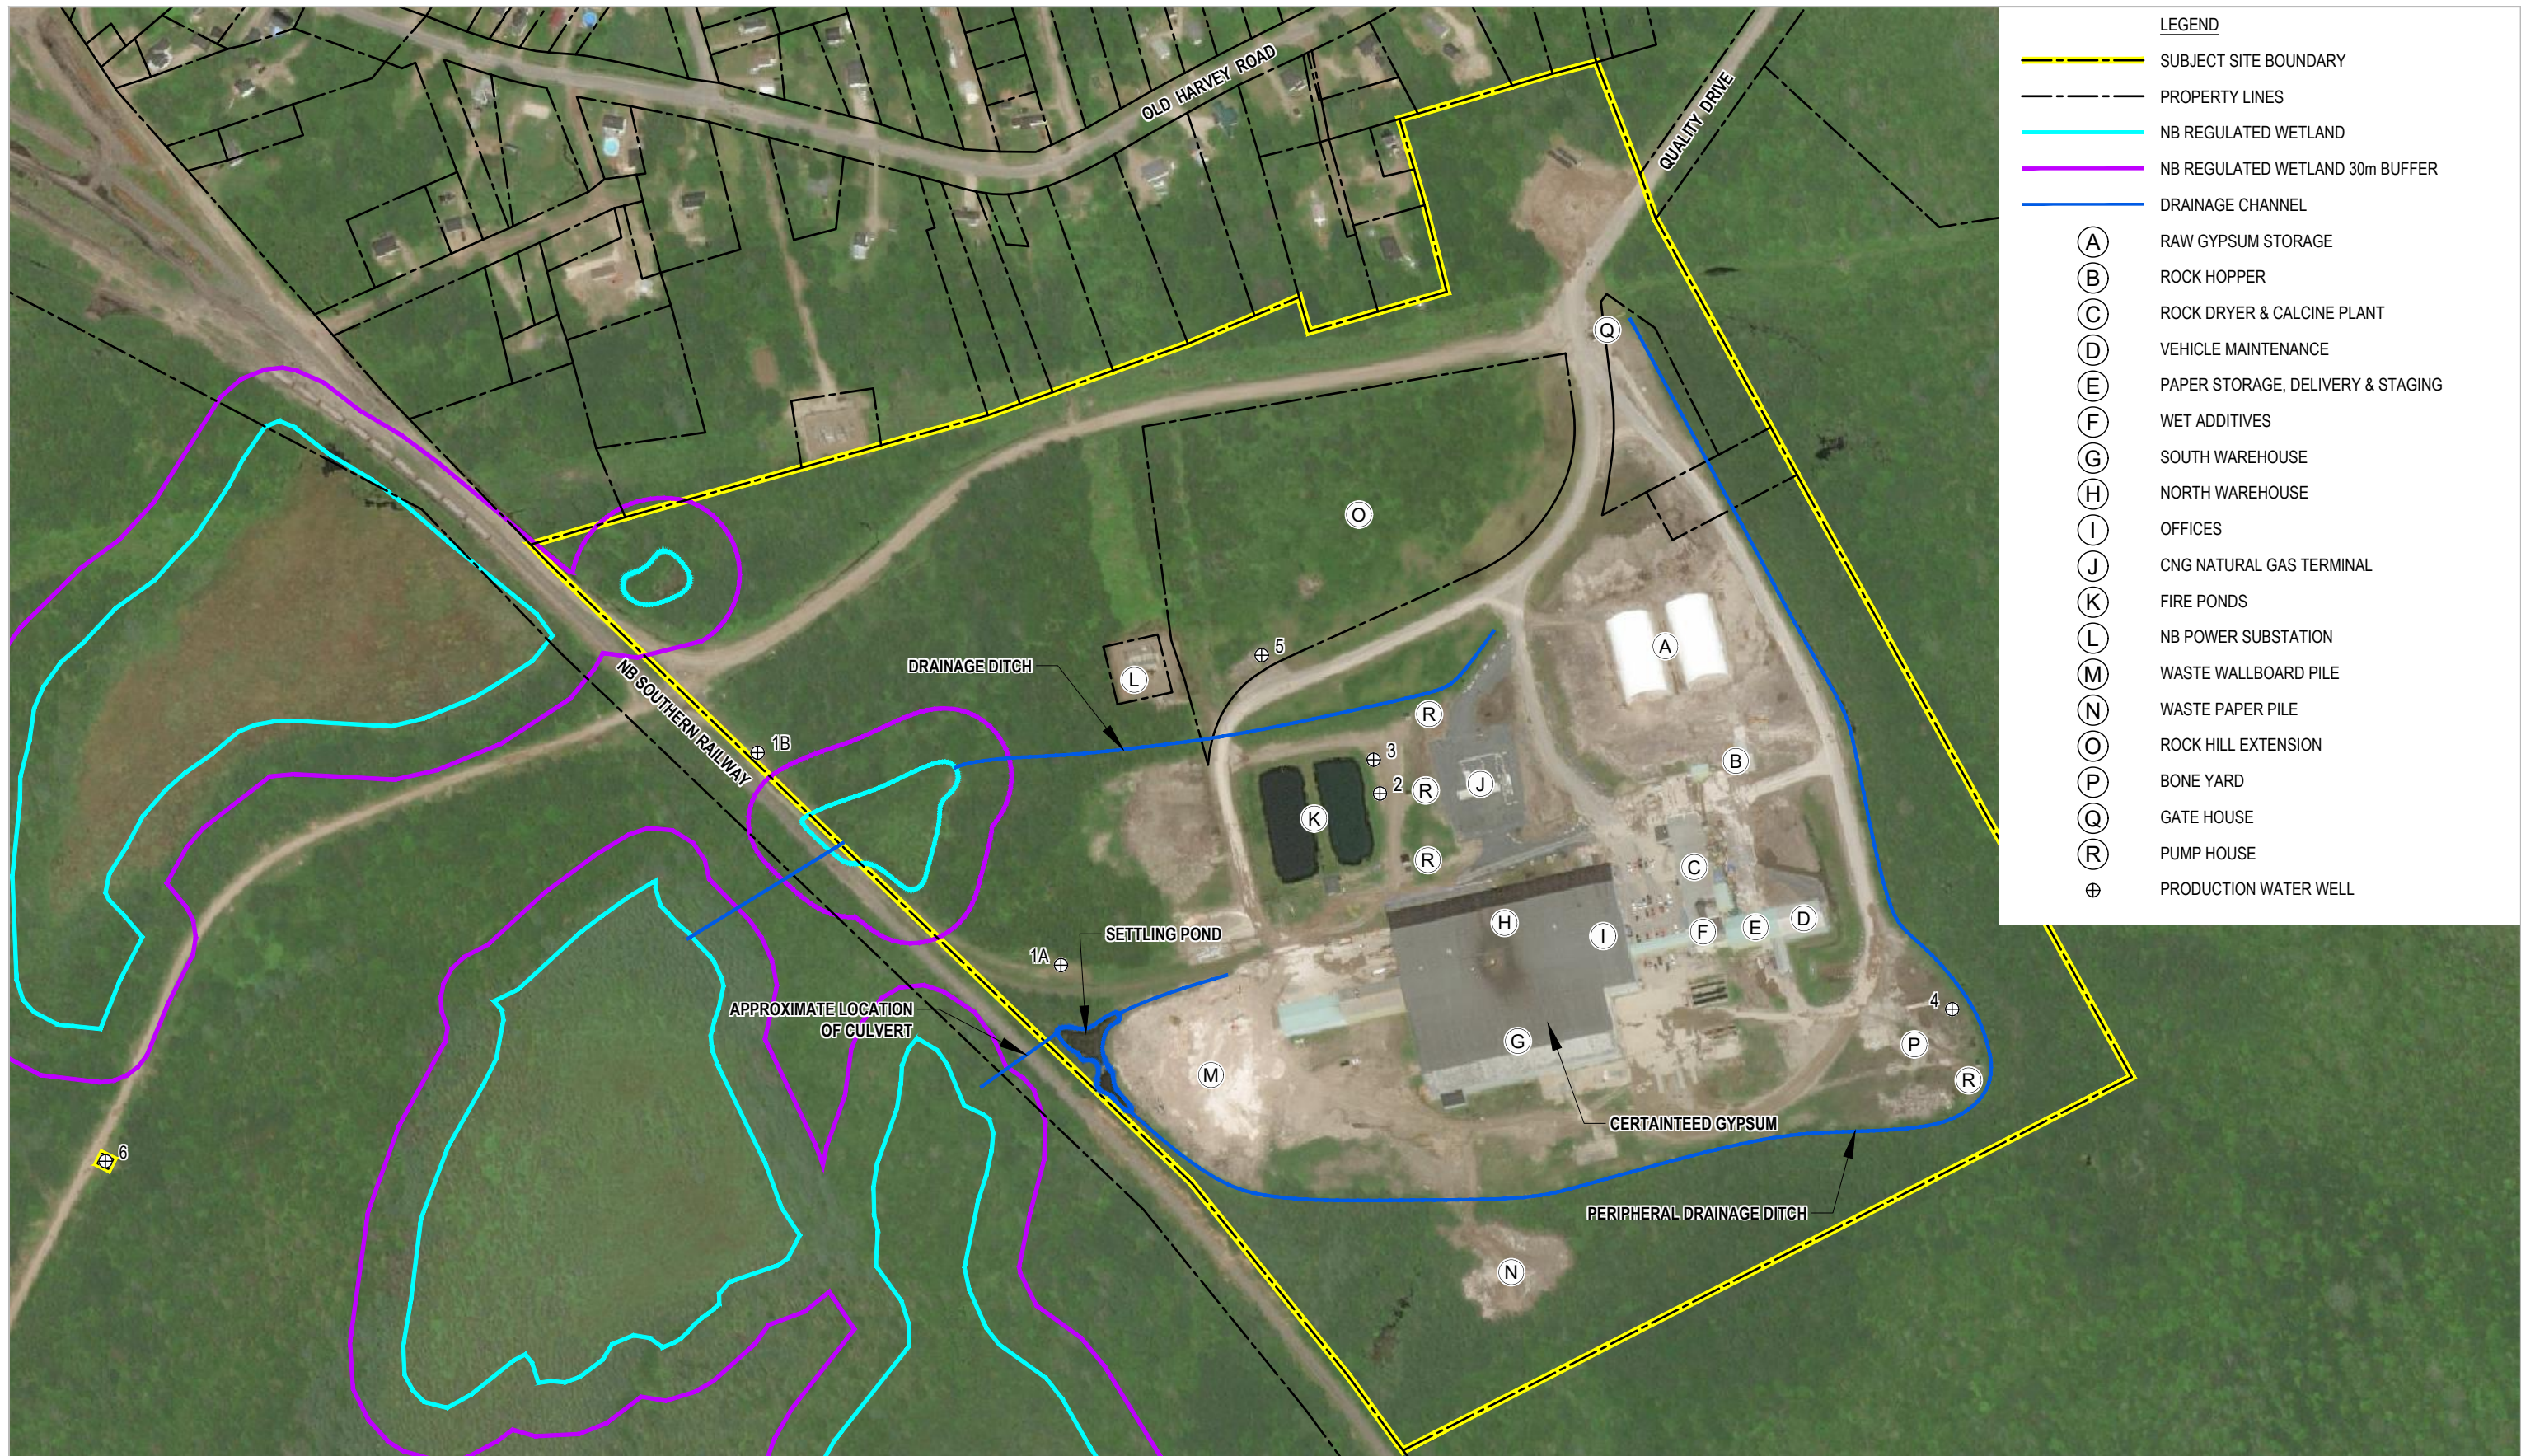
FIGURE 1.3a

EXISTING CONDITIONS SITE PLAN

There are six process water production wells (labeled 1A, 1B, and 2 to 5) and four pump houses on-Site, as shown on Figure 1.3a. As noted in Section 1.2, a production well (labeled 6) is also located approximately 400 m off-Site. The pump house will be locked and the well heads secured at the end of the Closure Project for future supply of process water by a new property owner.

The wetlands mapped by the GNB along with a 30-m protective buffer are presented on Figure 1.3. A portion of two wetlands are located within the Site, but outside any of the planned working areas. Three other regulated wetlands, larger in size, are found off-Site; one of them is downgradient of the PDD.

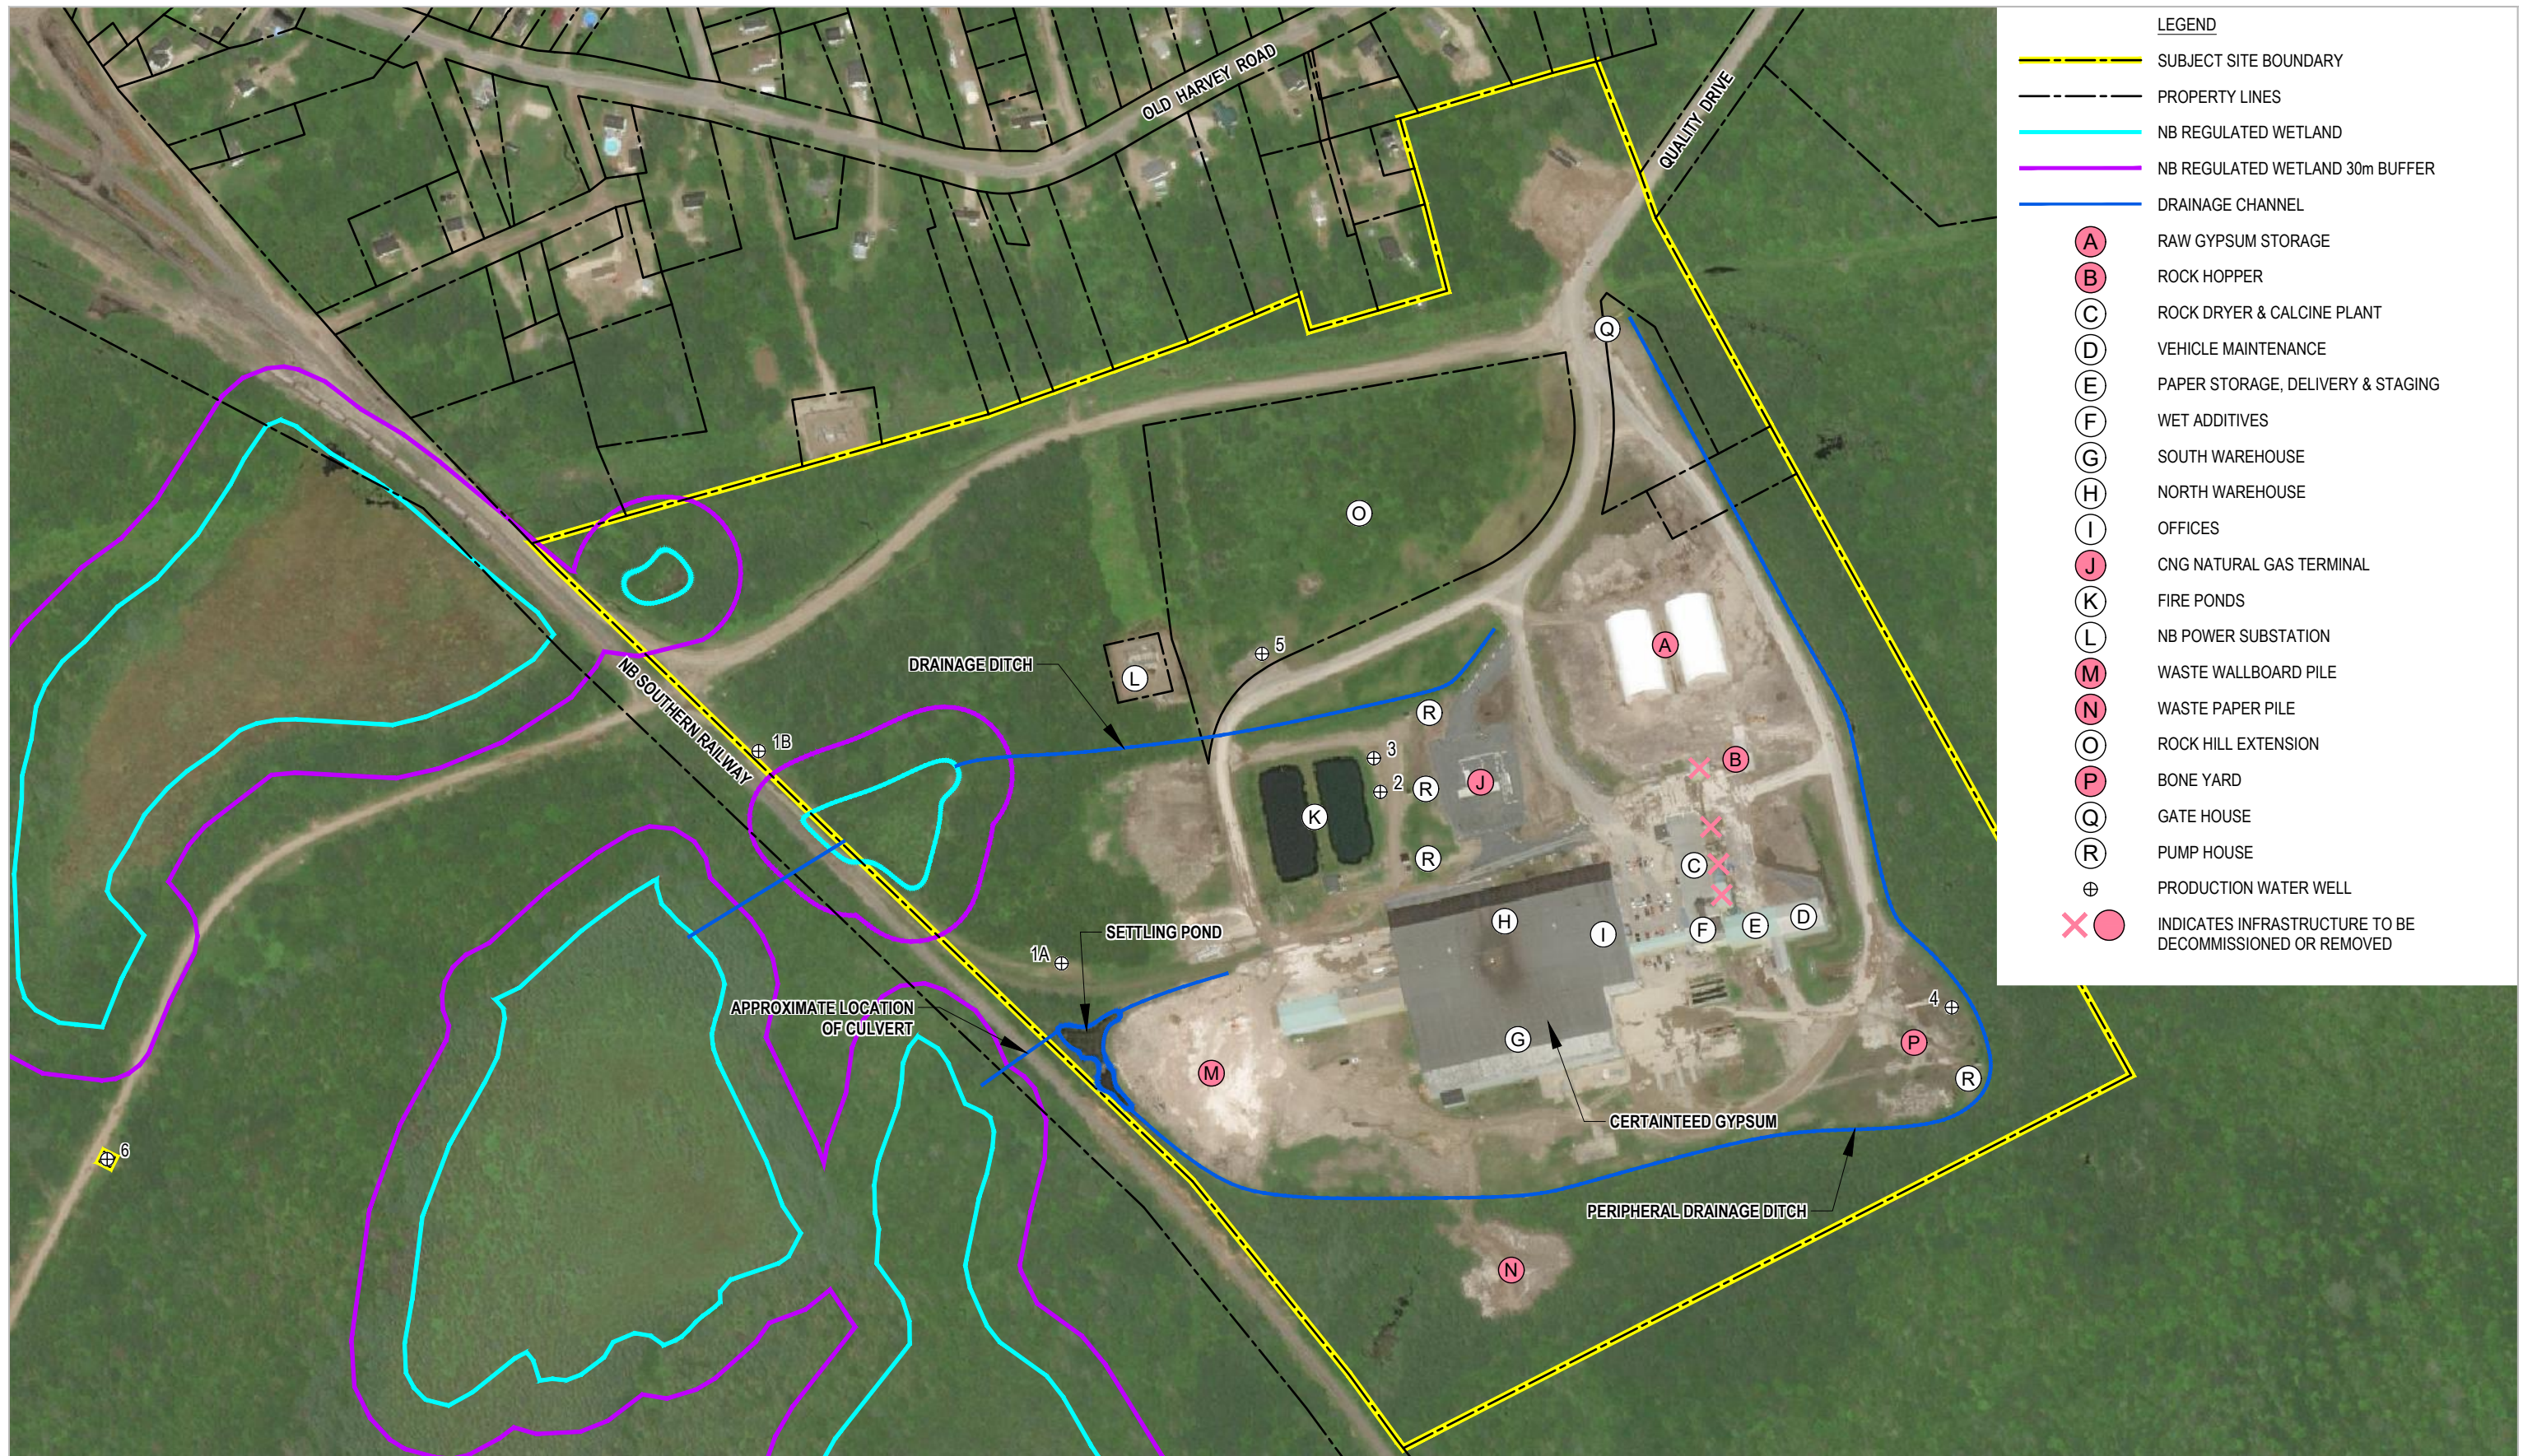
**FIGURE 1.3b**

- LEGEND**
- SUBJECT SITE BOUNDARY
  - PROPERTY LINES
  - NB REGULATED WETLAND
  - NB REGULATED WETLAND 30m BUFFER
  - DRAINAGE CHANNEL
  - A RAW GYPSUM STORAGE
  - B ROCK HOPPER
  - C ROCK DRYER & CALCINE PLANT
  - D VEHICLE MAINTENANCE
  - E PAPER STORAGE, DELIVERY & STAGING
  - F WET ADDITIVES
  - G SOUTH WAREHOUSE
  - H NORTH WAREHOUSE
  - I OFFICES
  - J CNG NATURAL GAS TERMINAL
  - K FIRE PONDS
  - L NB POWER SUBSTATION
  - M WASTE WALLBOARD PILE
  - N WASTE PAPER PILE
  - O ROCK HILL EXTENSION
  - P BONE YARD
  - Q GATE HOUSE
  - R PUMP HOUSE
  - + PRODUCTION WATER WELL
  - X INDICATES INFRASTRUCTURE TO BE DECOMMISSIONED OR REMOVED
