Fish and Fish Habitat Technical Report

Milltown Generating Station Decommissioning Project
Milltown, New Brunswick

November 2020 – 19-1594

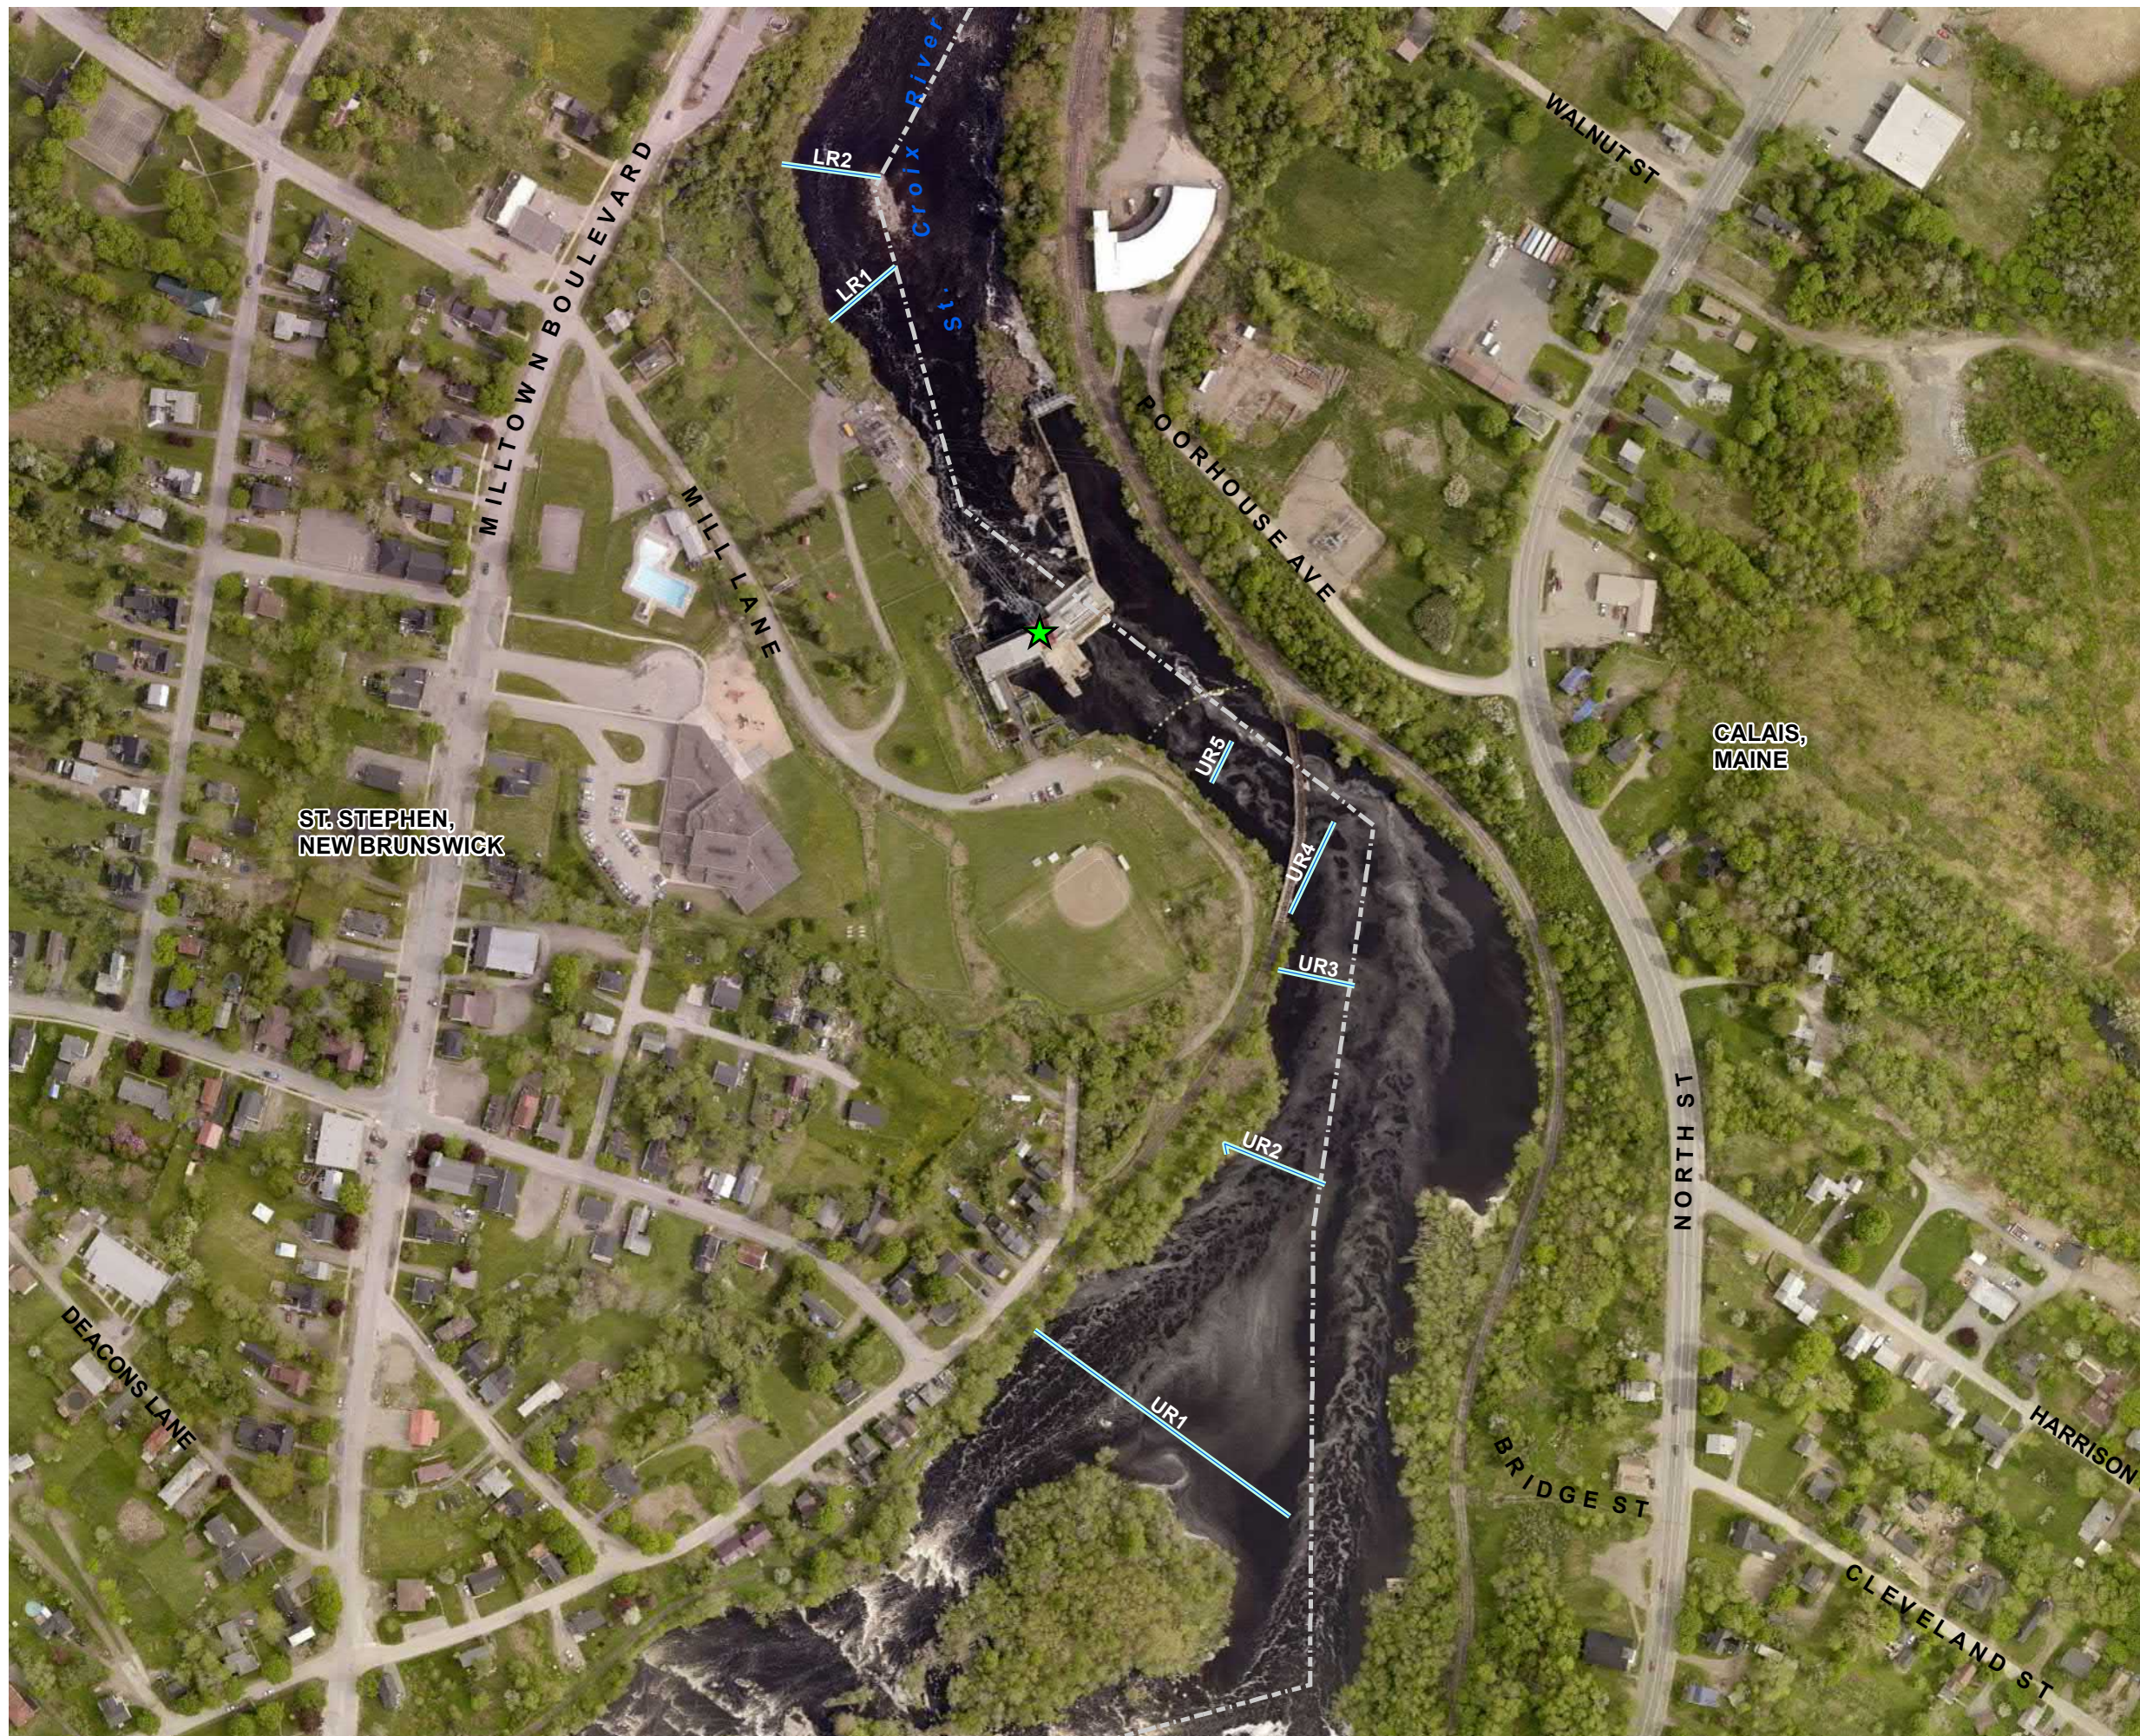
FIGURE 4

- Project Location
- Fish and Fish Habitat Survey Transects
LR=Lower Reach, UR= Upper Reach
- Canada-USA Border

Fish habitat surveys were conducted via transects within the upper reach (i.e., transects UR-1 to UR-5) and the lower reach (i.e., transects LR-1 and LR-2) of the study area (refer to **Figure 4**). The upper reach was characterized, in general, as a headpond impoundment. The lower reach was characterized as run habitat throughout the restricted/confined tailrace area before braiding into two separate riffles/channeled sections. Of the two reaches surveyed within the study area, the upper reach was observed to provide suitable habitat for species such as smallmouth bass (*Micropterus dolomieu*), which

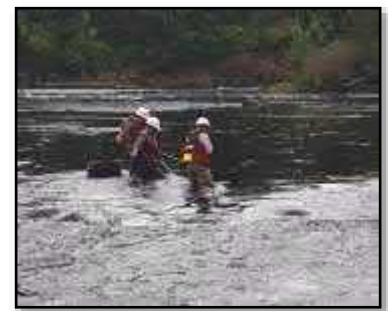
- Fyke nets are modified hoops with nets and equipped with netted/webbed wings intended to intercept fish and funnel them into the hoop net. Fyke nets can be set for 12 to 24 hour periods and can be deployed with the aid of a boat where needed. This method was used in areas where the backpack electrofisher unit could not be used (i.e., above the Milltown Station in portions of the upper reach of the study area).

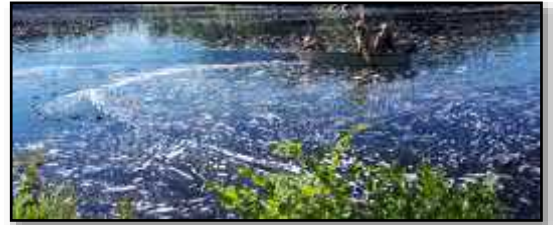
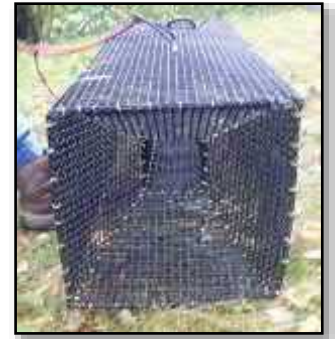
- Seine nets are large nets that hang vertically in the water with floatation devices on the top and weights on the bottom, used to intercept fish. Personnel held and manoeuvred the net on either side. The net was deployed in a circular shape in the water, and the net was slowly brought to shore and retrieved with the intent that fish are funneled into the net's catchment bag. This method was attempted in shallow areas, in water less than a metre deep; however, it was not successful at capturing fish, despite multiple efforts.

- Eel traps funnel fish into a framed or cylindrical trap via a tapered mesh opening at the subsurface of the water using bait where once the fish swim through they cannot get out. Traps were used both above and below the Milltown Station in the upper and lower portions of the study area, using mackerel as bait.

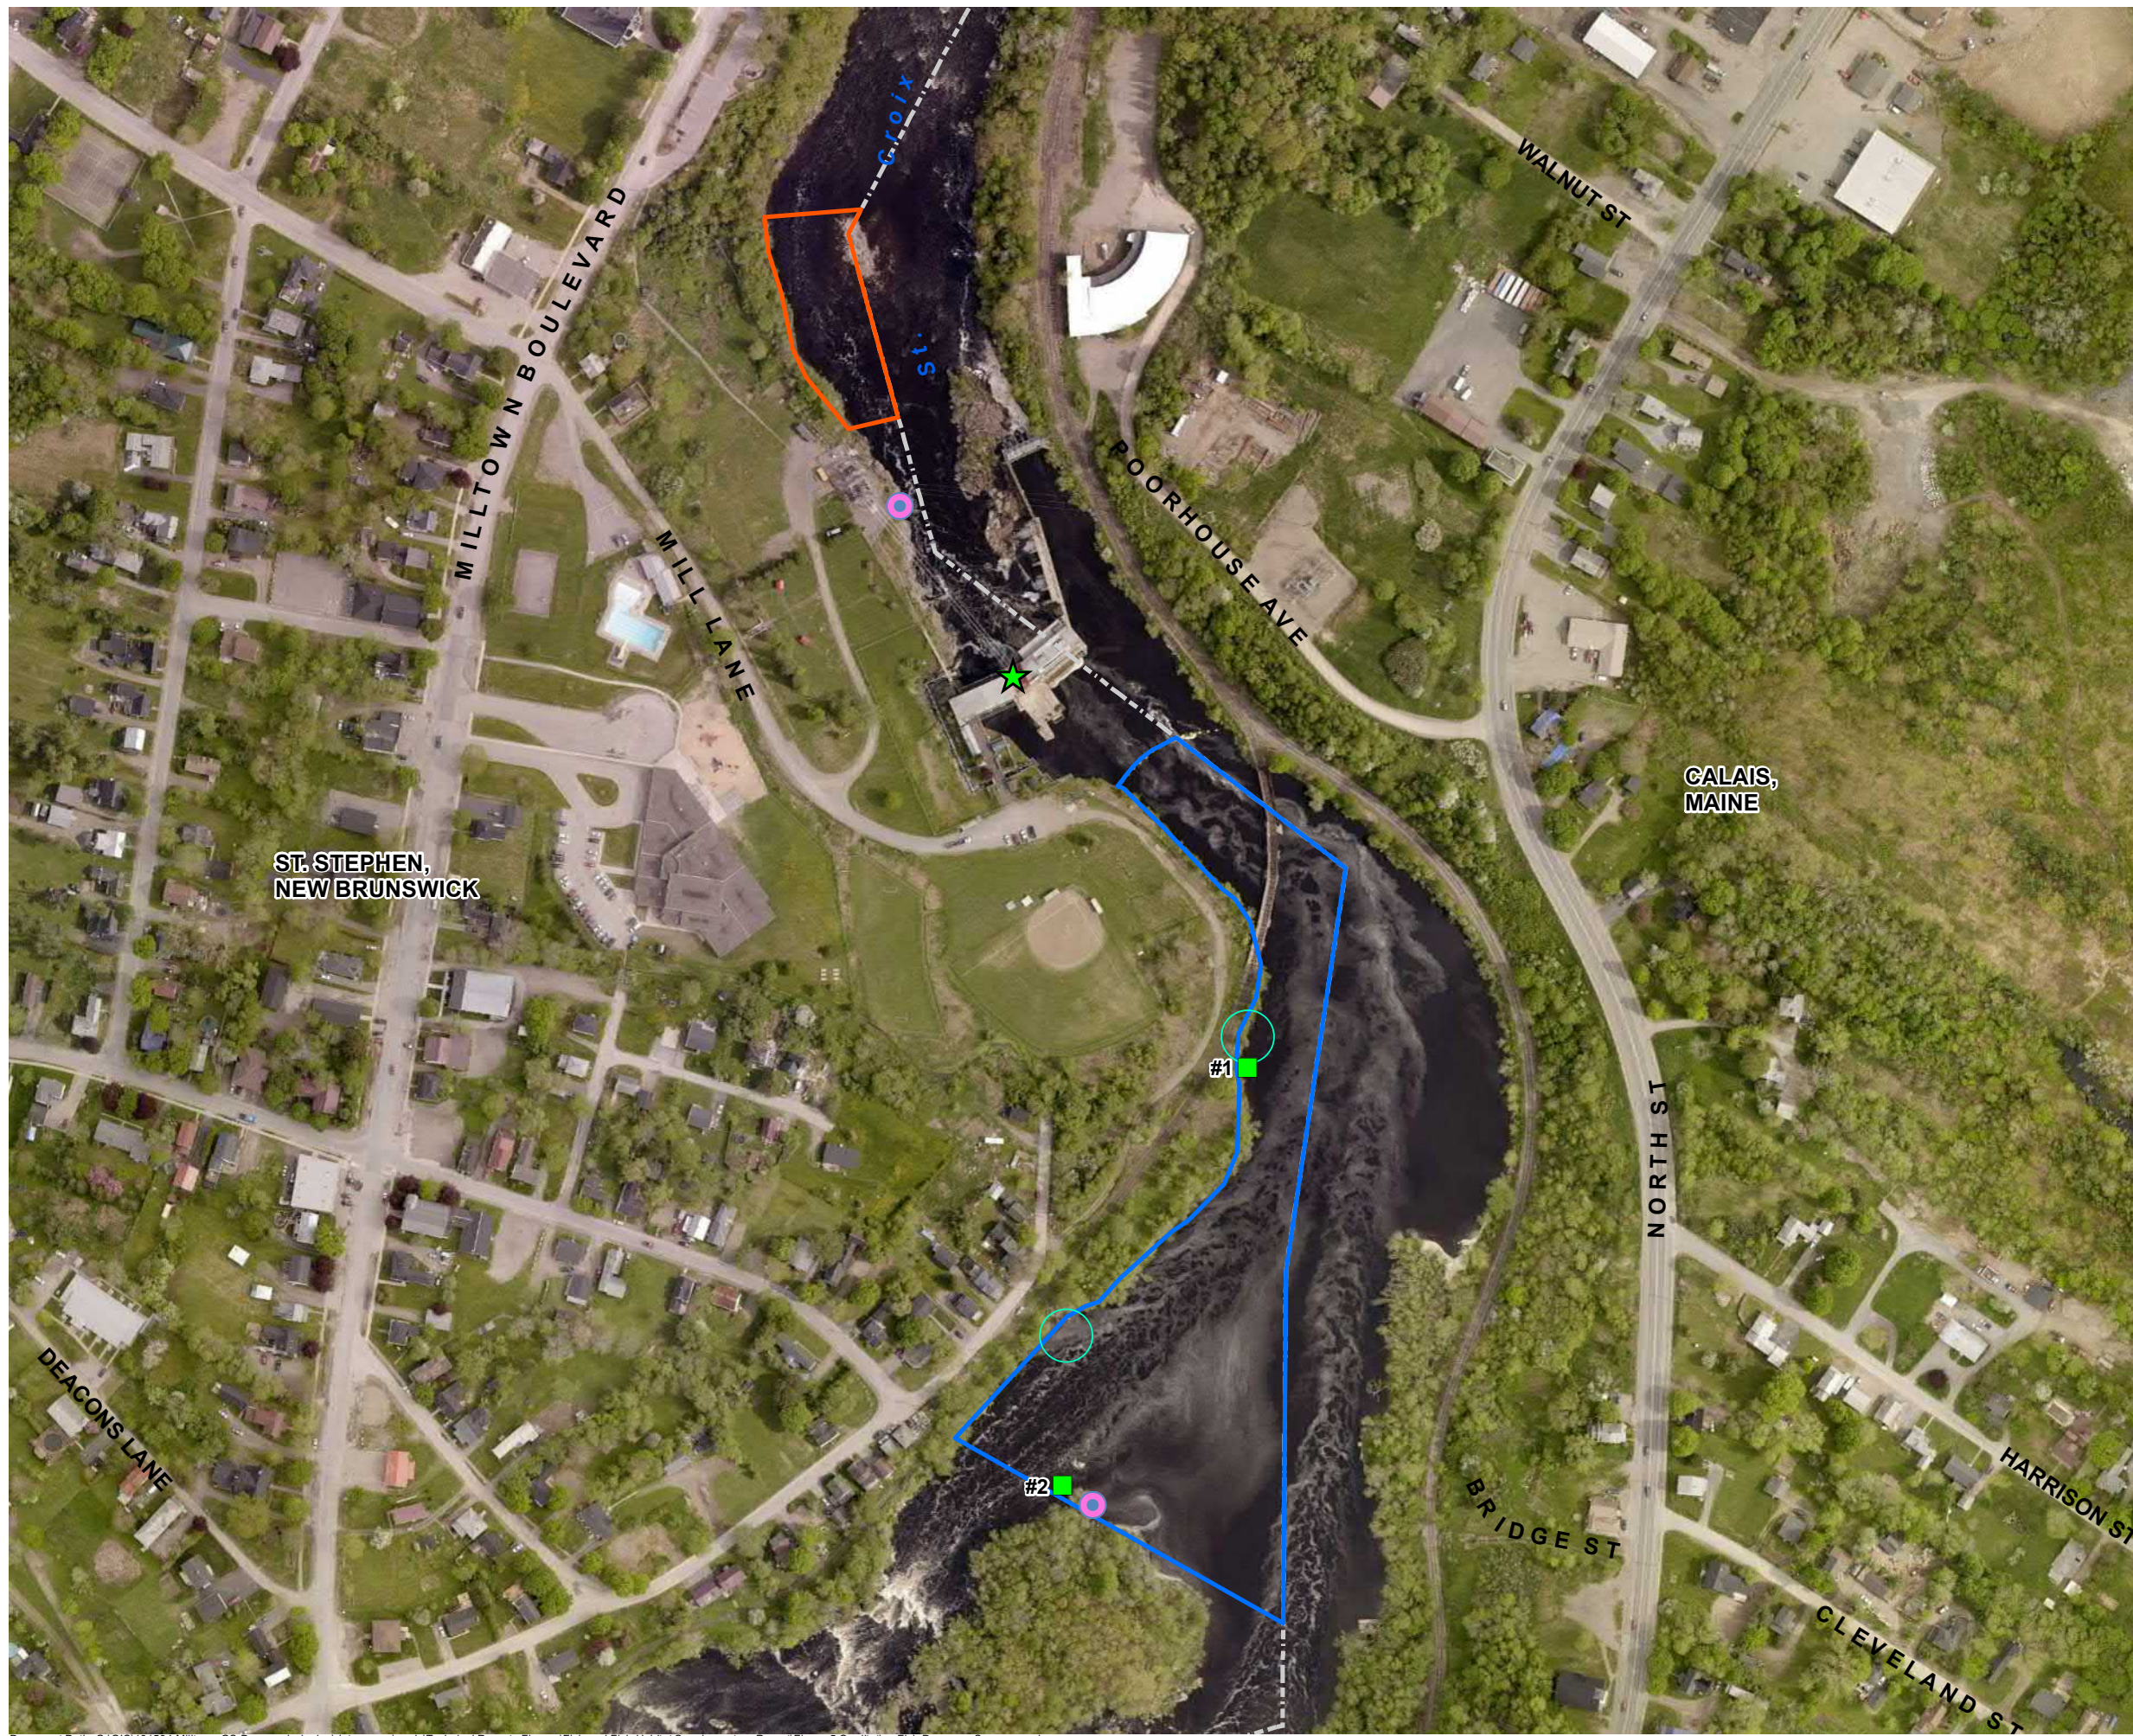
FIGURE 5

-   Project Location
-   Eel Trap Location
-   Fyke Net Location
-   Seine Net Location
-   Angling Area
-   Electrofishing Area
-   Canada-USA Border

- **Fyke Nets:** Fyke nets were deployed in two areas (refer to **Figure 5**) within the upper reach. One fyke net was deployed for two hours, due ease of access and the potential to lose the equipment, and the second net was in place for a period of 24 hours. Several species were captured using this method, as noted in **Table 6**.

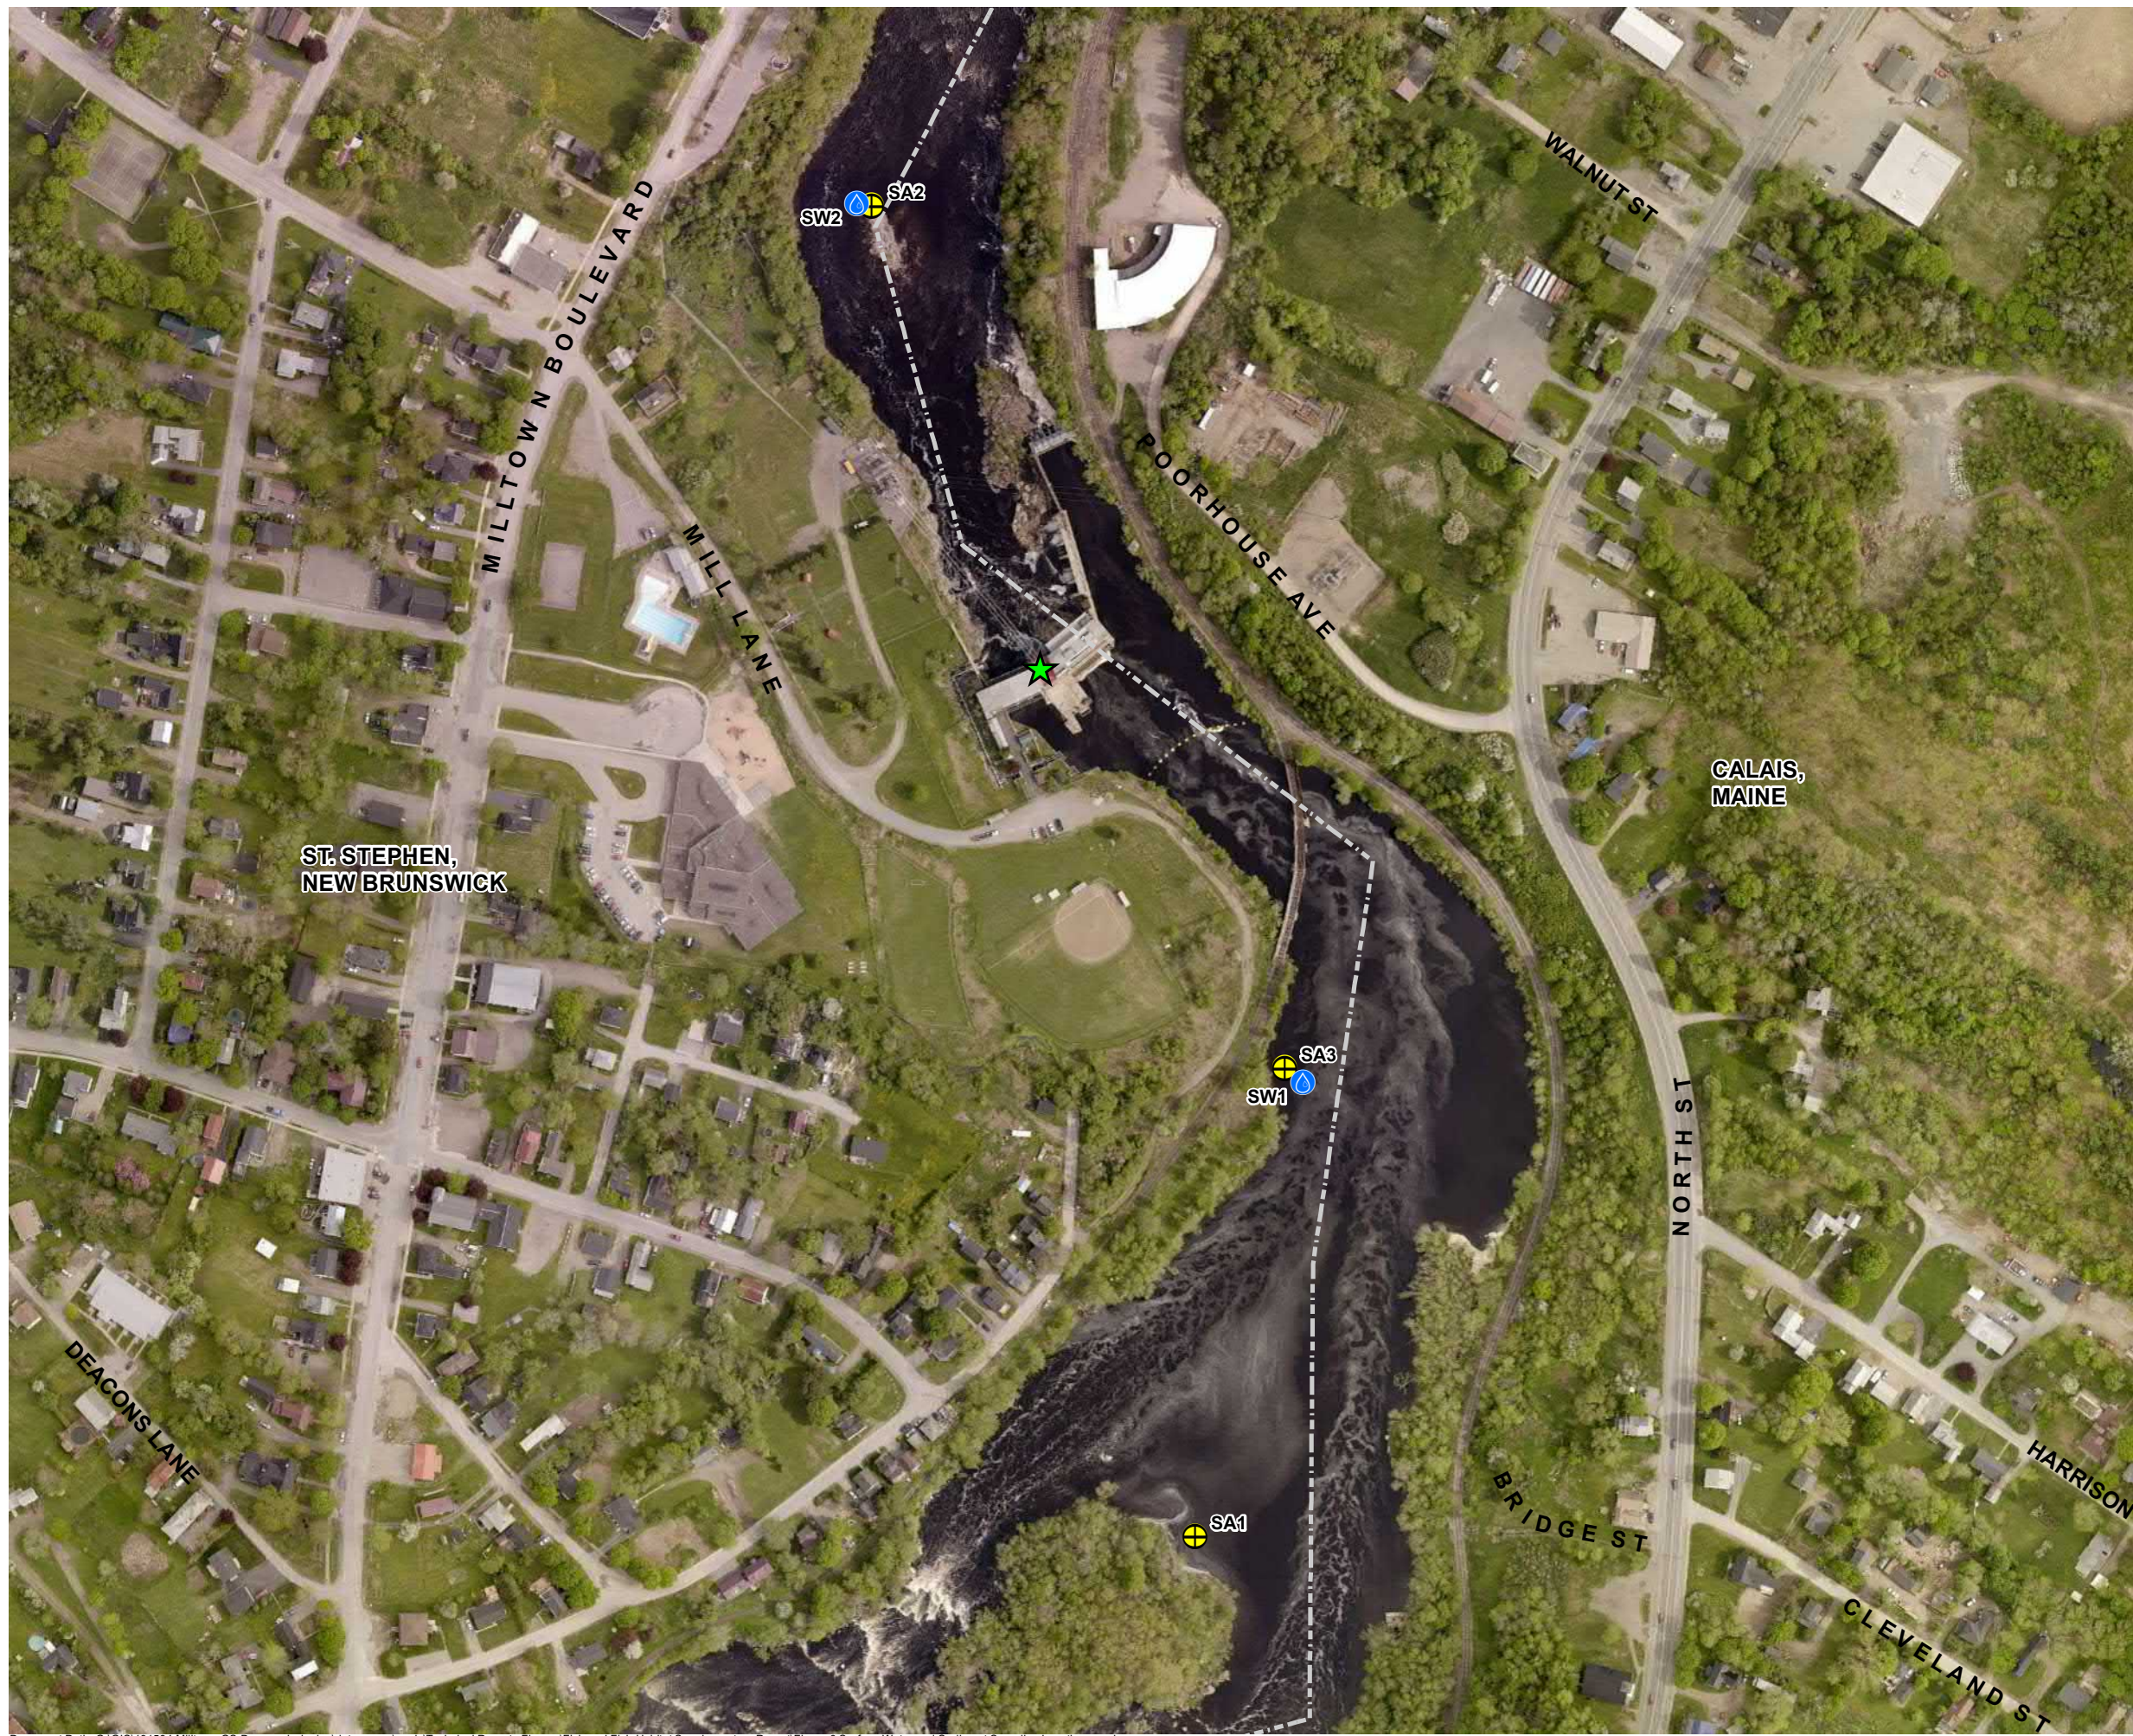
FIGURE 6

-   Surface Water Sample Location
-   Sediment Sample Location
-   Project Location
-   Canada-USA Border

Sediment samples were collected at two locations within the upper reach and one location within the lower reach of the study area (**Figure 6**). These locations were selected based on overall fish habitat representativeness and proximity to areas used to assess fish presence and assemblages. The two sediment sampling locations in the upper reach were areas of known sediment deposition as determined through depth-to-refusal sounding conducted in November 2019 by GHD and Inter-Fluve (GHD and Inter-Fluve 2020). The sediment samples were collected wearing nitrile gloves using a 6"x6" mini-ponar grab sampler, either from a boat or the shoreline (depending upon water depths/accessibility). The samples were decanted and collected using a composition of multiple grabs to

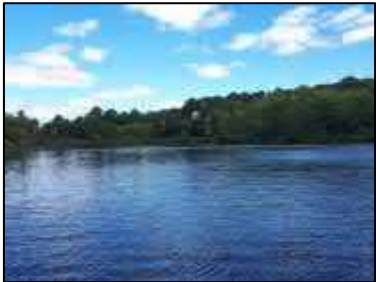
Transect ID	Representative Photo	Average Widths (m)	Dominant Aquatic Habitat Type and Other Observations
Upper Reach - Headpond Impoundment			
UR-1

Wet Width: 192 m Bankfull Width: 194 m	<u>Fish Habitat Suitability and Watercourse Characteristics:</u> Deep pools with bedrock and gravel substrates. Potential for some forage habitat (e.g., smallmouth bass) and cold water refuge at depth. <u>Dominant Substrate:</u> 70% Bedrock, 10% Boulder, 5% Rock, 5% Rubble, 5% Gravel, 5% Sand. <u>Average Depth(s):</u> 3.37 m – Pool/run
UR-2

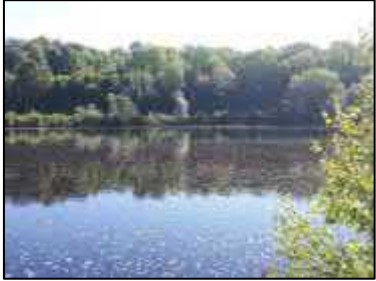
Wet Width: 105 m Bankfull Width: 109 m	<u>Fish Habitat Suitability and Watercourse Characteristics:</u> Deep pools with bedrock and gravel substrates. Potential for some forage habitat (e.g., smallmouth bass) and cold water refuge at depth. <u>Dominant Substrate:</u> 70% Bedrock, 10% Boulder, 5% Rock, 5% Rubble, 5% Gravel, 5% Sand. <u>Average Depth(s):</u> 3.91 m – Pool/run

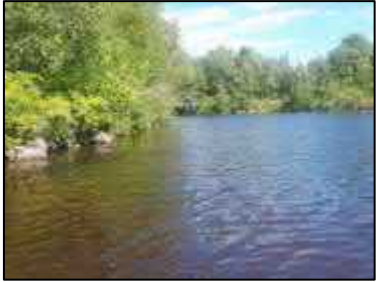
UR-3

Wet Width: 122 m Bankfull Width: 128 m	<u>Fish Habitat Suitability and Watercourse Characteristics:</u> Deep pools with bedrock and gravel substrates. Potential for some forage habitat (e.g., smallmouth bass) and cold water refuge at depth. <u>Dominant Substrate:</u> 70% Bedrock, 10% Boulder, 5% Rock, 5% Rubble, 5% Gravel, 5% Sand. <u>Average Depth(s):</u> 4.1 m – Pool/run

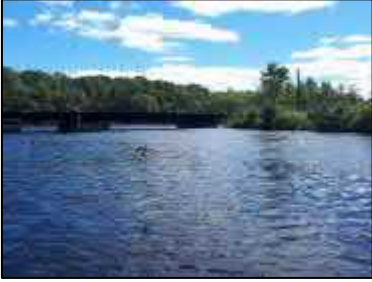
<p>Wet Width: 65 m</p> <p>Bankfull Width: 66 m</p>	<p><u>Fish Habitat Suitability and Watercourse Characteristics:</u> Deep pools with bedrock and gravel substrates. Potential for some forage habitat (e.g., smallmouth bass) and cold water refuge at depth.</p> <p><u>Dominant Substrate:</u> 70% Bedrock, 10% Boulder, 5% Rock, 5% Rubble, 5% Gravel, 5% Sand.</p> <p><u>Average Depth(s):</u> 4.93 m – Pool/run</p>
UR-5

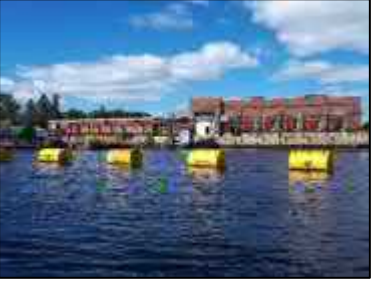
<p>Wet Width: 550 m</p> <p>Bankfull Width: 56 m</p>	<p><u>Fish Habitat Suitability and Watercourse Characteristics:</u> Deep pools with bedrock and gravel substrates. Potential for some forage habitat (e.g., smallmouth bass) and cold water refuge at depth.</p> <p><u>Dominant Substrate:</u> 70% Bedrock, 10% Boulder, 5% Rock, 5% Rubble, 5% Gravel, 5% Sand.</p> <p><u>Average Depth(s):</u> 4.35 m – Pool/run</p>

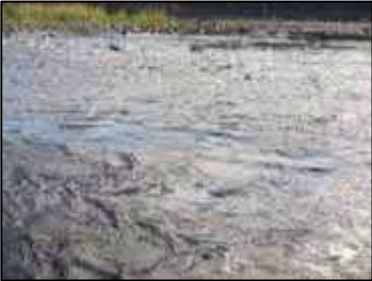
Lower Reach - Braided Channel			
LR-1

<p>Wet Width: 33 m (1 of 2 channels)</p> <p>Bankfull Width: 84 m</p>	<p><u>Fish Habitat Suitability and Watercourse Characteristics:</u> Braided channels with good riffle/run (fish) habitat. Potential spawning, rearing, foraging and passage habitat for multiple species, including salmonids.</p> <p><u>Dominant Substrate:</u> 40% Bedrock, 15% Rock, 15% Rubble, 15% Gravel, 10% Sand, 5% Fines</p> <p><u>Average Depth(s):</u> 0.44 m – Riffle</p>
LR-2

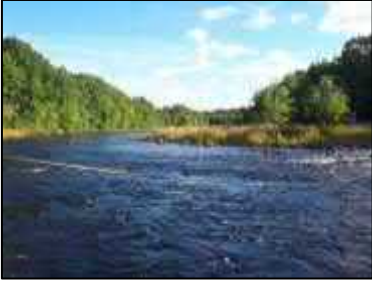
<p>Wet Width: 31 m (1 of 2 channels)</p> <p>Bankfull Width: 98 m</p>	<p><u>Fish Habitat Suitability and Watercourse Characteristics:</u> Braided channels with good riffle/run (fish) habitat. Potential spawning, rearing, foraging and passage habitat for multiple species, including salmonids.</p> <p><u>Dominant Substrate:</u> 40% Bedrock, 10% Boulder, 5% Rock, 15% Rubble, 15% Gravel, 15% Sand</p> <p><u>Average Depth(s):</u> 0.50 m – Riffle</p>

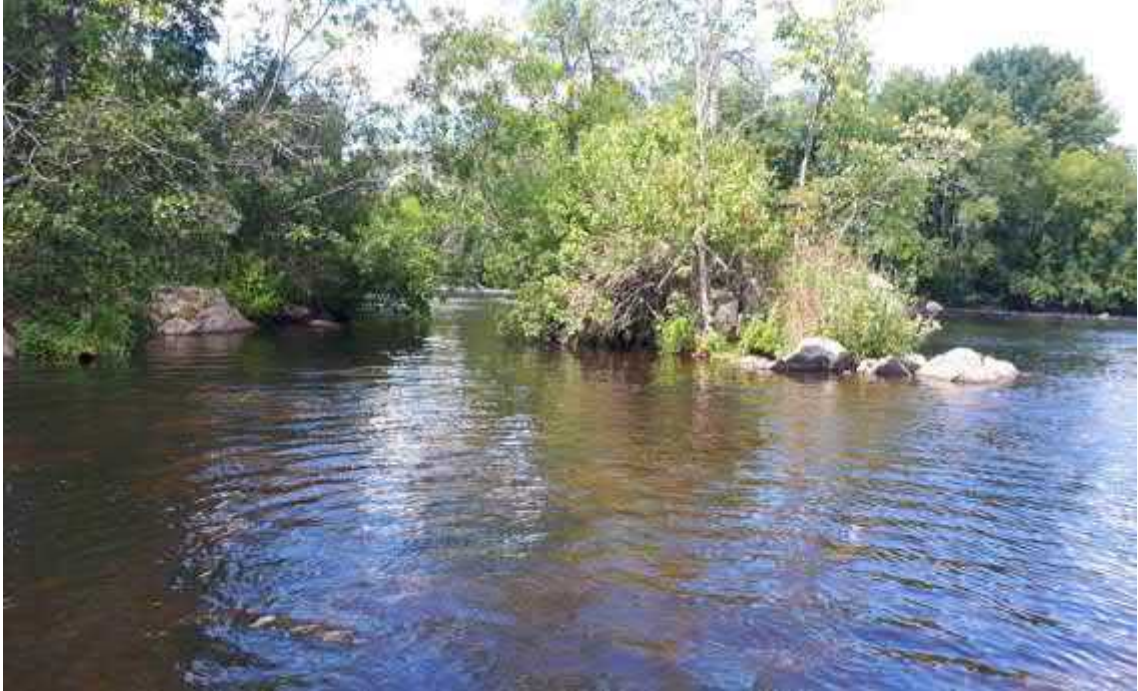
Photo 3 – Looking west toward the Canadian above the Milltown Station showing the general location of SA1 (August 2020).

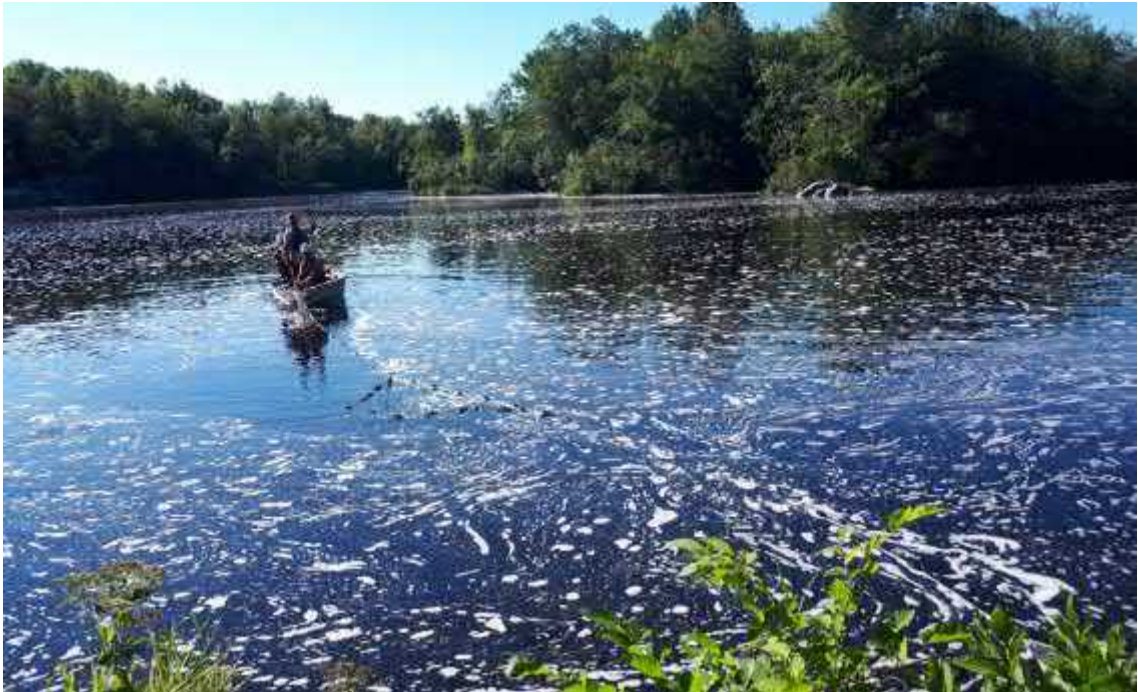
Photo 12 – Looking south east at technicians setting nets for population data taken from the boat launch (September 2020)

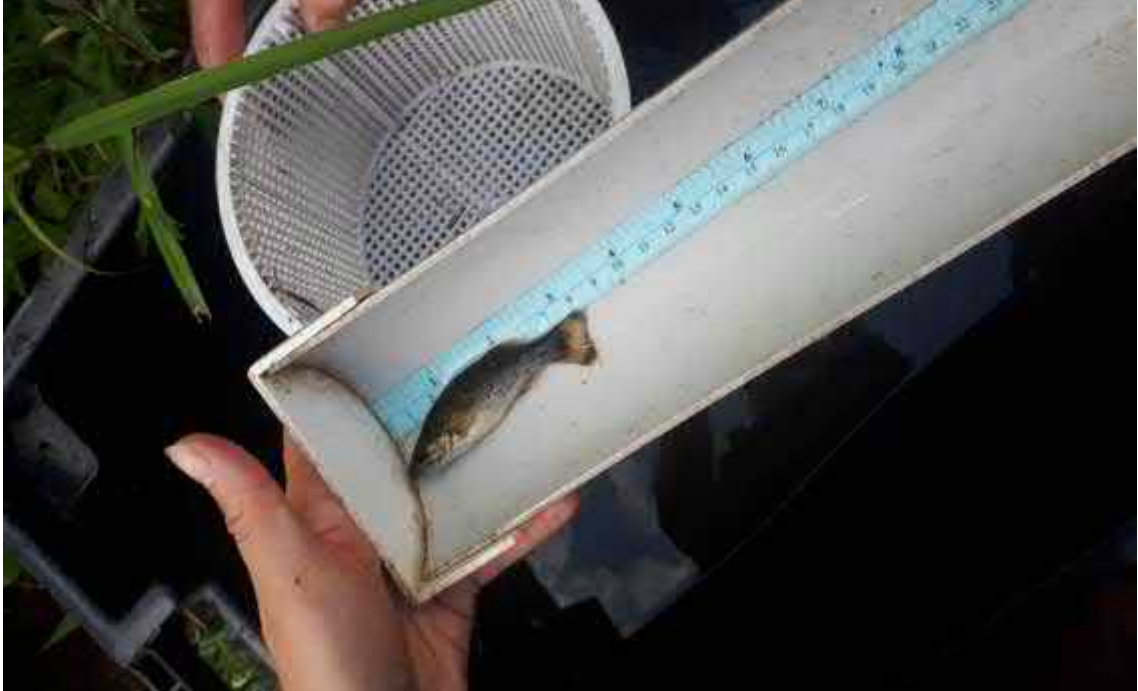
Photo 13 – A Small Mouth Bass caught in a fyke net above the Milltown station being processed by technicians (September 2020).

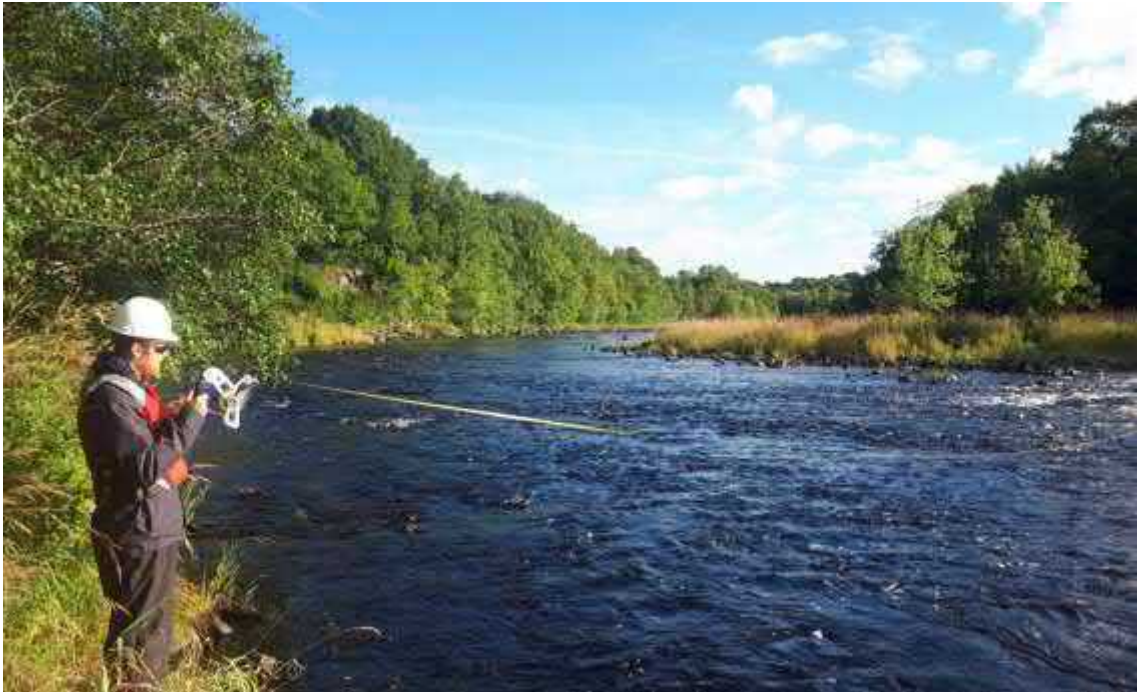
Photo 14 – Looking north from below the Milltown Station at technicians taking watercourse measurements (September 2020).

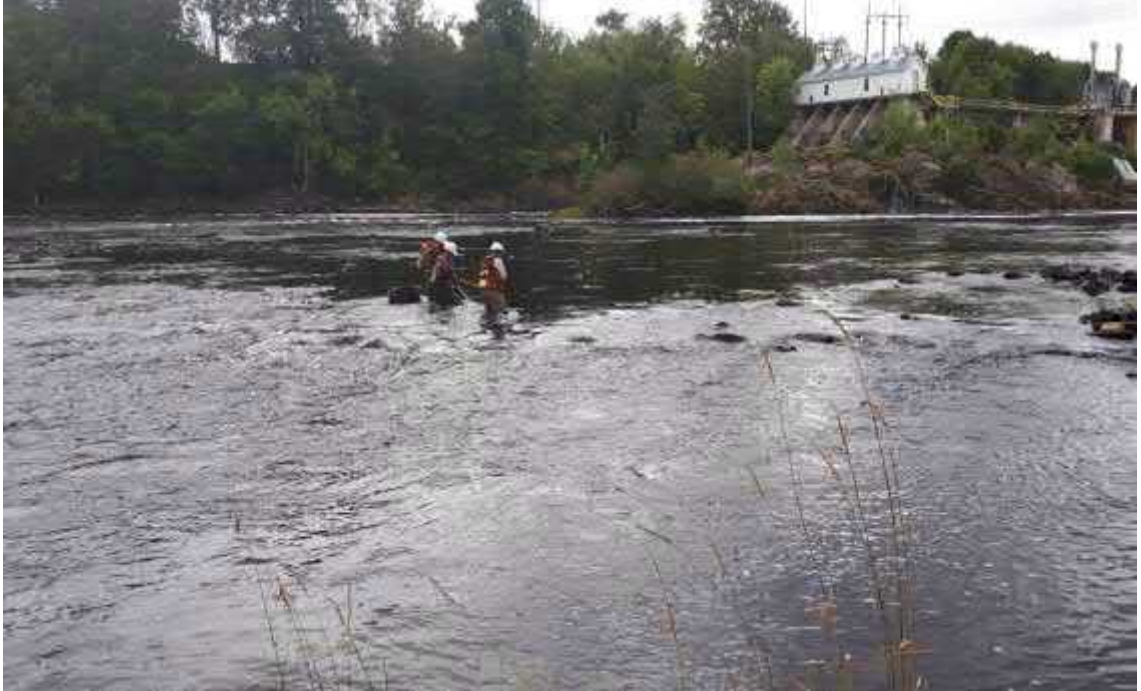
Photo 15 – Looking south east from below the Milltown station at technicians electrofishing for population data (September 2020).
