#### Re: Proposed Apartment Complex Cap Bimet, NB

## EIA Registration Brinkley Investments Inc.

Name: The Brinkley

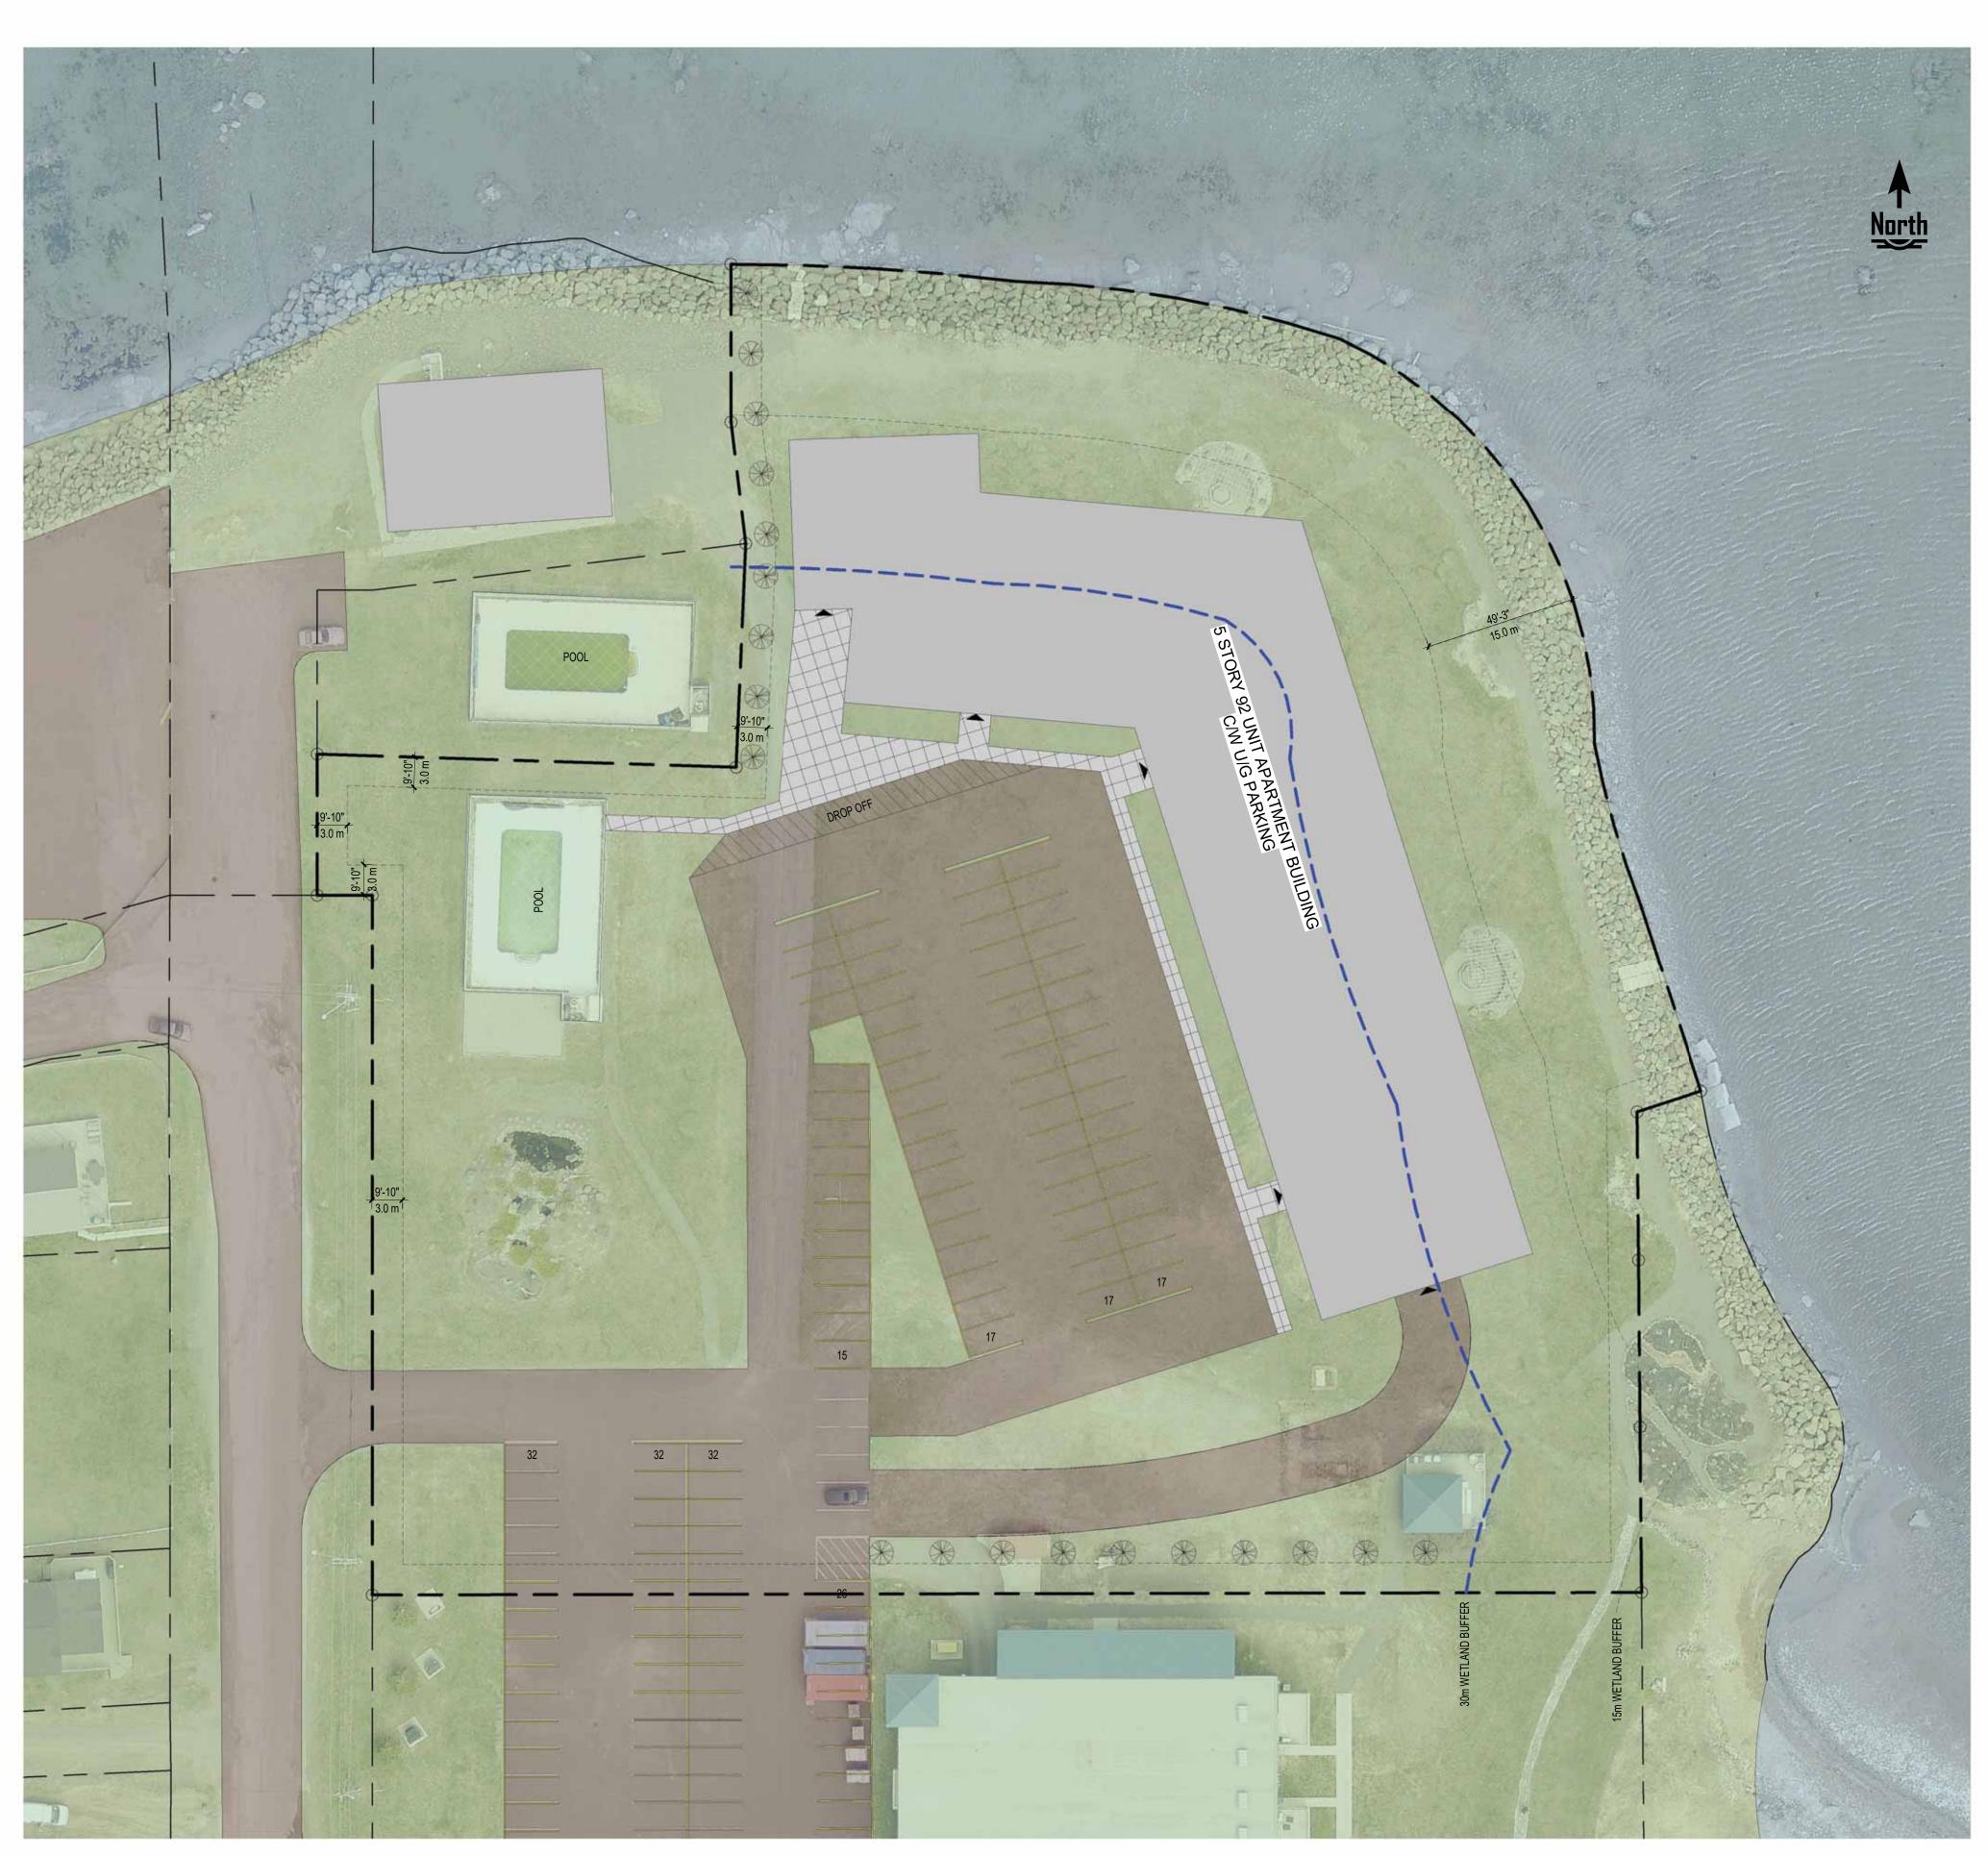
SITE PLAN - 5 STORY 92 UNIT W/ U/G PARKING

**Project Overview:** The proposed project is the construction of a 92 unit apartment building complete with both underground and above ground parking. Currently the majority of the property is grass landscaped with a portion covered with an asphalt parking lot, pool, and a few outdoor gazebos. The grounds are currently used by the adjacent condominium building located on the adjacent property to the south.

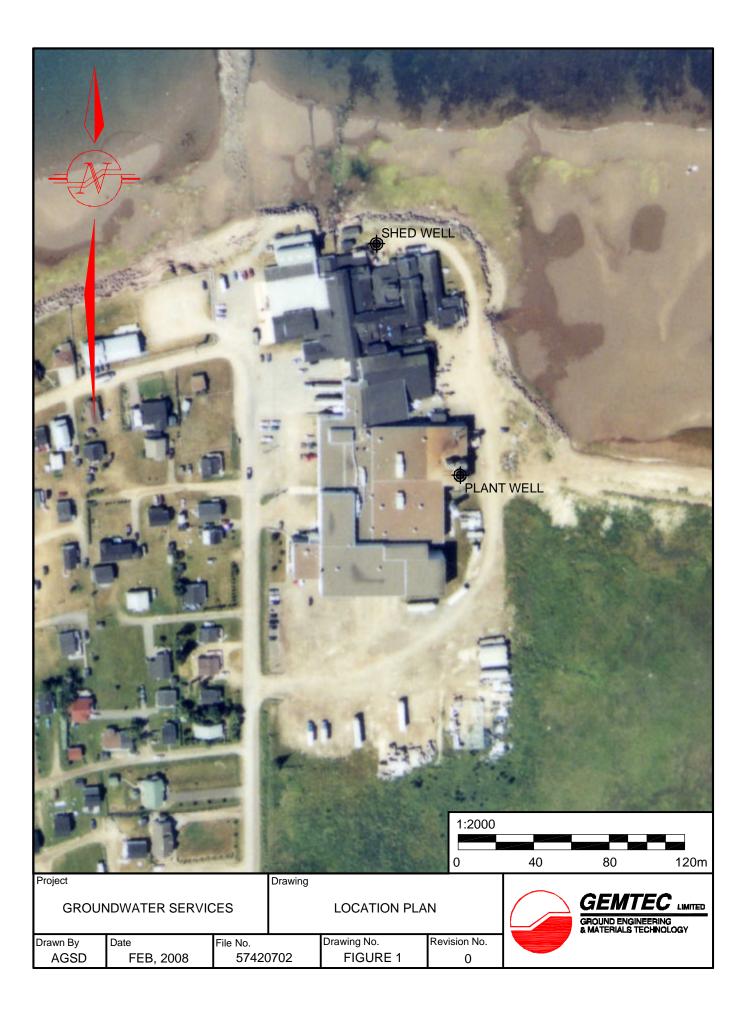
The aquifer tapped by the Plant well is highly transmissive (T>10,000 igal/day/ft) and the low storage coefficient (S =  $3.3 \times 10^{-5}$ ) indicates confined to semi-confined aquifer conditions. When pumping started in the Plant well, the water level in the Shed well responded almost immediately indicating that the two wells tap the same aquifer. Once the pumping stopped the wells were monitored for 210 minutes and the Plant well recovered 92% during the recovery period. Although the recovery of the Shed well was only 68%, a plot of recovery time (t/t') versus residual drawdown shows close to an ideal aquifer response, indicating that complete recovery will eventually occur.

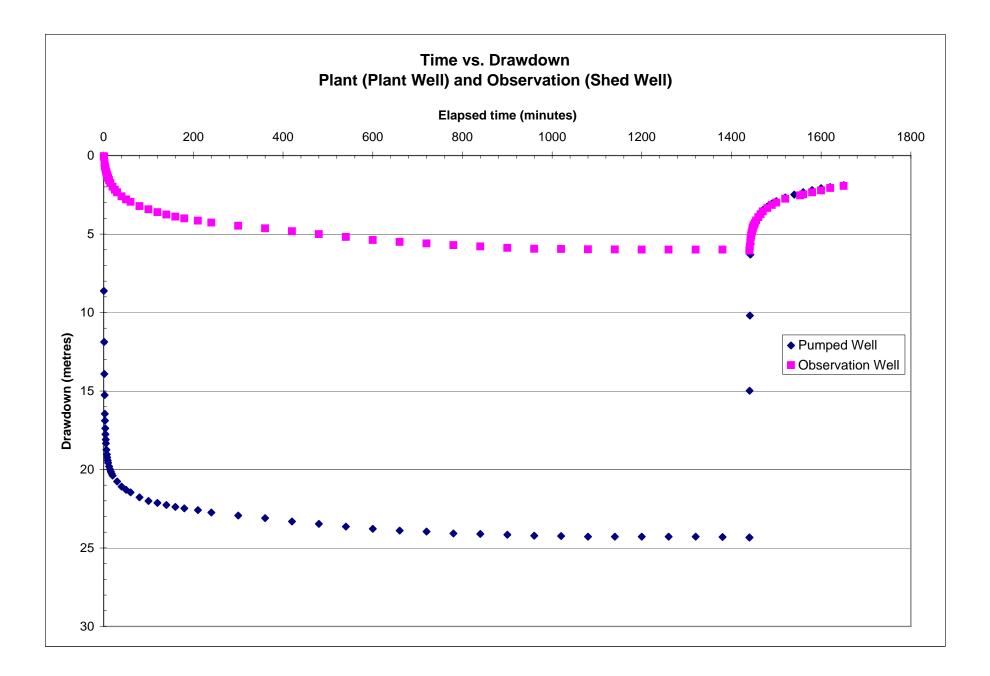
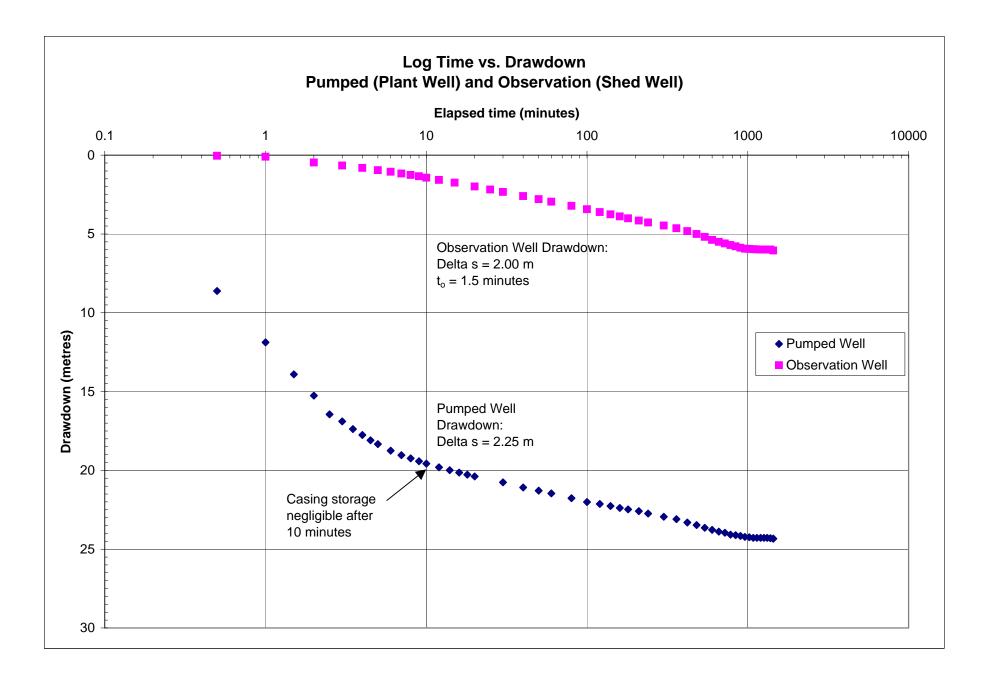
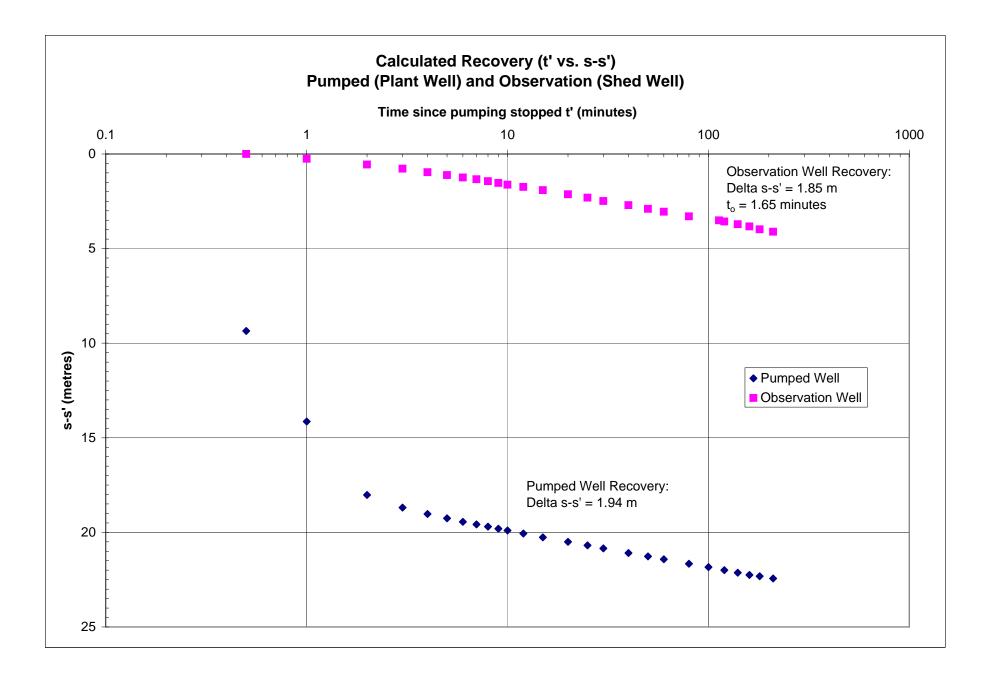
Pumping Well (Plant Well) - Drawdown Data							
Time since pumping started (minutes)	Water level (metres)	Drawdown (m)	Comments				
0	1.19	0.00					
0.5	9.81	8.62	13" Orifice = 367 igpm				
1	13.07	11.88

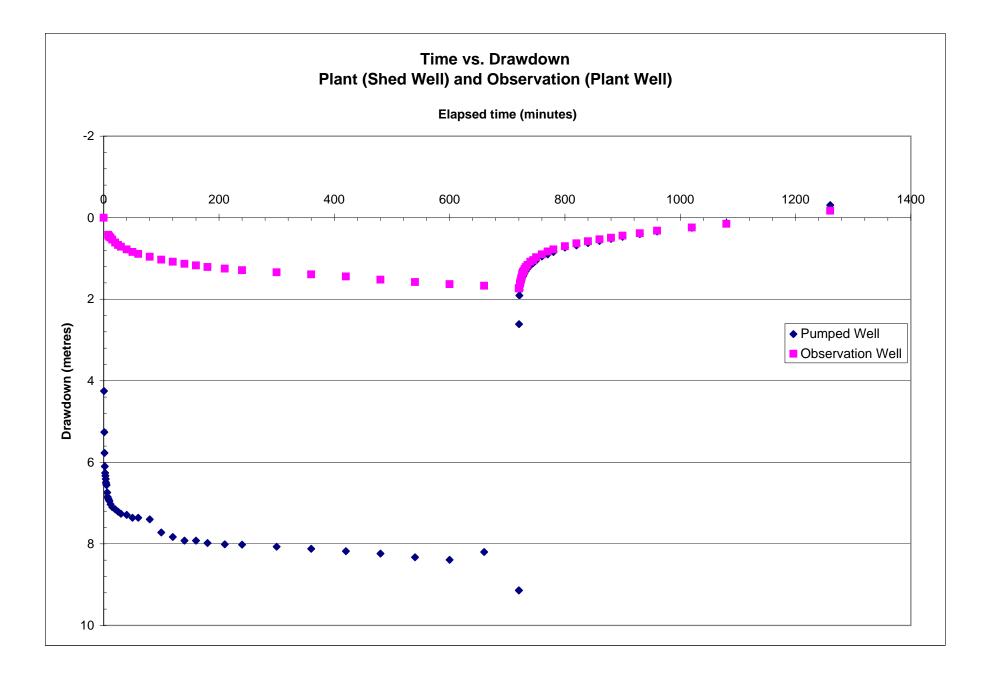
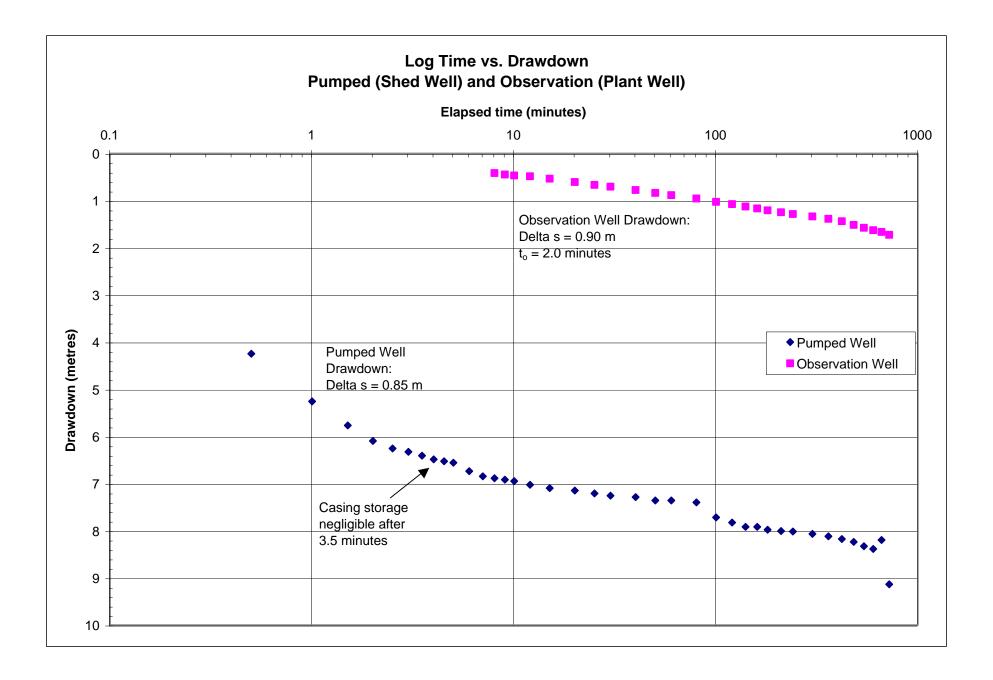
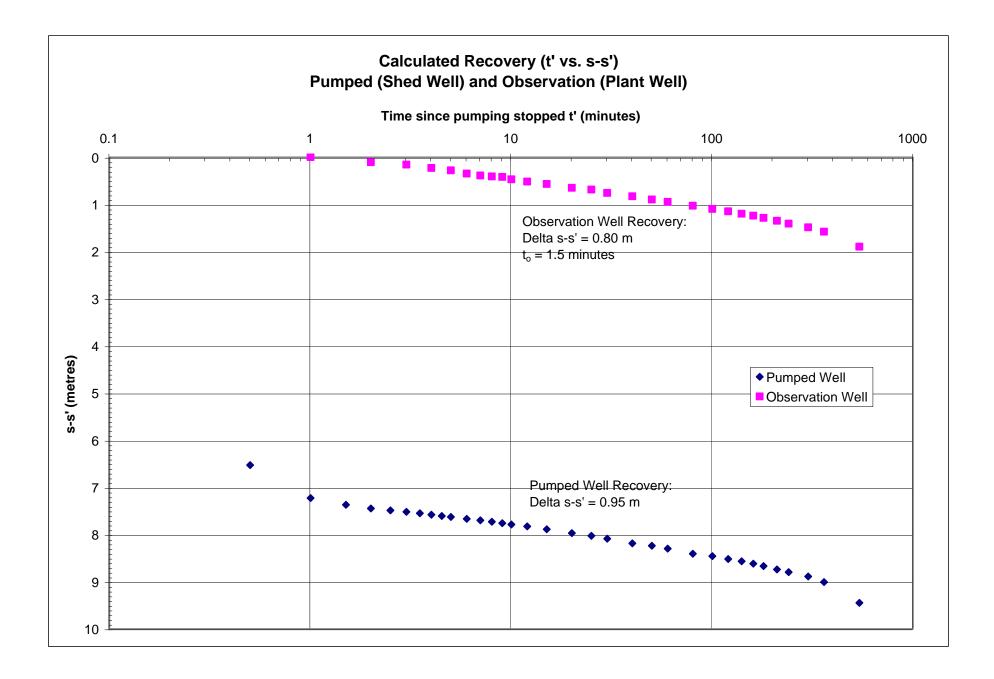
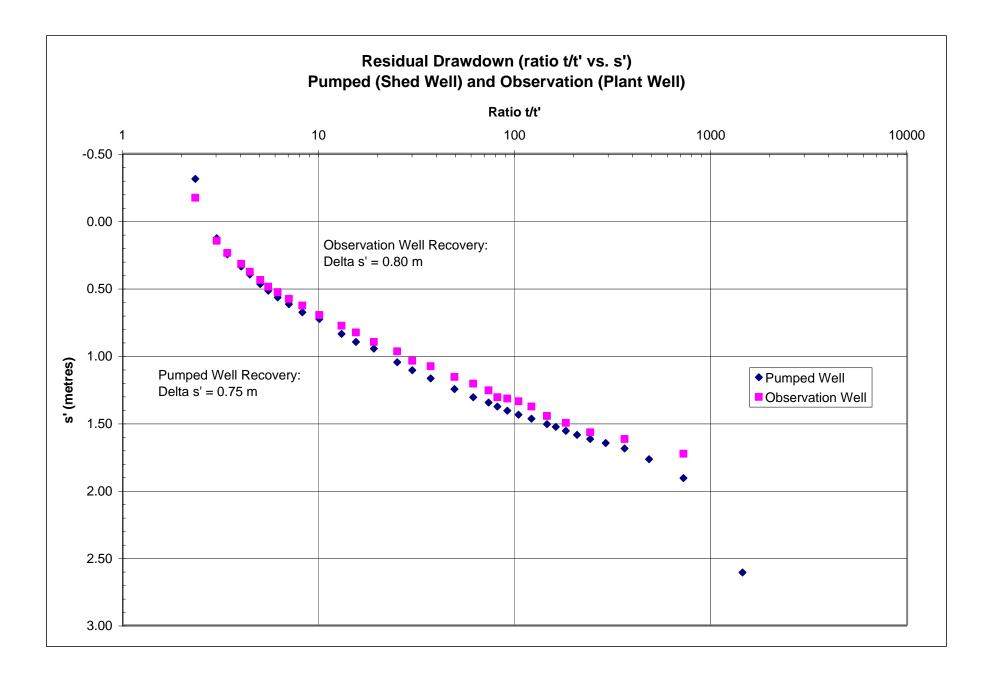
Pumping Well (Shed Well) - Drawdown Data							
Time since pumping started (minutes)	Water level (metres)	Drawdown (m)	Comments				
0	2.12	0	18" Orifice = 148 igpm

The pump test on the Shed well indicates that the two site wells intersect the same confined to semi-confined aquifer. The capacity of the Shed well is likely higher than pump test rate of 672 L/minute (148 igpm), however, we do not recommend pumping above this rate without additional pump testing. At the recommended rate, the Shed well can meet the average water demand of the development.
