Environmental Impact Assessment

Blue Acres Development Ltd.

Environmental Impact Assessment Aldouane Irrigation Project

Registration February 2021

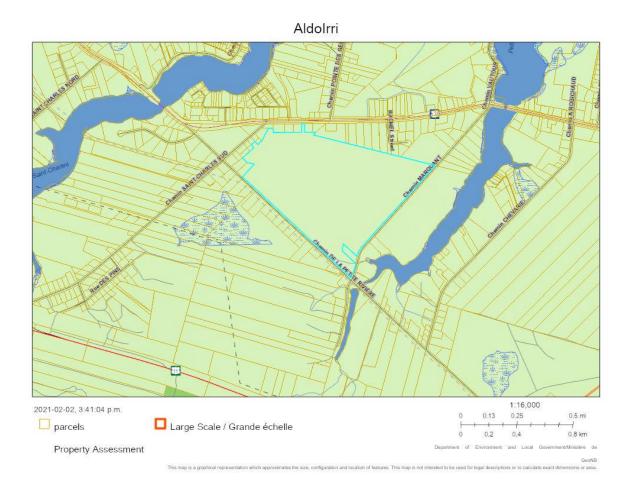
Figure 1 Site Map

The property id is 25164658, and is located between Route 134, Marquant Road and Chemin Petite Riviere in Aldouane, Kent County New Brunswick (Figure 1).

Owner: Gordon Reidpath Owner of Blue Acres Development The intended use of the water is to provide irrigation for a 150-acre wild blueberry farm that currently operates on the property (Figure 1).

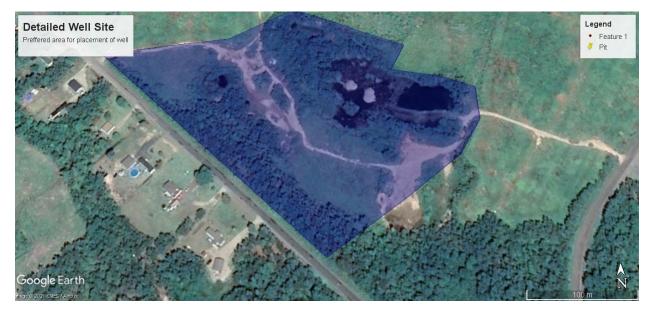
The proposed well site was selected due to its proximity to both electrical access as well as the largest of the existing gravel pits that could be used for water storage or access should the need arise (Figure 2). It is also one of the few locations on the property that is not occupied by producing fields and is central enough on the property to efficiently supply water to the entire property. Access to electricity is required in order to eliminate the need for diesel powered pumps, thus increasing efficiency and reducing noise pollution.

The adjacent gravel pit came out of use because the excavators encountered clay. The clay is holding enough water on the surface that is impractical to grow berries on it and has remained scrub land for several years (Figure 2).

The adjacent gravel pit came out of use because the excavators encountered clay. The clay is holding enough water on the surface that is impractical to grow berries on it and has remained scrub land for several years (Figure 2).

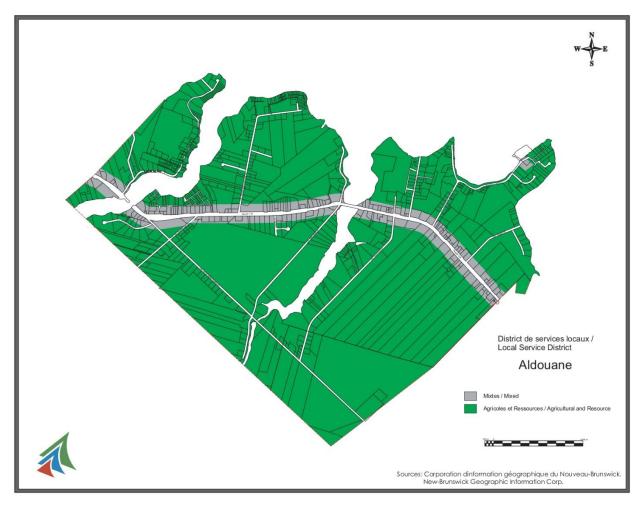
The site is located withing the LSD of Aldouane and is currently zoned agricultural (Figure 3).

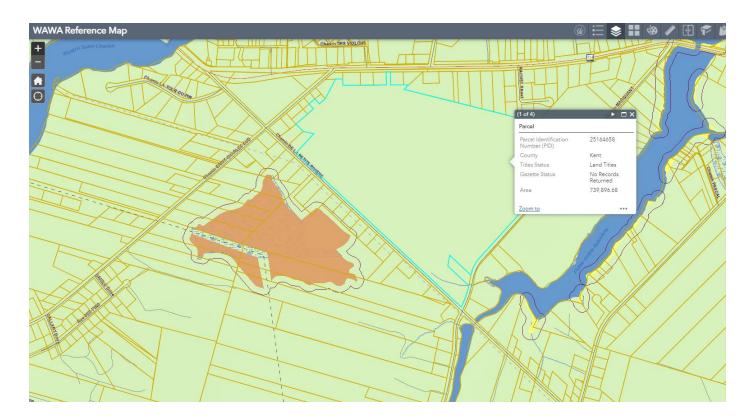
Figure 4 – WAWA Reference Map

The proposed development area on the project site does not fall within 30m of a coastal marsh or provincially significant wetland, refer to attached WAWA Reference Map, Figure 4. There is an adjacent regulated wetland located to Northwest; however, there is no proposed work within 30m of this wetland.

There are no water courses, streams or wetlands within 60 m of proposed well (Figure 4).

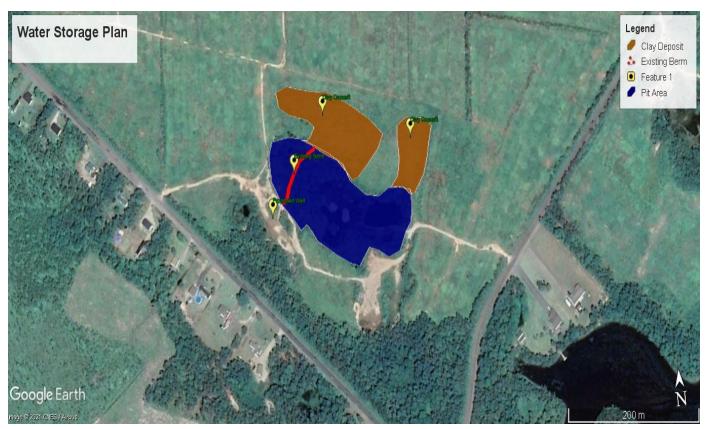
Figure 5. Water Storage Plan

In order to achieve the projects' goal of being able to provide irrigation this year we would use the existing division in the pit to isolate the smaller section, move water to the larger section, which will allow us to cap the small section and complete the larger section in the fall when there would naturally be no water in the pit. The worked would be completed by Blue Acre Development (Figure 5).

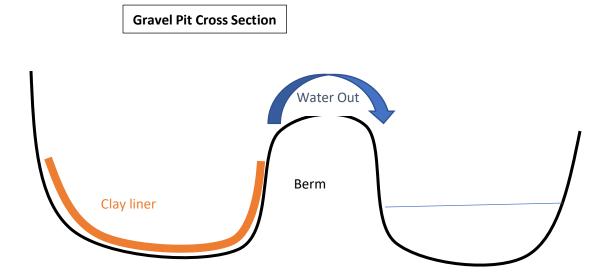
The Pit in total measures 4.56 acres and is on average 4 metres in depth with parts in the excess of 5 metres. At its lowest points water remains year-round in most years. If the entire pit is

sealed and we maintain a depth of 4 meters and account for modifications to the pit, the estimated volume of water it can store should be approximately 59,000 cubic meters.

The Pit in total measures 4.56 acres and is on average 4 metres in depth with parts in the excess of 5 metres. At its lowest points ground water remains year-round in most years. If the entire pit is sealed and we maintain a depth of 4 meters and account for modifications to the pit, the estimated volume of water it can store should be approximately 59,000 cubic meters.

In order to achieve the projects' goal of being able to provide irrigation this year we would use the existing division in the pit to isolate the smaller section, move water to the larger section, which will allow us to cap the small section and complete the larger section in the fall when there would naturally be no water in the pit.

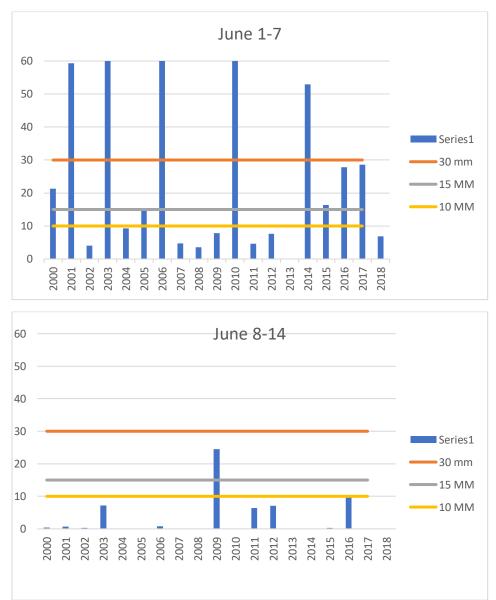
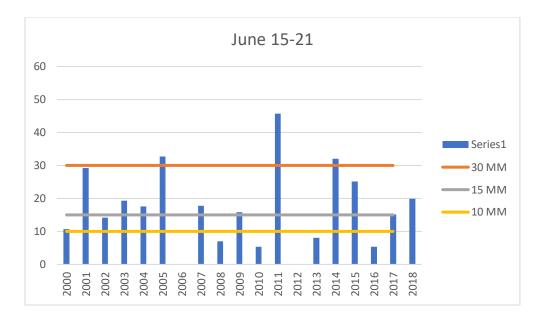
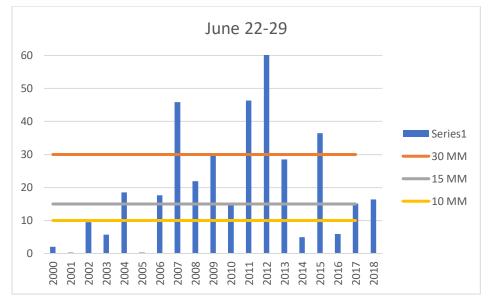
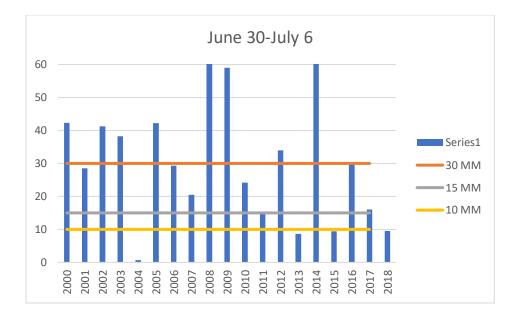
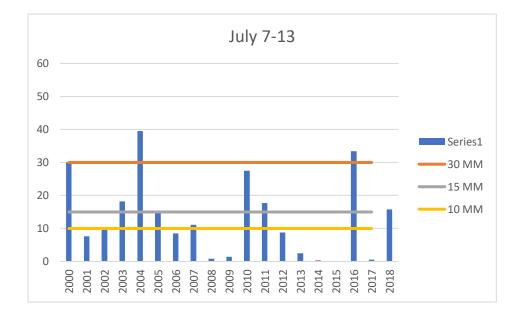
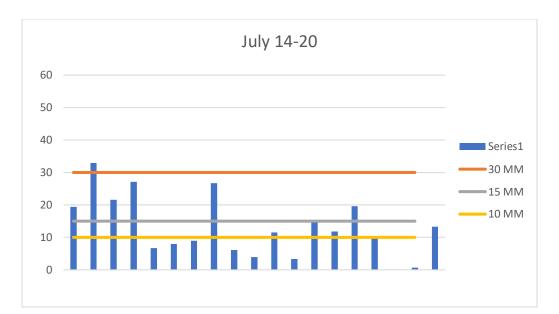
Appendix A – Average Weekly Precipitation Values

In **Appendix A**, a series of charts that shows the weekly precipitation values for the months in which irrigation would be applied to the blueberry crop. The data is taken from Environment Canada's nearest weather station at Kouchibouguac National Park. The seven-day amount was used to demonstrate accurately the shortcomings in water for crop in question. The Wild Blueberry factsheet indicates that 2.5 cm of water per week is required for optimum plant growth. The weeks when the blueberry plant requires precipitation have been extrapolated and include June and July. The weeks when the plant requires precipitation the most are those of July 15 through to August 15th. The charts show that over the past 18 years that amount has consistently not been available to the plants.
