**Re: Environmental Impact Assessment Registration for upgrades
of the existing Septic System at Crabbe Mountain**

Environmental Impact Assessment
Registration Document for the:

**On-site Effluent Disposal System Upgrades at the
Crabbe Mountain Ski Lodge**

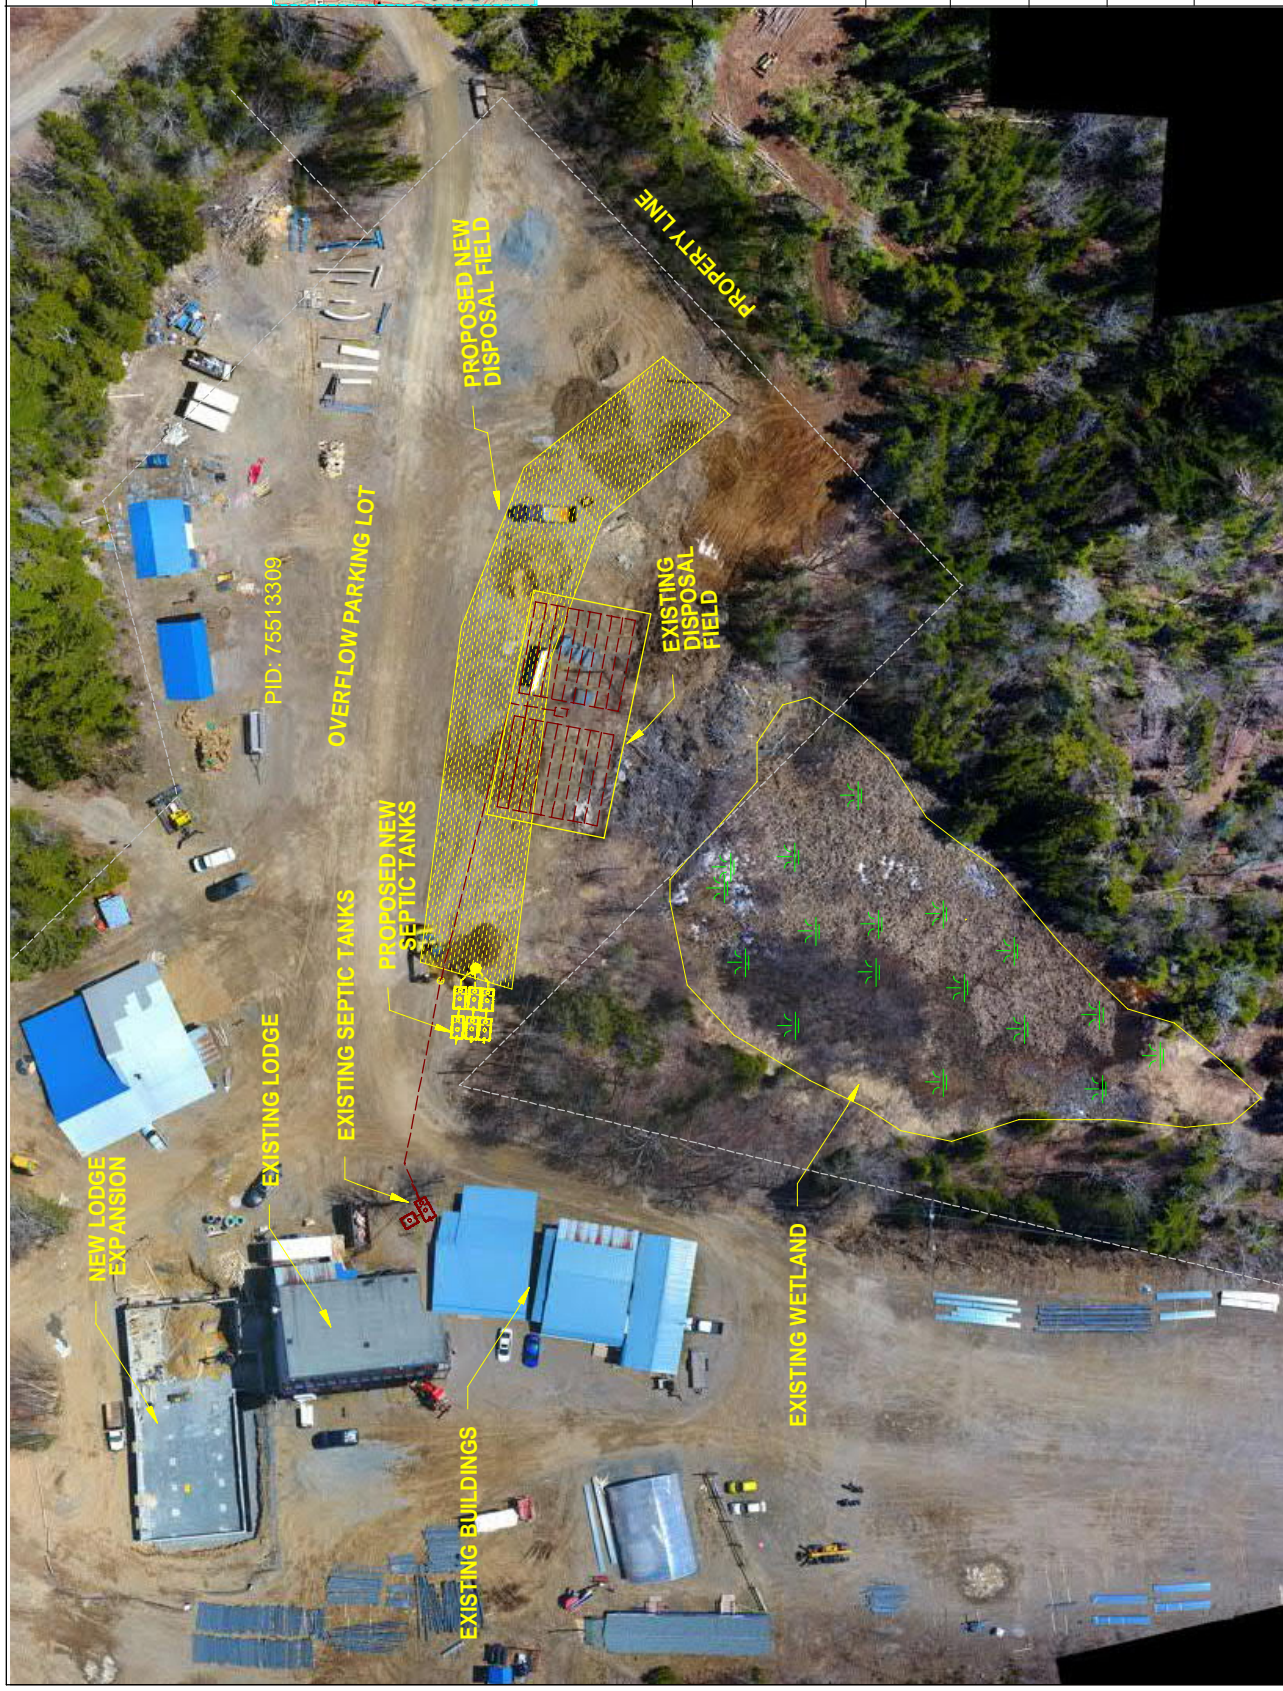
FIGURE 1

DRONE PHOTO WAS TAKEN ON:
MAY 13, 2022
(NOT TO SCALE)

ON-SITE EFFLUENT DISPOSAL REPLACEMENT SYSTEM

- The Site is defined as the general location of the proposed Project as depicted in Figure 1; and
- The Assessment Area is generally defined as nearby sensitive receptors on properties adjoining SNB PID 75513309 (*i.e.*, neighbouring residential dwellings, environmentally sensitive areas, *etc.*).

The Site is a portion of an active commercial ski resort that typically operates four months annually. Ancillary buildings near the Site include a main lodge housing a full-service licensed restaurant, a retail shop, and public washroom facilities – the Project is required to support this facility as the existing septic infrastructure has reached the end of its useful life. A rental / repair shop and ticketing / change house are located west of the Site. The main parking area is situated southwest, the Site is an area considered for overflow parking (Figure 1).

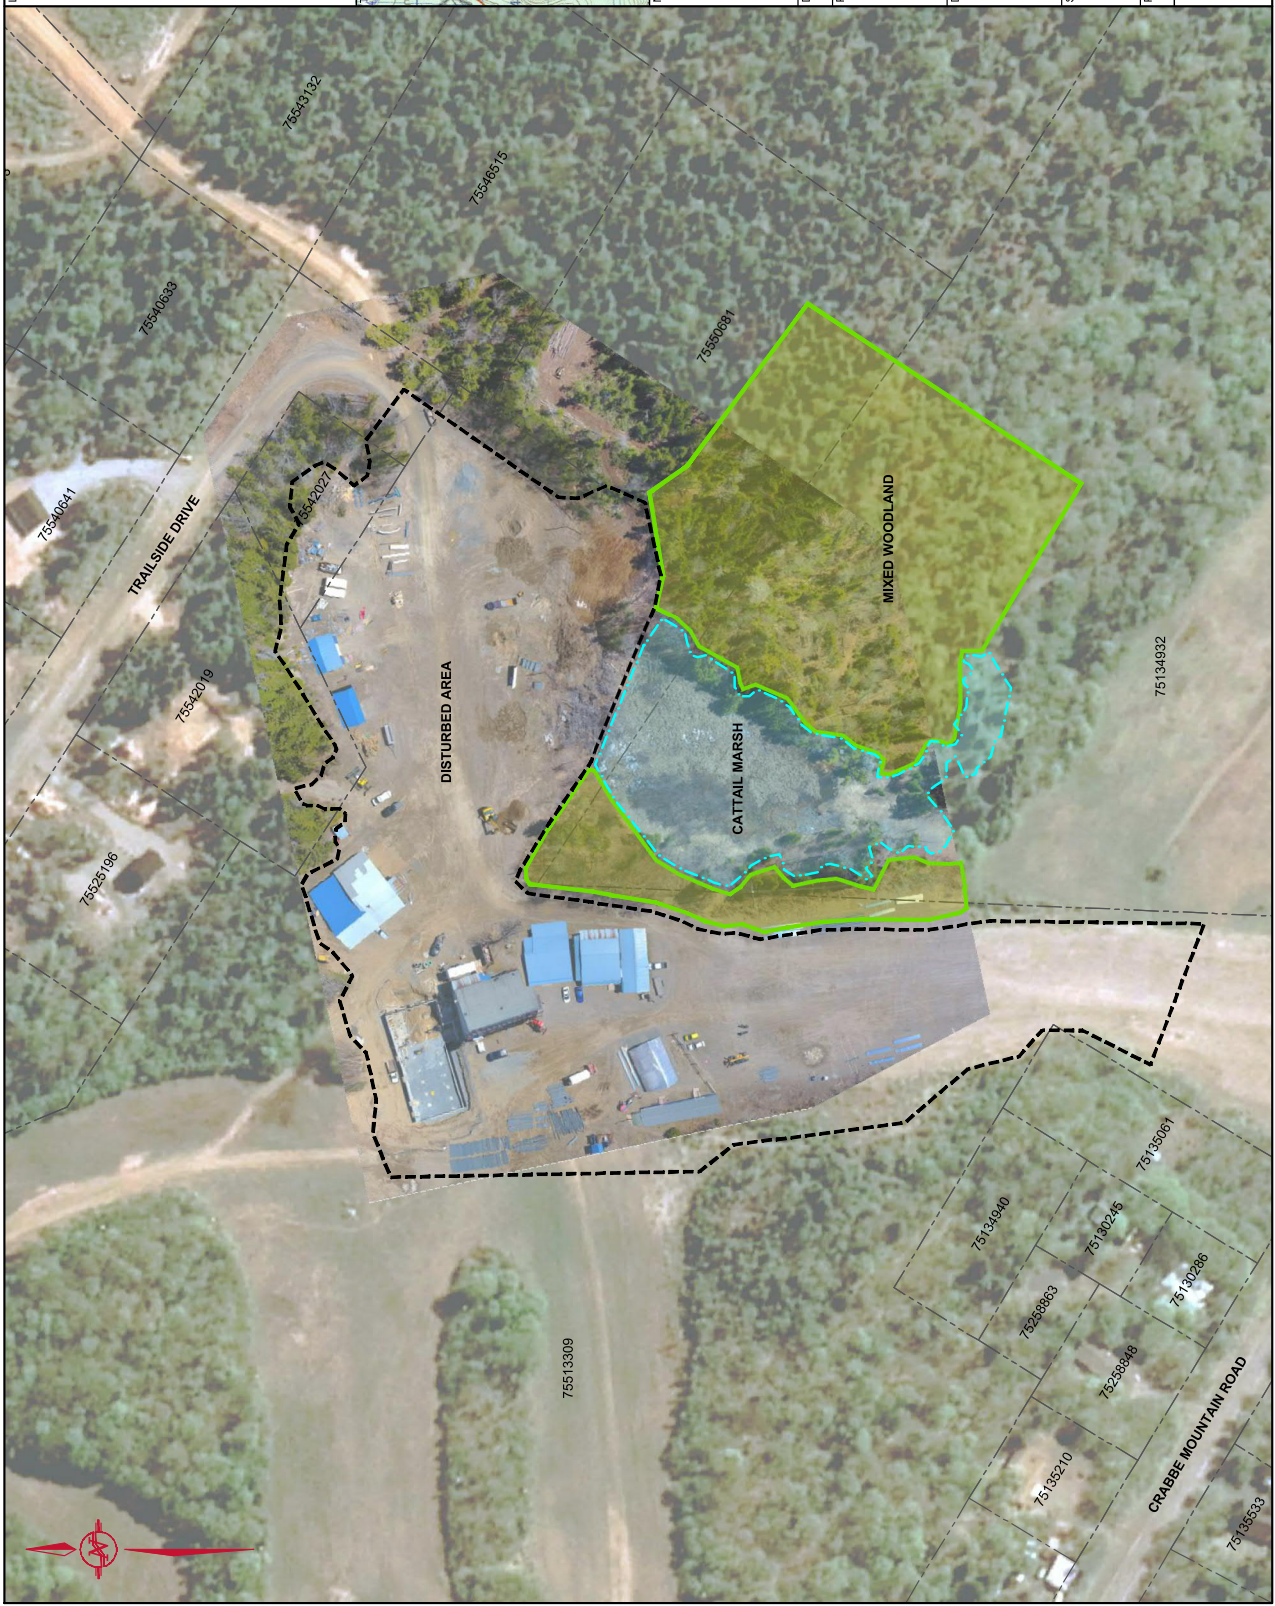
Date	MAY 2022	Draw	CHG	Checked	SG
Project	EIA REGISTRATION CRABBE MOUNTAIN ON-SITE SEPTIC DISPOSAL SYSTEM				
Drawing	WETLAND DELINEATION

- DISTURBED AREA
- DELINEATED WETLAND
- MIXED WOODLAND AREA
- PROPERTY LINE

- This drawing is a schematic representation. Sizes, locations and dimensions are approximate.
- Coordinate system: New Brunswick, Stereographic projection, NAD83 (CSRS) Datum.
- Base aerial photograph from May 20, 2021. Source Google Earth.
- Site drone image from May 03, 2022. Provided by the client.

habitats were identified and are discussed below. The results of the investigation are illustrated on Figure 2.

The provincial GeoNB mapping was reviewed prior to the Site visit and showed no mapped wetlands within proximity to the Site. A small wetland (approximately 0.5 hectares) was identified during the Site visit; this wetland is not associated with any watercourse. Aerial imagery and LiDAR was collected by NATECH on-site on May 3, 2022. The LiDAR data (Appendix B) shows clear definition of the wetland on-site which was used in combination with the collected field data to delineate this feature.

Hydrophytic vegetation, hydrology indicators and soil characteristics are all found in the habitat unit. The wetland is largely dominated by Broadleaf cattail (*Typha latifolia*) with associate species including Speckled alder (*Alnus incana*) and Willow sp. (*Salix sp.*). The wetland is located at the bottom of a bowl feature surrounded by a mixed woodland and disturbed area. Surface water (A1) was observed throughout the wetland. The standing water and sediment contained a rusty appearance making a soils assessment difficult; although, a loamy gleyed matrix (F2) was observed to be the dominant matrix in the soil assessment. Wetland delineation data sheets are provided in Appendix B.

A mixed woodland was identified east and west of the wetland. This feature is located on the sloped lands of the bowl feature and continues into a larger

The dominant habitat in the Site has been subject to anthropogenic disturbance. Construction activities including grading, staging areas, excavation, and dumping are common in the area. Landscaping material and construction material from the parking lot north of the wetland has been piled immediately north of the wetland. Limited vegetation is present in this area.

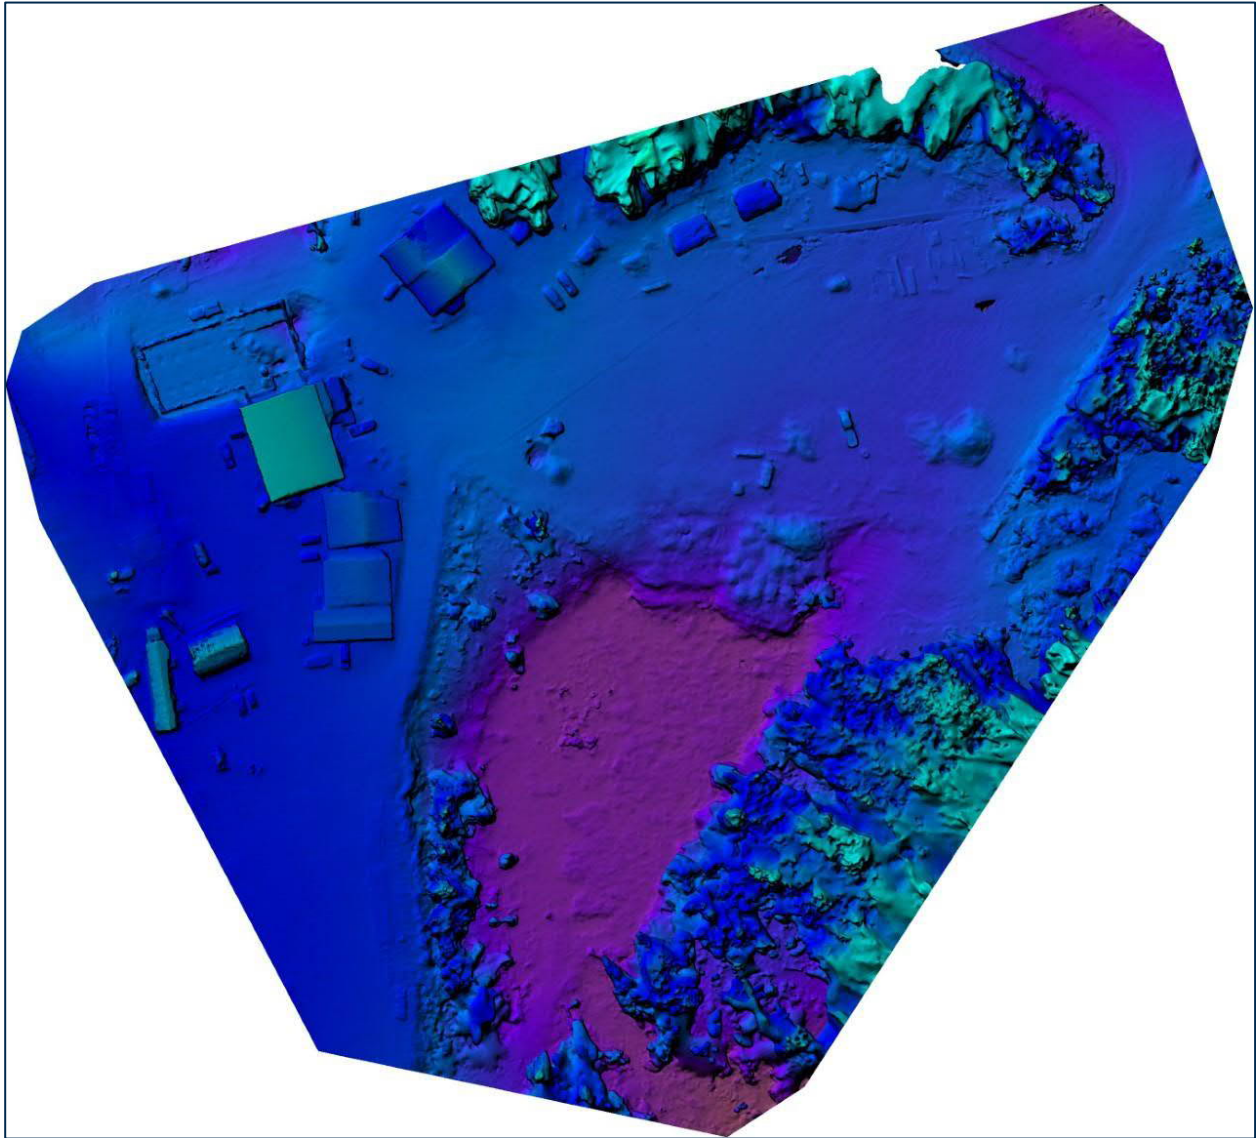
Figure 1 - LiDAR Imagery taken on May 3rd, 2022 by Natech

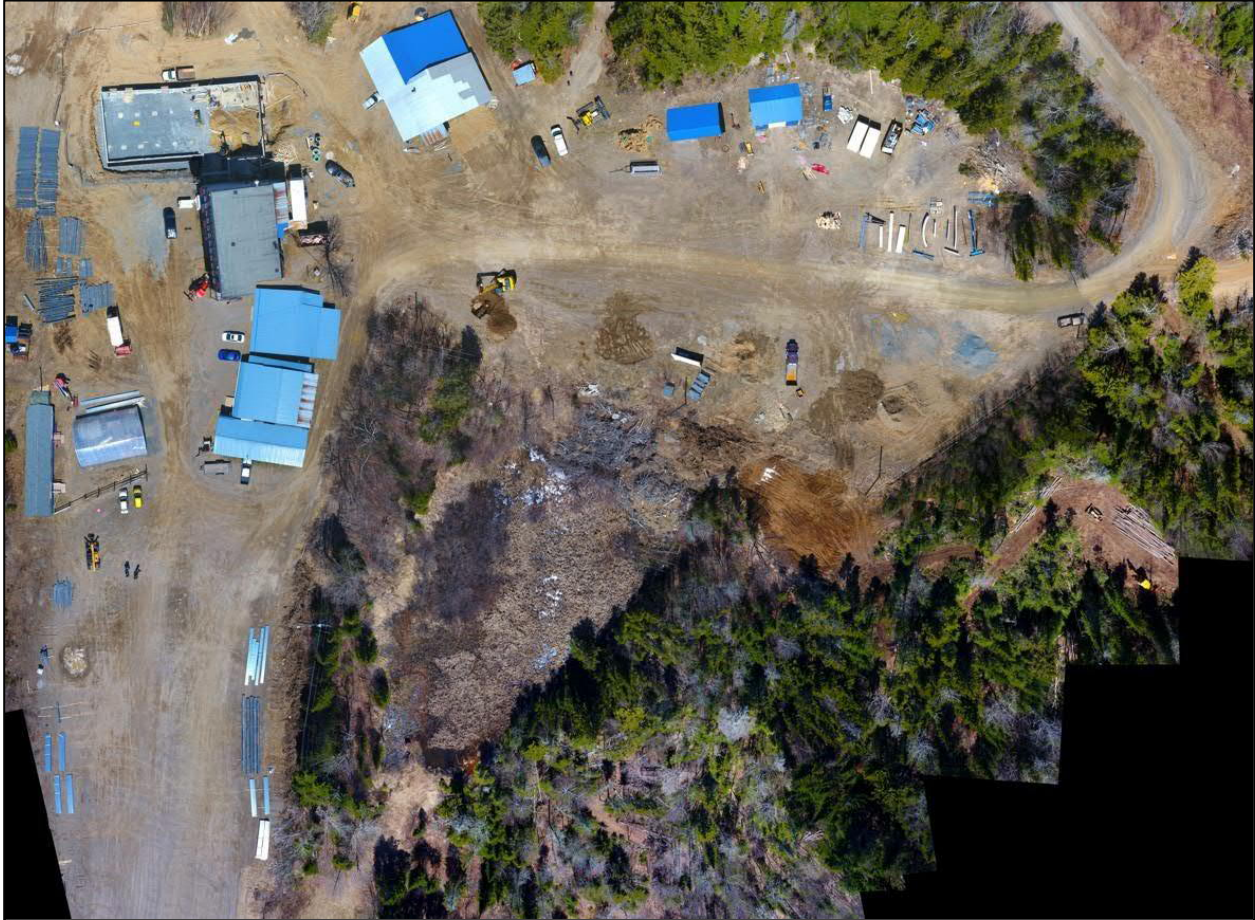
Figure 2 - Drone imagery captured on My 3rd, 2022 by Natech
