**Étude d'impact sur
l'environnement**

Reconstruction du pont à usages multiples d'Inkerman
Inkerman, Nouveau-Brunswick

**Objet : Étude d'impact sur l'environnement
Pont à usages multiples d'Inkerman, Inkerman, NB**

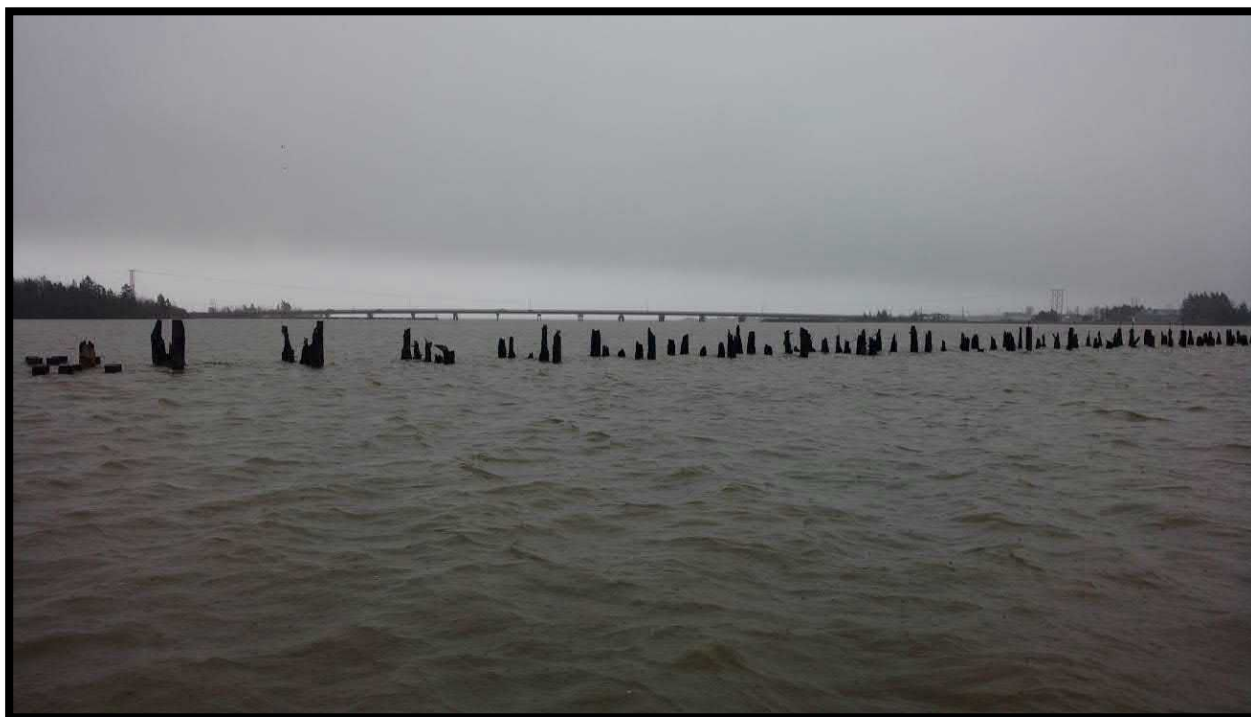
Photo no 4 : Pieux de bois créosoté calcinés
(vue vers le sud, 6 décembre 2017)

Les pieux en bois qui restent sont traités à la créosote, sont partiellement détruits, se détériorent à cause de l'incendie de 2017 et des années d'altération et sont en très mauvais état. L'enlèvement des pieux entraînerait probablement des bris et des impacts localisés sur les sédiments et la qualité de l'eau. Un examen de la littérature disponible montre qu'il y a à la fois des avantages et des inconvénients à enlever les pieux en bois traités à la créosote, selon leur intégrité structurelle et leur niveau de dégradation. Selon l'information disponible, il est proposé que seuls les pieux interférant avec l'installation de la construction du nouveau pont ou avec la navigation soient retirés.

Sur la base de l'état détérioré des pieux de créosote, leur enlèvement n'est probablement pas réalisable - le retrait des pieux avec un équipement à grappin, des élingues ou l'utilisation de vibrations peut provoquer la rupture du dessus des pieux, libérant des débris et/ou des produits chimiques chargés de créosote dans l'eau. Cela pourrait créer des impacts localisés sur la qualité de l'eau, nécessitant l'isolement du site et la collecte des matériaux. Cela créerait également probablement des impacts sur les sédiments autour de la base des pieux, car des matériaux plus profonds seraient amenés à la surface et dispersés.

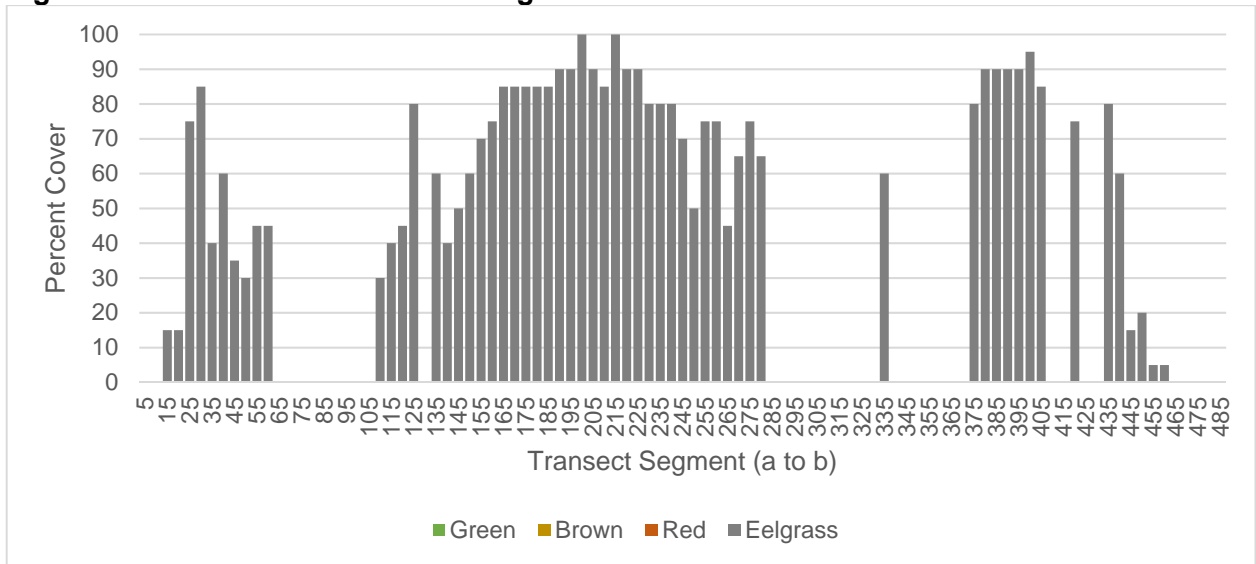
Figure 3 Macrofloral Cover along T1

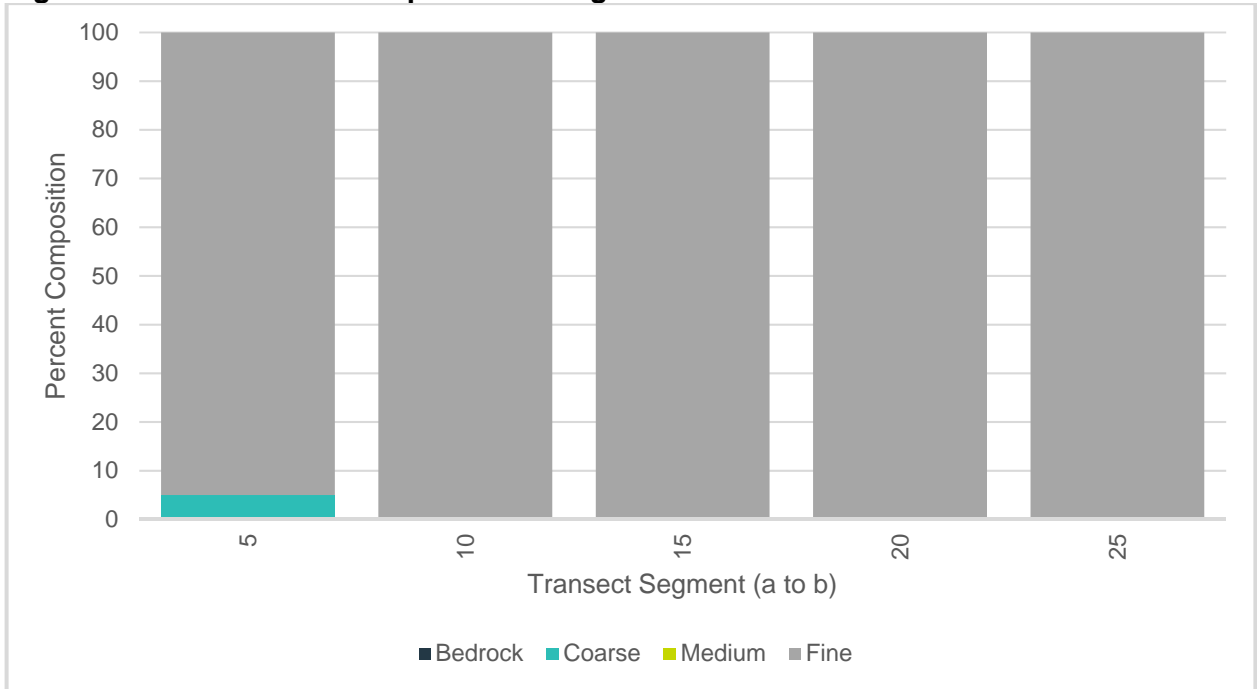
Figure 5 Substrate Composition along T3

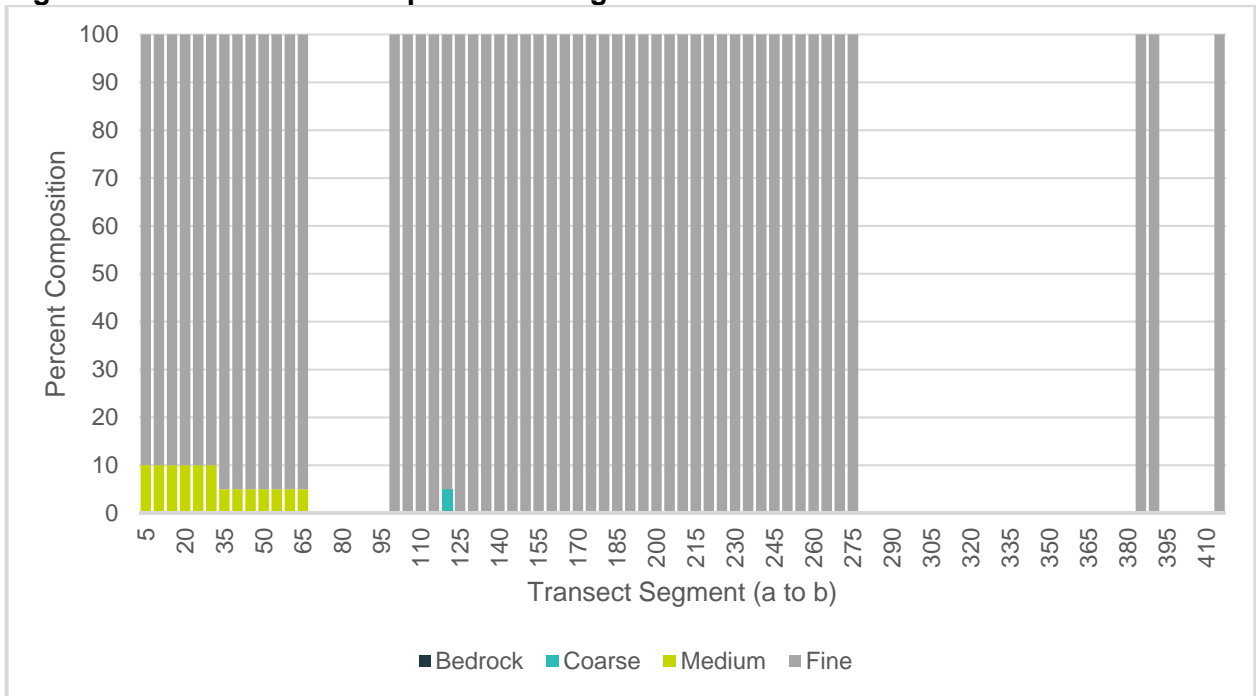
Figure 9 Substrate Composition along T5

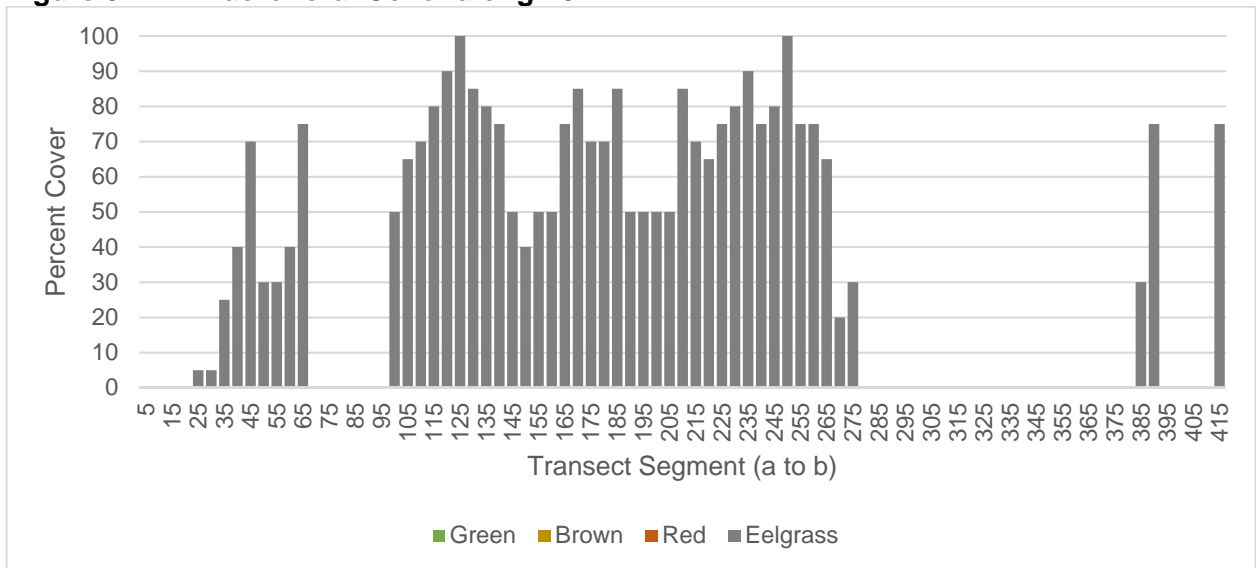
Figure 5 Macrofloral Cover along T5
