**PHASE II AND III  
ENVIRONMENTAL SITE ASSESSMENT  
AND REMEDIAL CONSIDERATIONS  
MARINE EXTRACT LIMITED  
PECHERIES FN FISHERIES LTEE  
EASTPRE FEEDS LTD.  
SHIPPAGAN, NB**

**For  
MARINE EXTRACT LTD  
PECHERIES FN FISHERIES LTEE/LTD  
EASTPRE FEEDS LTD.  
FINAL REPORT  
DATE: MARCH 6, 2020**

Date: March 6, 2020  
File: CBT 60-1

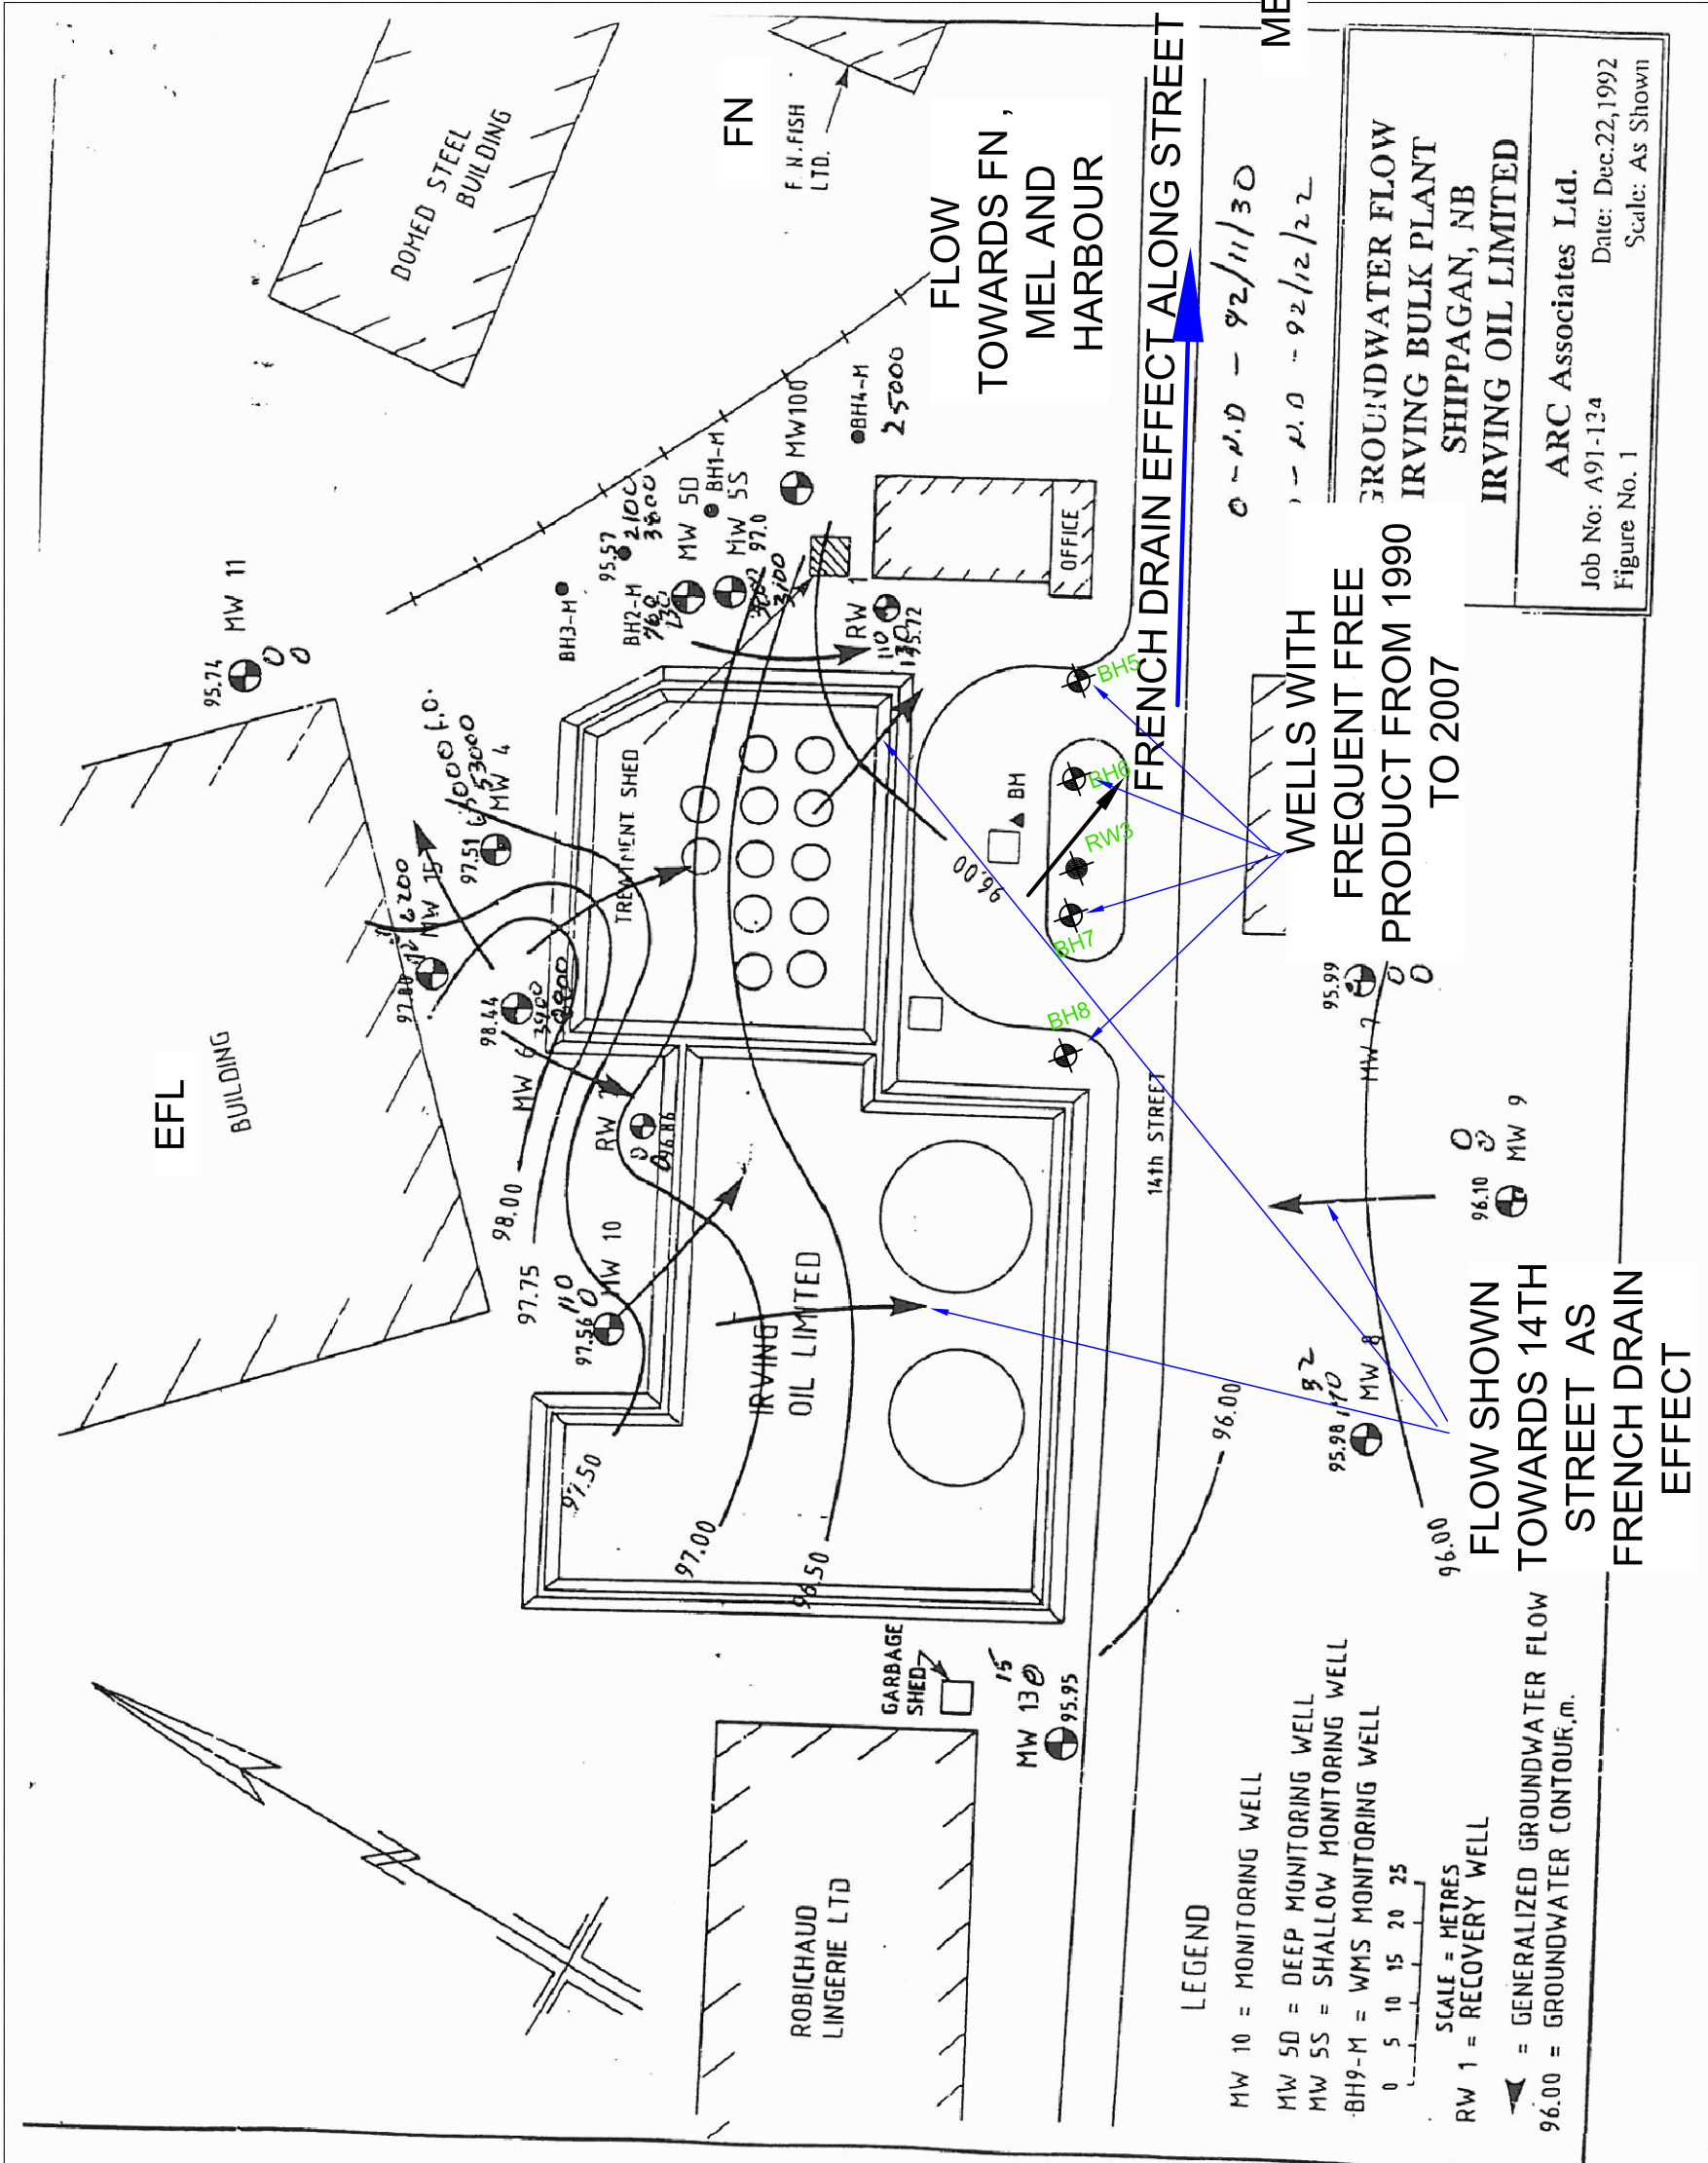
FIGURE 1-5  
GROUNDWATER FLOW TOWARD 14TH STREET WITH FRENCH DRAIN EFFECT INDICATED BY IOL CONSULTANT

- Movement of contamination from the IOL property appear to be subject to influences from possible movement of contaminates through the remediation piping trenches during either storm high tide water level or non-pumping events or combination of these events.

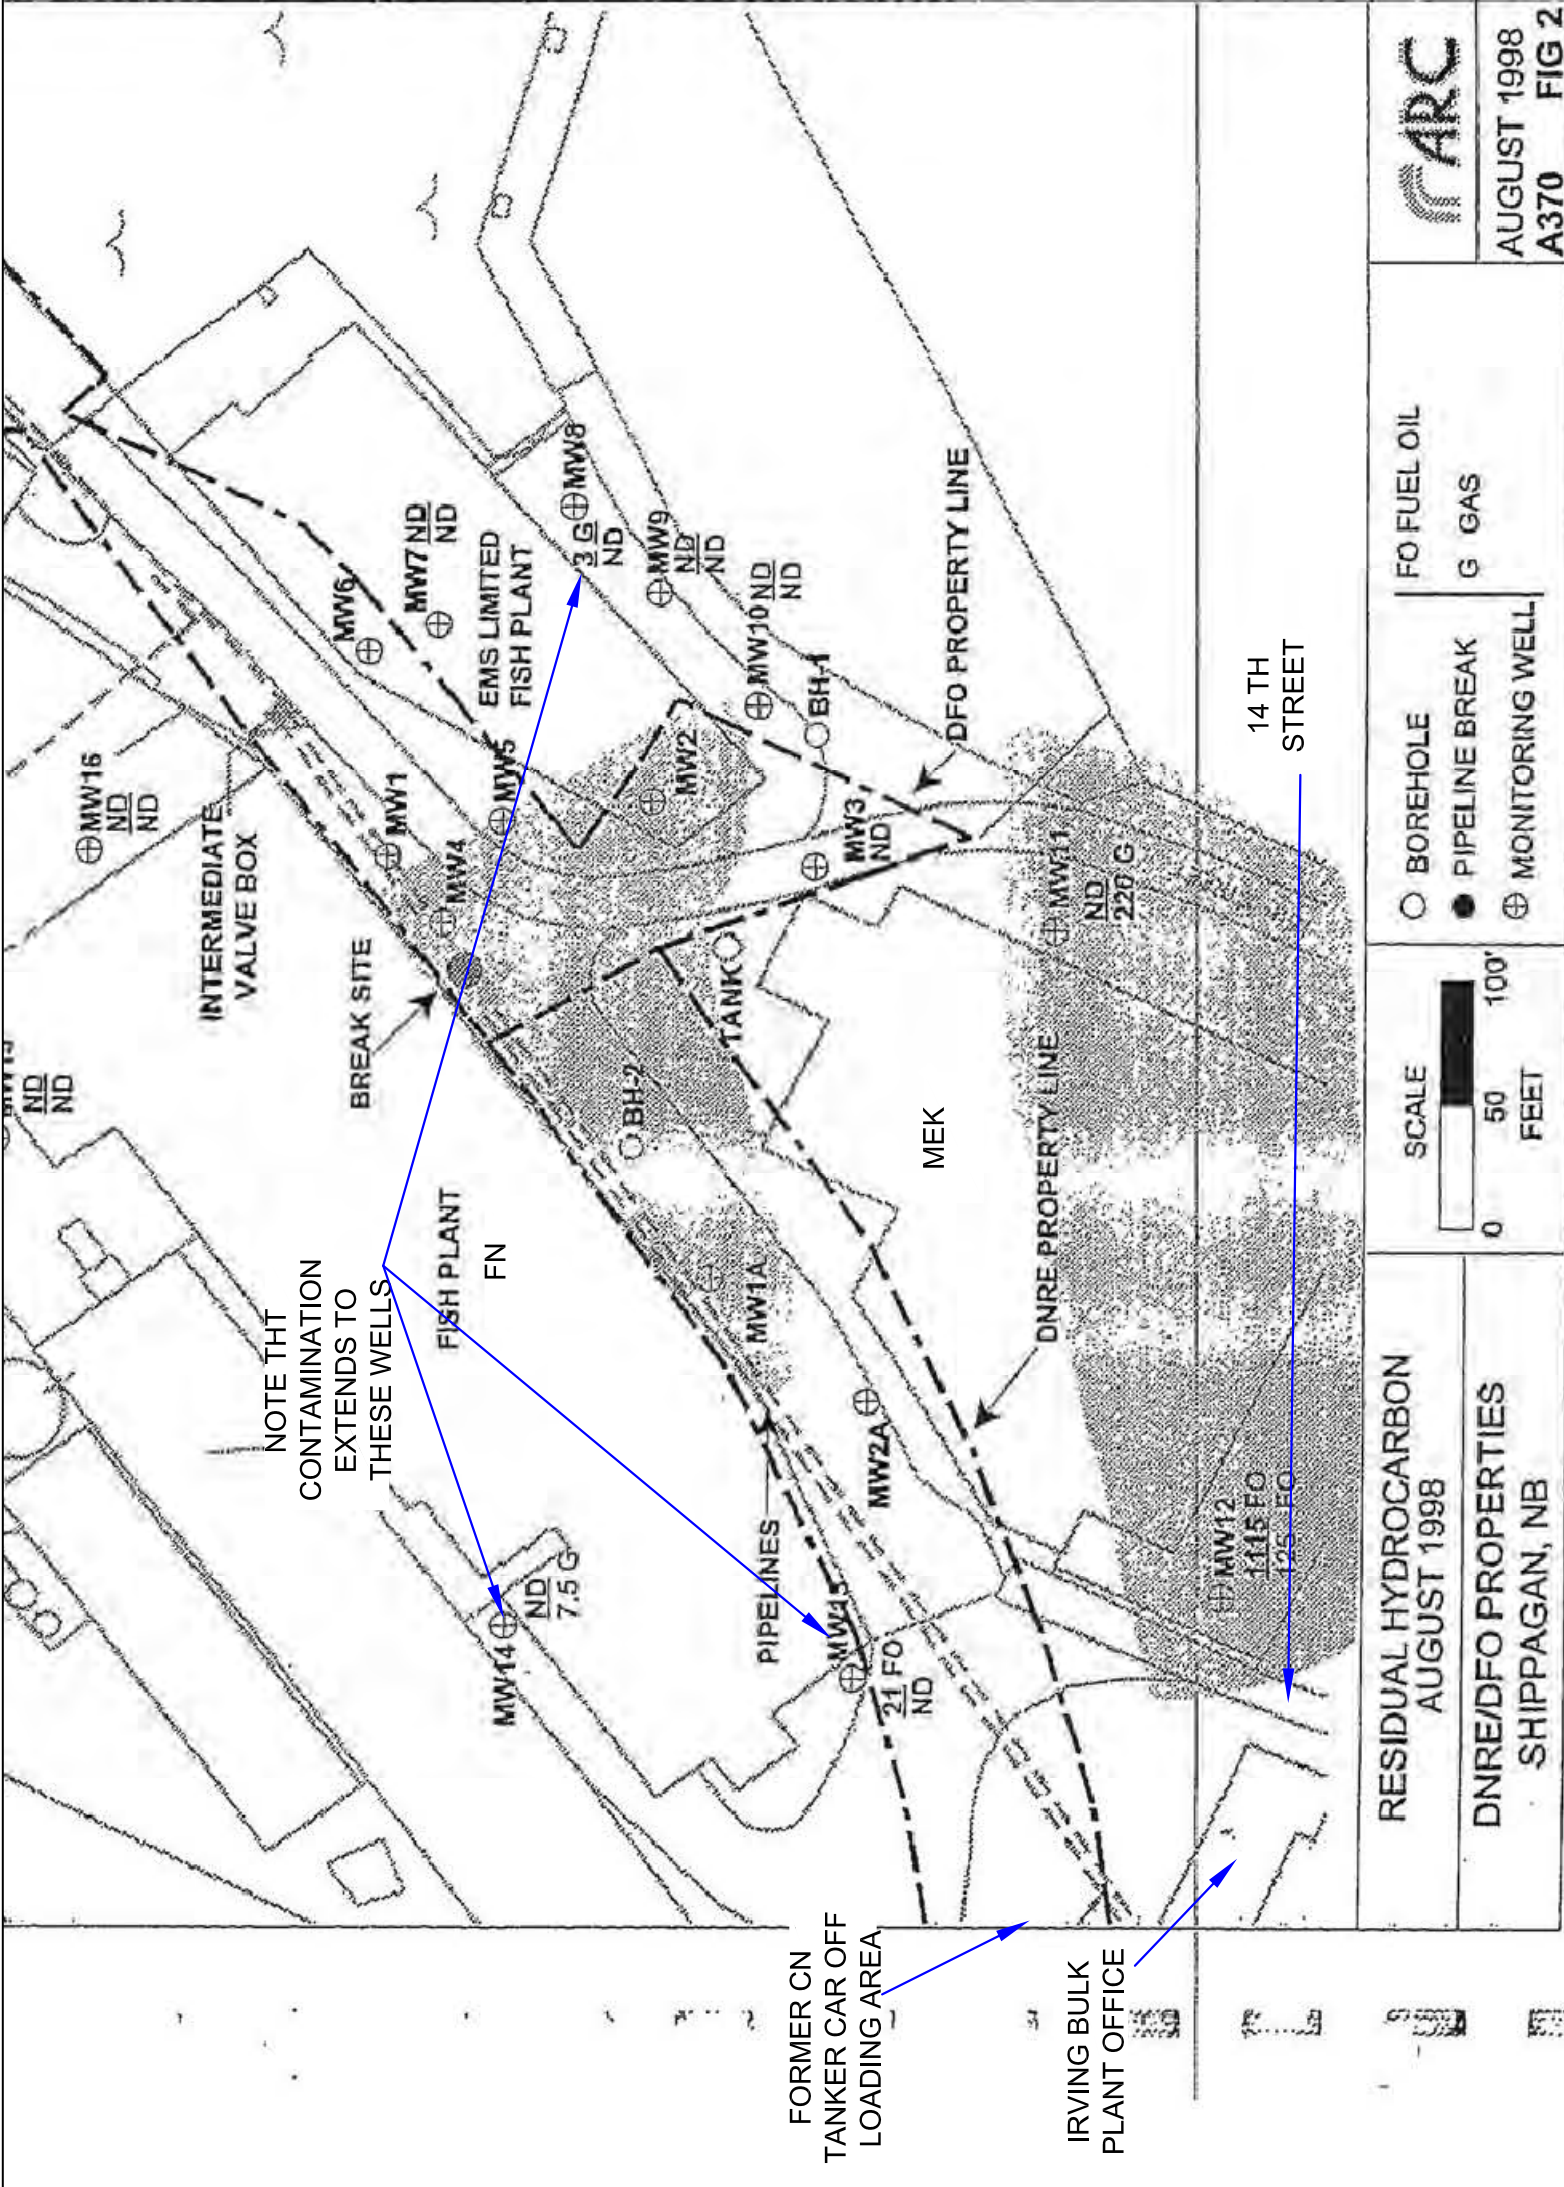
**FIGURE 1-6**

Acting at the request of IOL, ARC Associates Ltd. (ARC) carried out soil and groundwater sampling along the underground petroleum pipeline that extends between the IOL bulk plant and wharf, that was located adjacent to the FN Pecheries Ltd. building (ARC, 1997A and 1998 as A-592 a,b and A-332 with AG-438 having better figures all included in Appendix 21, Appendix 22, Appendix 23 respectively). The estimated extent of the hydrocarbon impacts in the soil and groundwater included a significant portion of the footprint for the FN Pecheries Ltd. building. See ACER Figures 1-6 and 1-7 that are also provided in Appendix 24.

**FOOTPRINT OF PETROLEUM HYDROCARBON CONTAMINATION IN SOIL FOR IOL UNDERGROUND GASOLINE TRANSFER PIPELINE INCLUDING FN AND MEL BY IOL CONSULTANT ARC 1998 A-332**

4. The extent/footprint of contamination identified by the IOL consultant for the EFL, FN, MEL, Town, SCH/DFO for soils and groundwater shown on Figures 1-6 and 1-7 (also contained in Appendix 24), is consistent with the current ACER investigations as shown in Figure 3-5 for soils and Figure 3-7 for groundwater and human health. The extent of contamination for the aquatic site specific pathway and preferential flow considerations identified by ACER is shown in Figure 3-7 (provided in Appendix 76). Concentrations are elevated along the preferential flow pathways as demonstrated by the contamination contours in Figures 4-1 and 4-2 for soil and groundwater (also provided in Appendix 97), respectively, and the IOL consultant Figures 1-6 and 1-7 for soil and groundwater, respectively (also contained in Appendix 24). Concentrations are generally expected to be higher for preferential flow pathways.

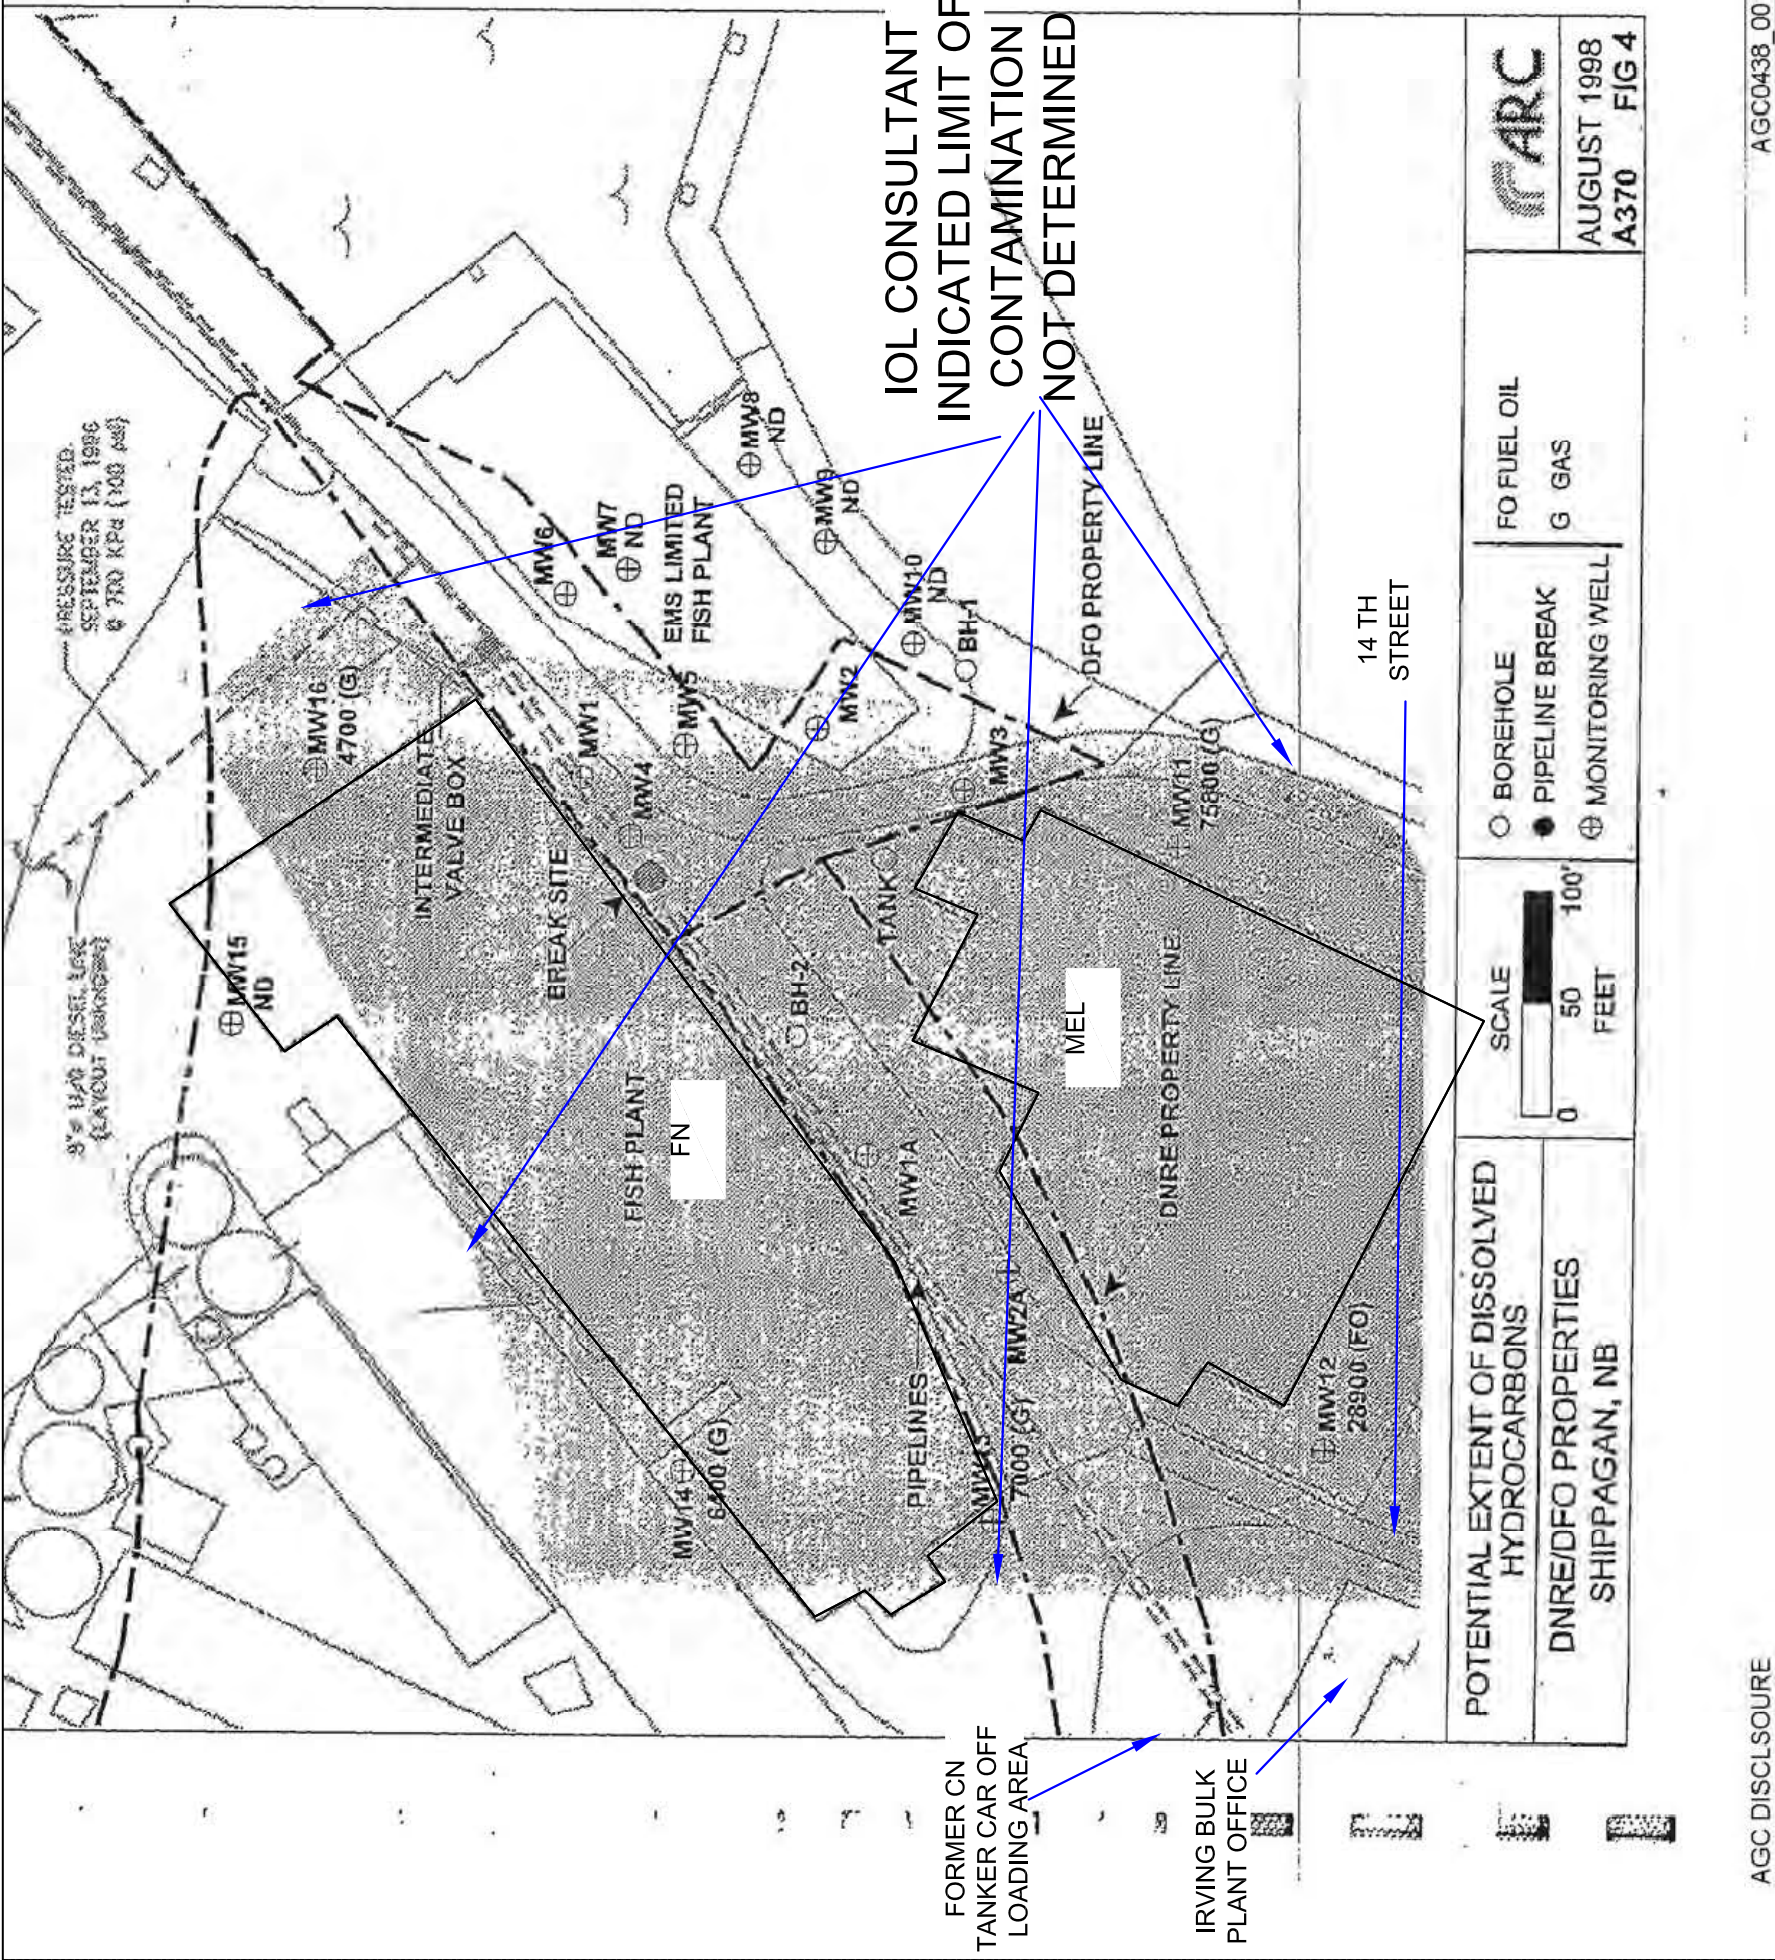
**FIGURE 1-7**

**FOOTPRINT OF PETROLEUM HYDROCARBON CONTAMINATION IN GROUNDWATER FOR IOL UNDERGROUND GASOLINE TRANSFER PIPELINE INCLUDING FN AND MEL BY IOL CONSULTANT ARC 1998 A-332**

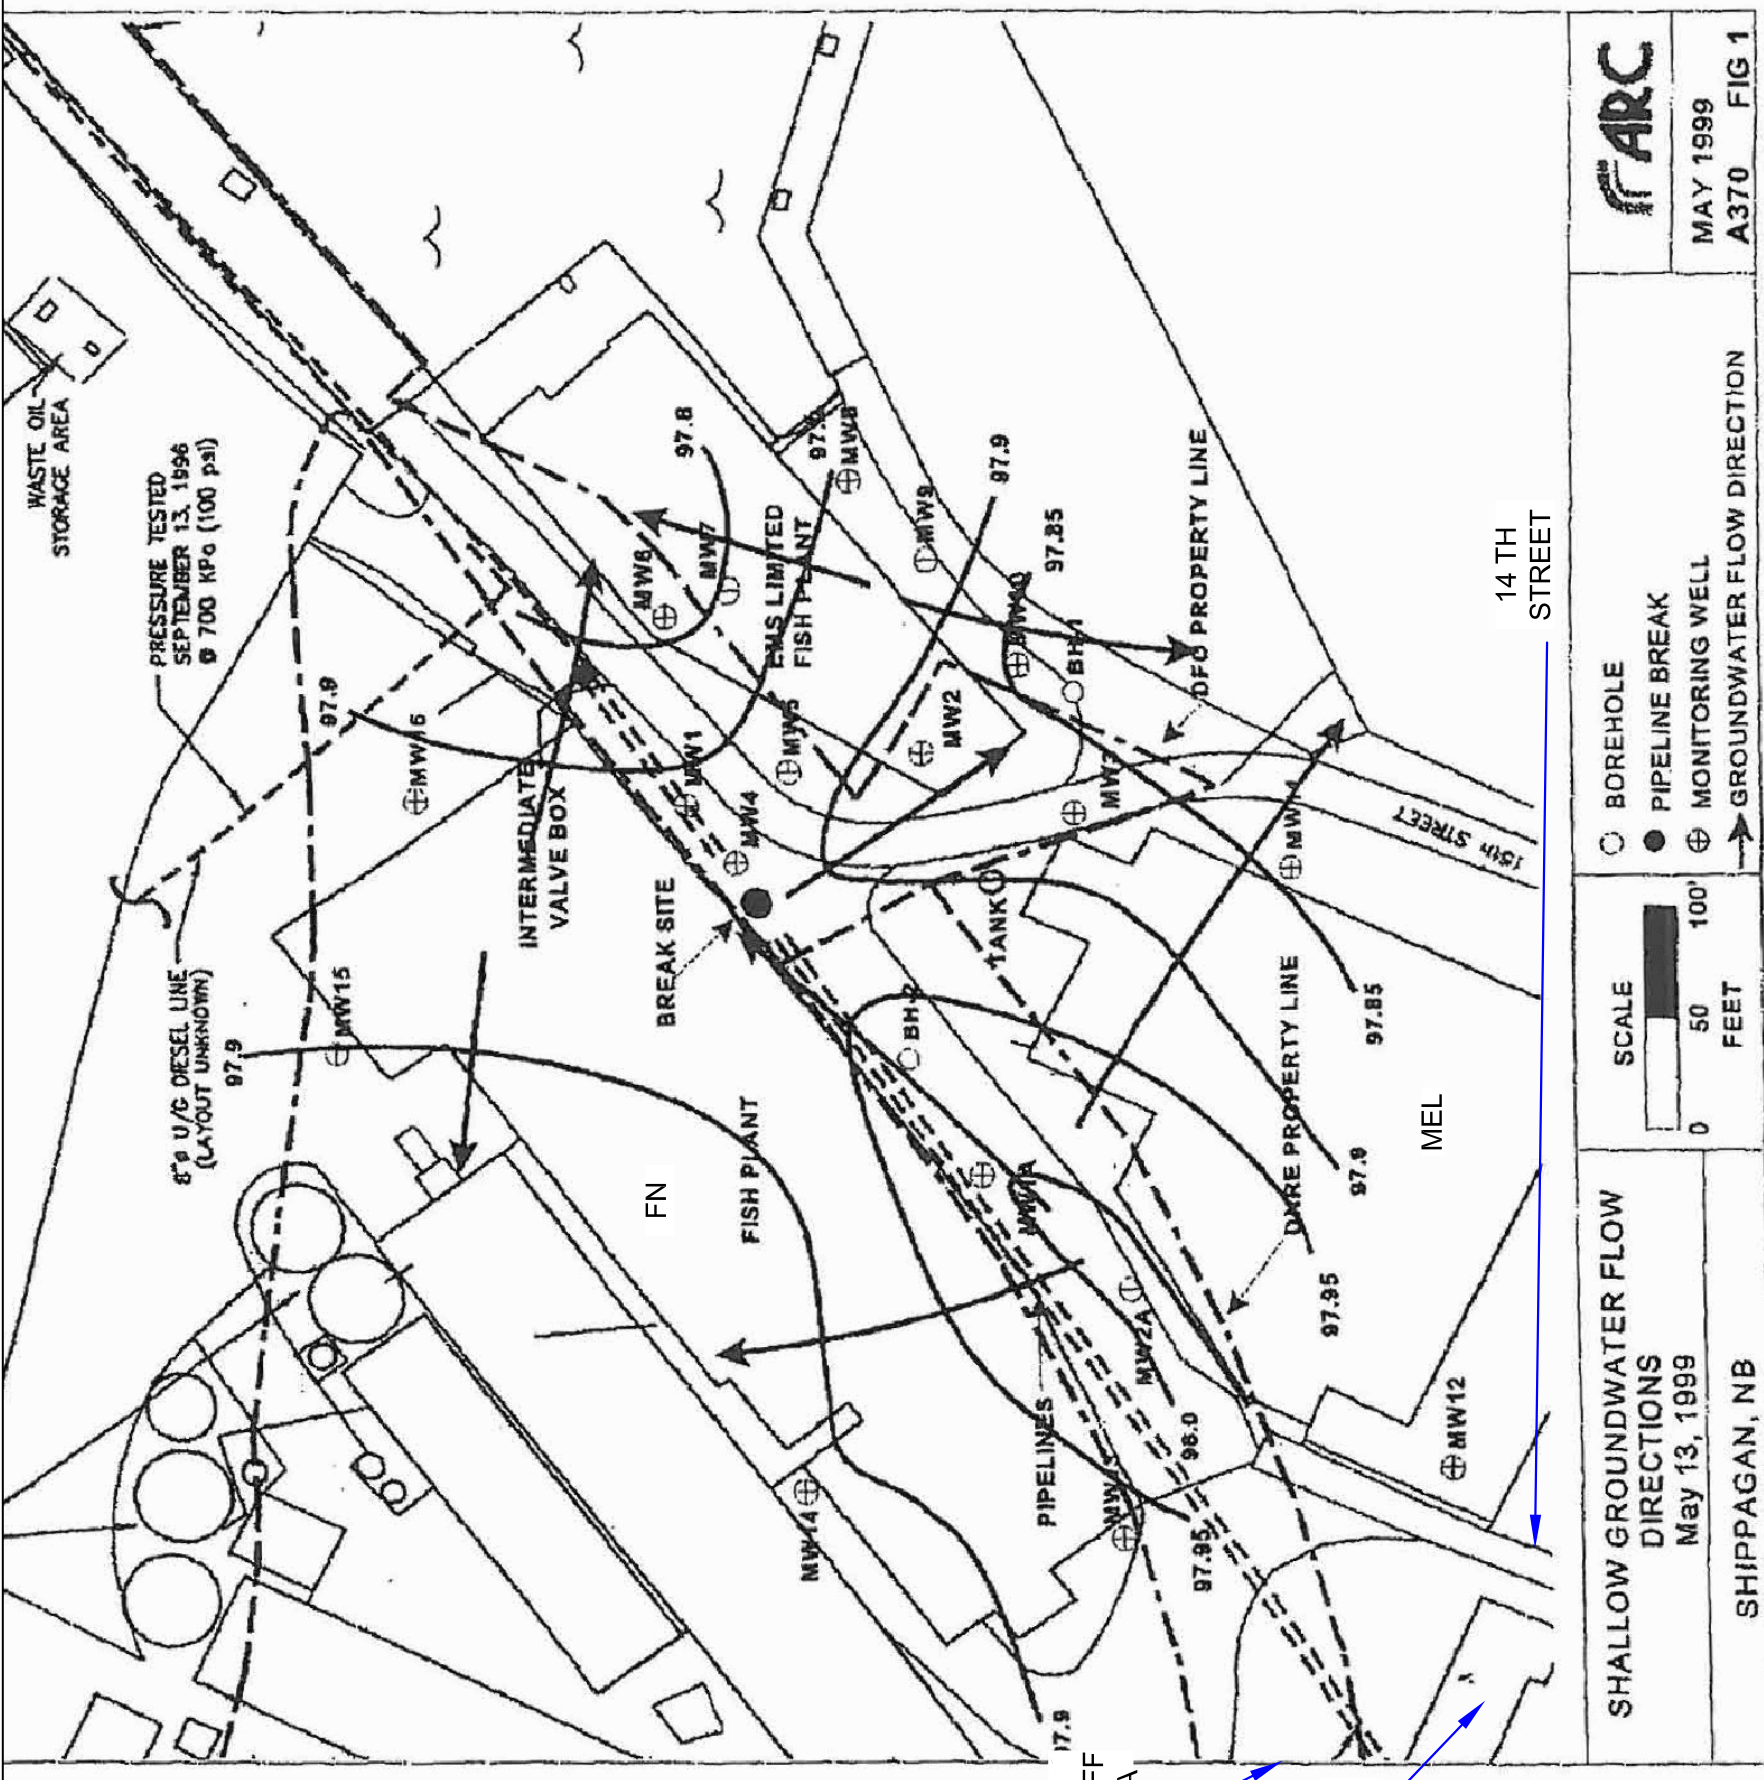
**FIGURE 1-9**

The ARC monitoring report, A-321 (Appendix 26) that also included the additional monitoring wells showed flow directions (see ACER Figure 1-9 also provided in Appendix 24) to be almost the opposite of that reported for the July 1998 investigations, prior to any remedial measures. It was noted by ACER that it was indicated in the report that "the treatment system was not operating. The electric panel was checked and all switches were noted to be in the off position." Therefore, it is reasonable to make a comparison of the flow conditions given there would be no pumping influences. It is apparent from the figures that conditions exist that can cause contamination occurring on

the DFO property to migrate onto the FN and MEL properties, and result in widespread contamination including the area of the building footprints, other adjacent properties and into the marine environment.

ARC indicated that for the flow conditions shown in Figure 1 that “This groundwater configuration is due to a number of reasons. The main groundwater high is centred in an area of disturbed soil (due to recent excavation) and previously present more permeable soils (due to the installation of pipeline and railway tracks). Consequently, infiltration in this area will be higher than the adjacent areas, thus causing local and temporary rising of the water table. The small area of groundwater low is likely due to natural discharge at the shoreline during a period of low tidal stage. During high tide it is expected that the groundwater elevation will rise due to blockage of discharge to the sea. The rise in tidal water head will cause a subsequent rise in groundwater head and local changes in groundwater flow directions.”

ACER also noted that groundwater flow under the MEL building was south to east towards the area between the two buildings. Also of note is Figure 1 (shown as ACER Figure 1-9, also provided in Appendix 24) in the ARC May, 1999 monitoring report, A-321 in Appendix 26, that shows groundwater flow for May 1999, to be almost opposite to that shown in Figure 3 (shown as ACER Figure 1-8 in Appendix 24) for July, 1998. ACER further notes that the figures show a strong component of groundwater flow occurring from the highly contaminated area between the FN and MEL buildings into the area represented by the footprints of the two buildings. ACER also noted in the ARC Report A-321 in Appendix 26 that “the treatment system was not operating. The electric panel was checked and all switches were noted to be in the off position.” Therefore, it is reasonable to make a comparison of the flow conditions given there would be no pumping influences. It is apparent from the figures that conditions exist that can cause contamination occurring on the DFO property to migrate onto the FN and MEL properties, and result in widespread contamination including the area of the building footprints, other adjacent properties and into the marine environment.

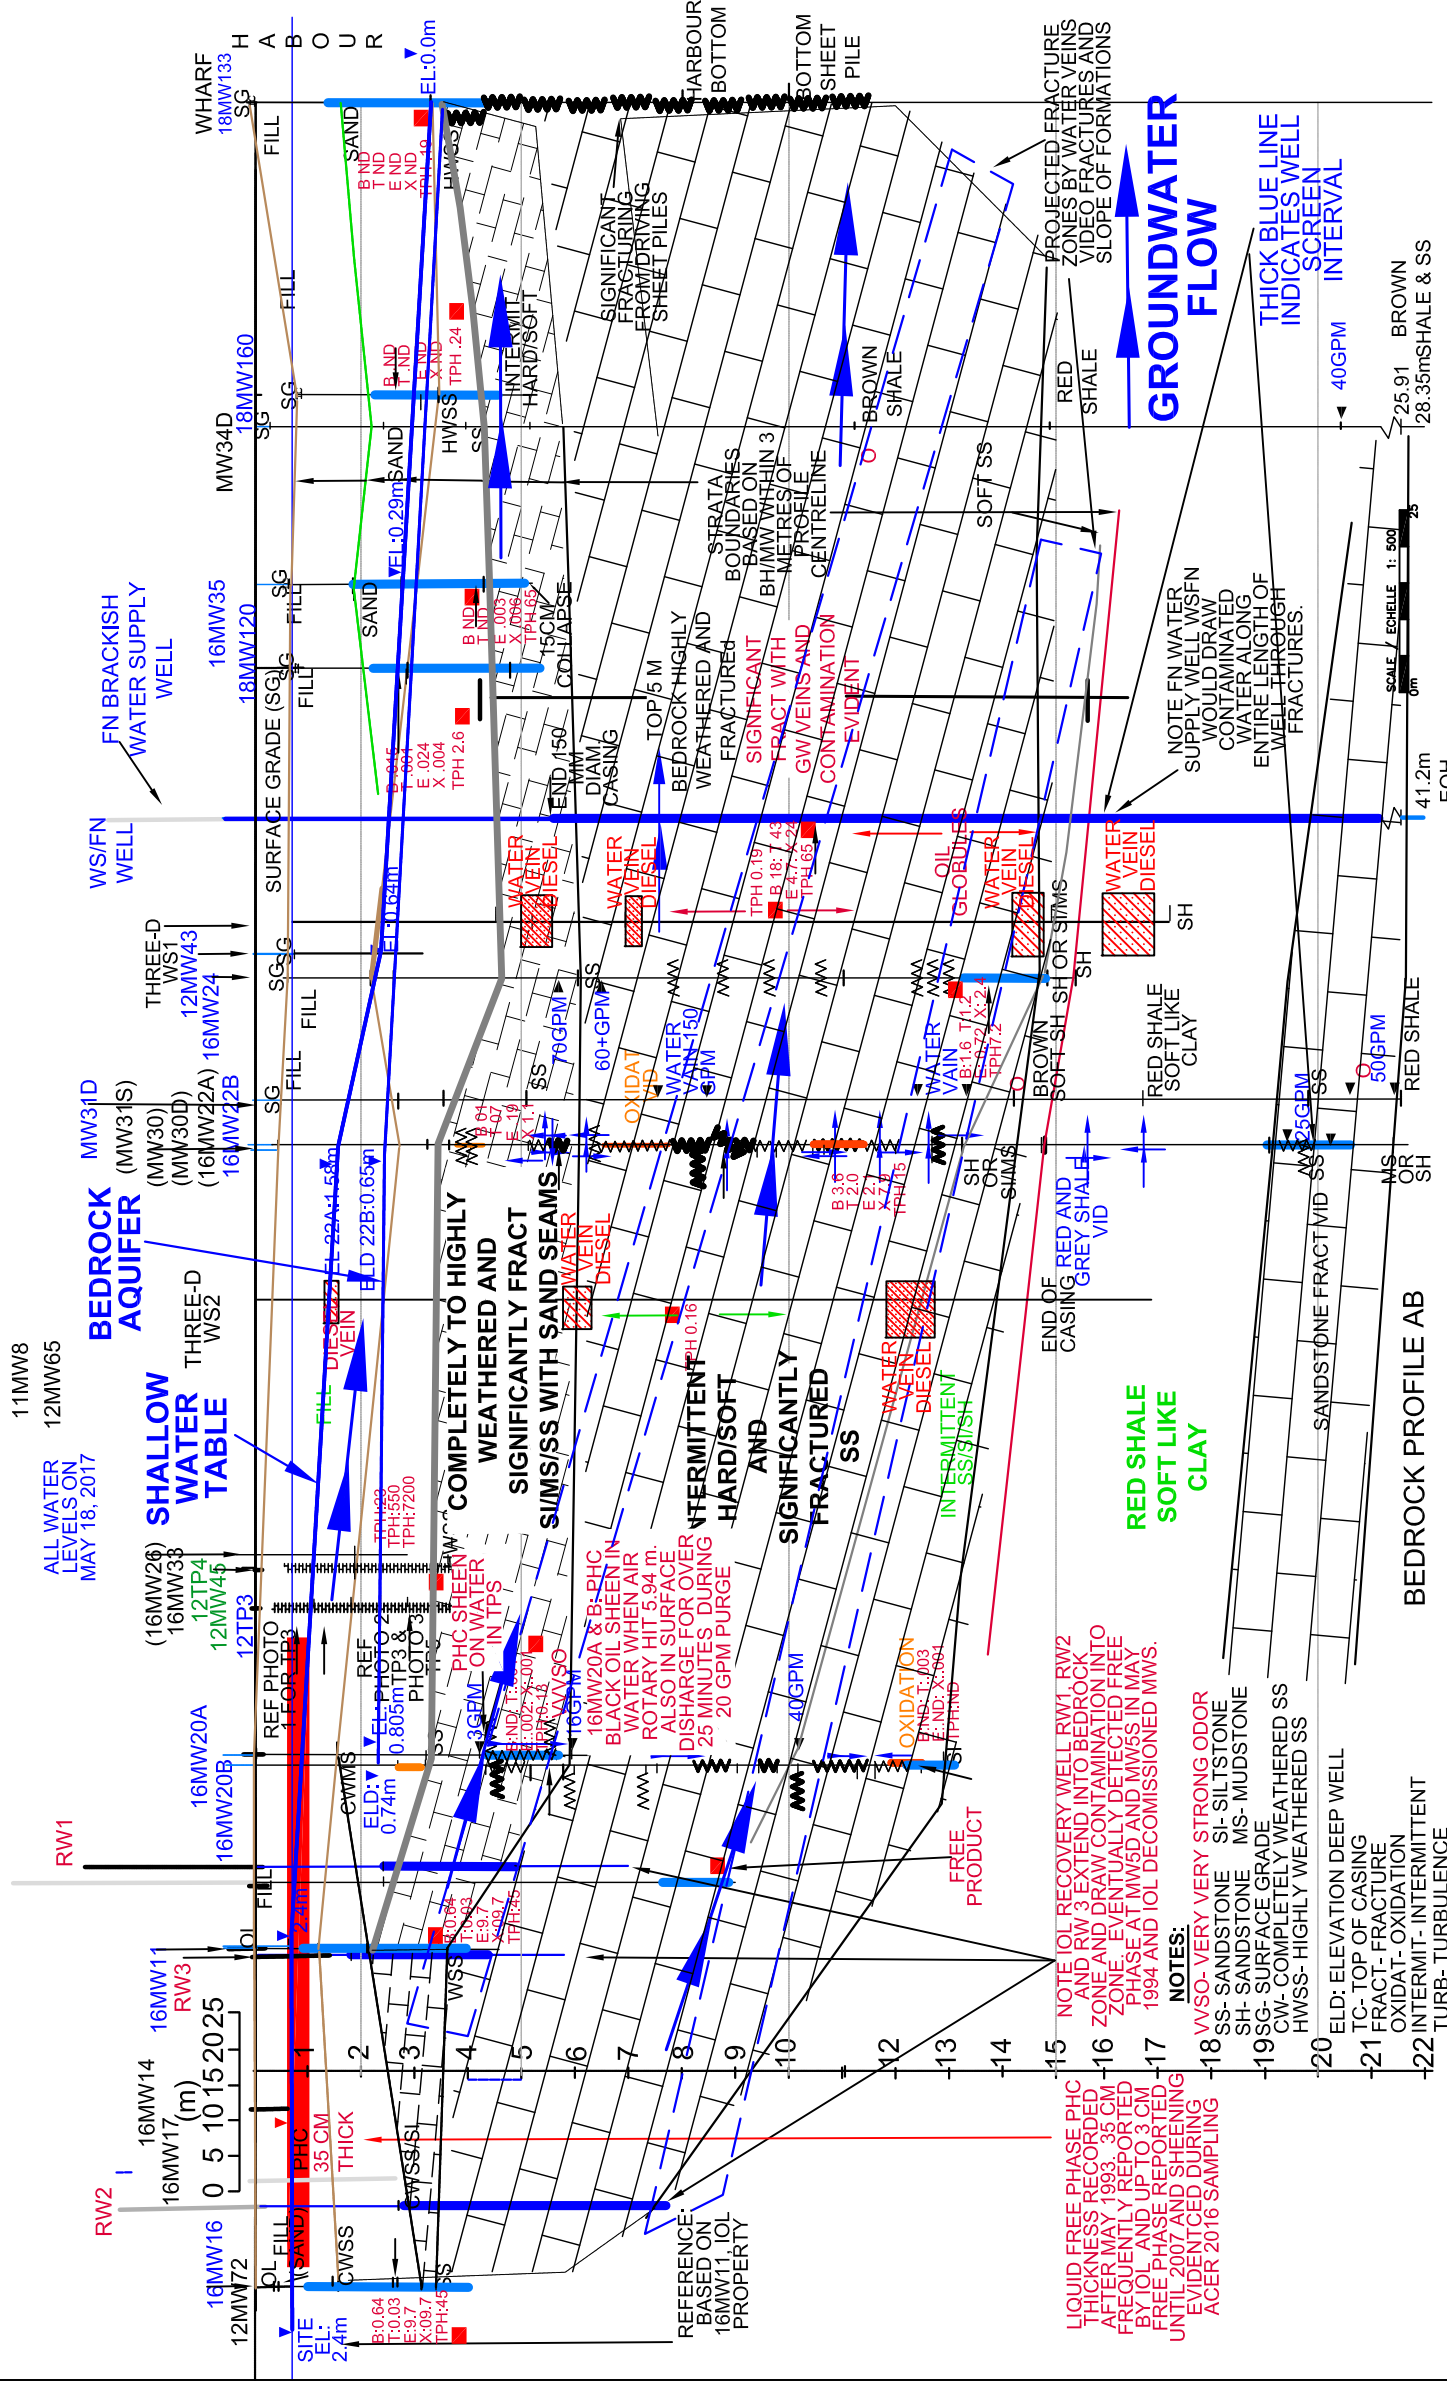
FIGURE 3-3  
 BEDROCK FRACTURE ZONES AND  
 GROUNDWATER LEVELS & FLOW FOR MID TIDE  
 EVENT AND GROUNDWATER CONTAMINATION

LIQUID FREE PHASE PHC THICKNESS RECORDED AT 1009.35 CM FREQUENTLY REPORTED BY IOL AND UP TO 3 CM FREE PHASE REPORTED UNTIL 2007 AND SHEENING EVIDENT DURING ACER 2016 SAMPLING

NOTE: IOL RECOVERY WELL RW1, RW2 AND RW 3 EXTEND INTO BEDROCK ZONE AND DRAW CONTAMINATION INTO ZONE. EVENTUALLY DETECTED FREE PHASE AT MW55 AND MW55 IN MAY 1994 AND IOL DECOMMISSIONED MW5.

The potentiometric water level for the shallow water table and bedrock aquifer is shown on Figures 3-3 and 3-4. With respect to the deeper groundwater aquifer(s), water veins were identified at depths of 19 and 21 metres

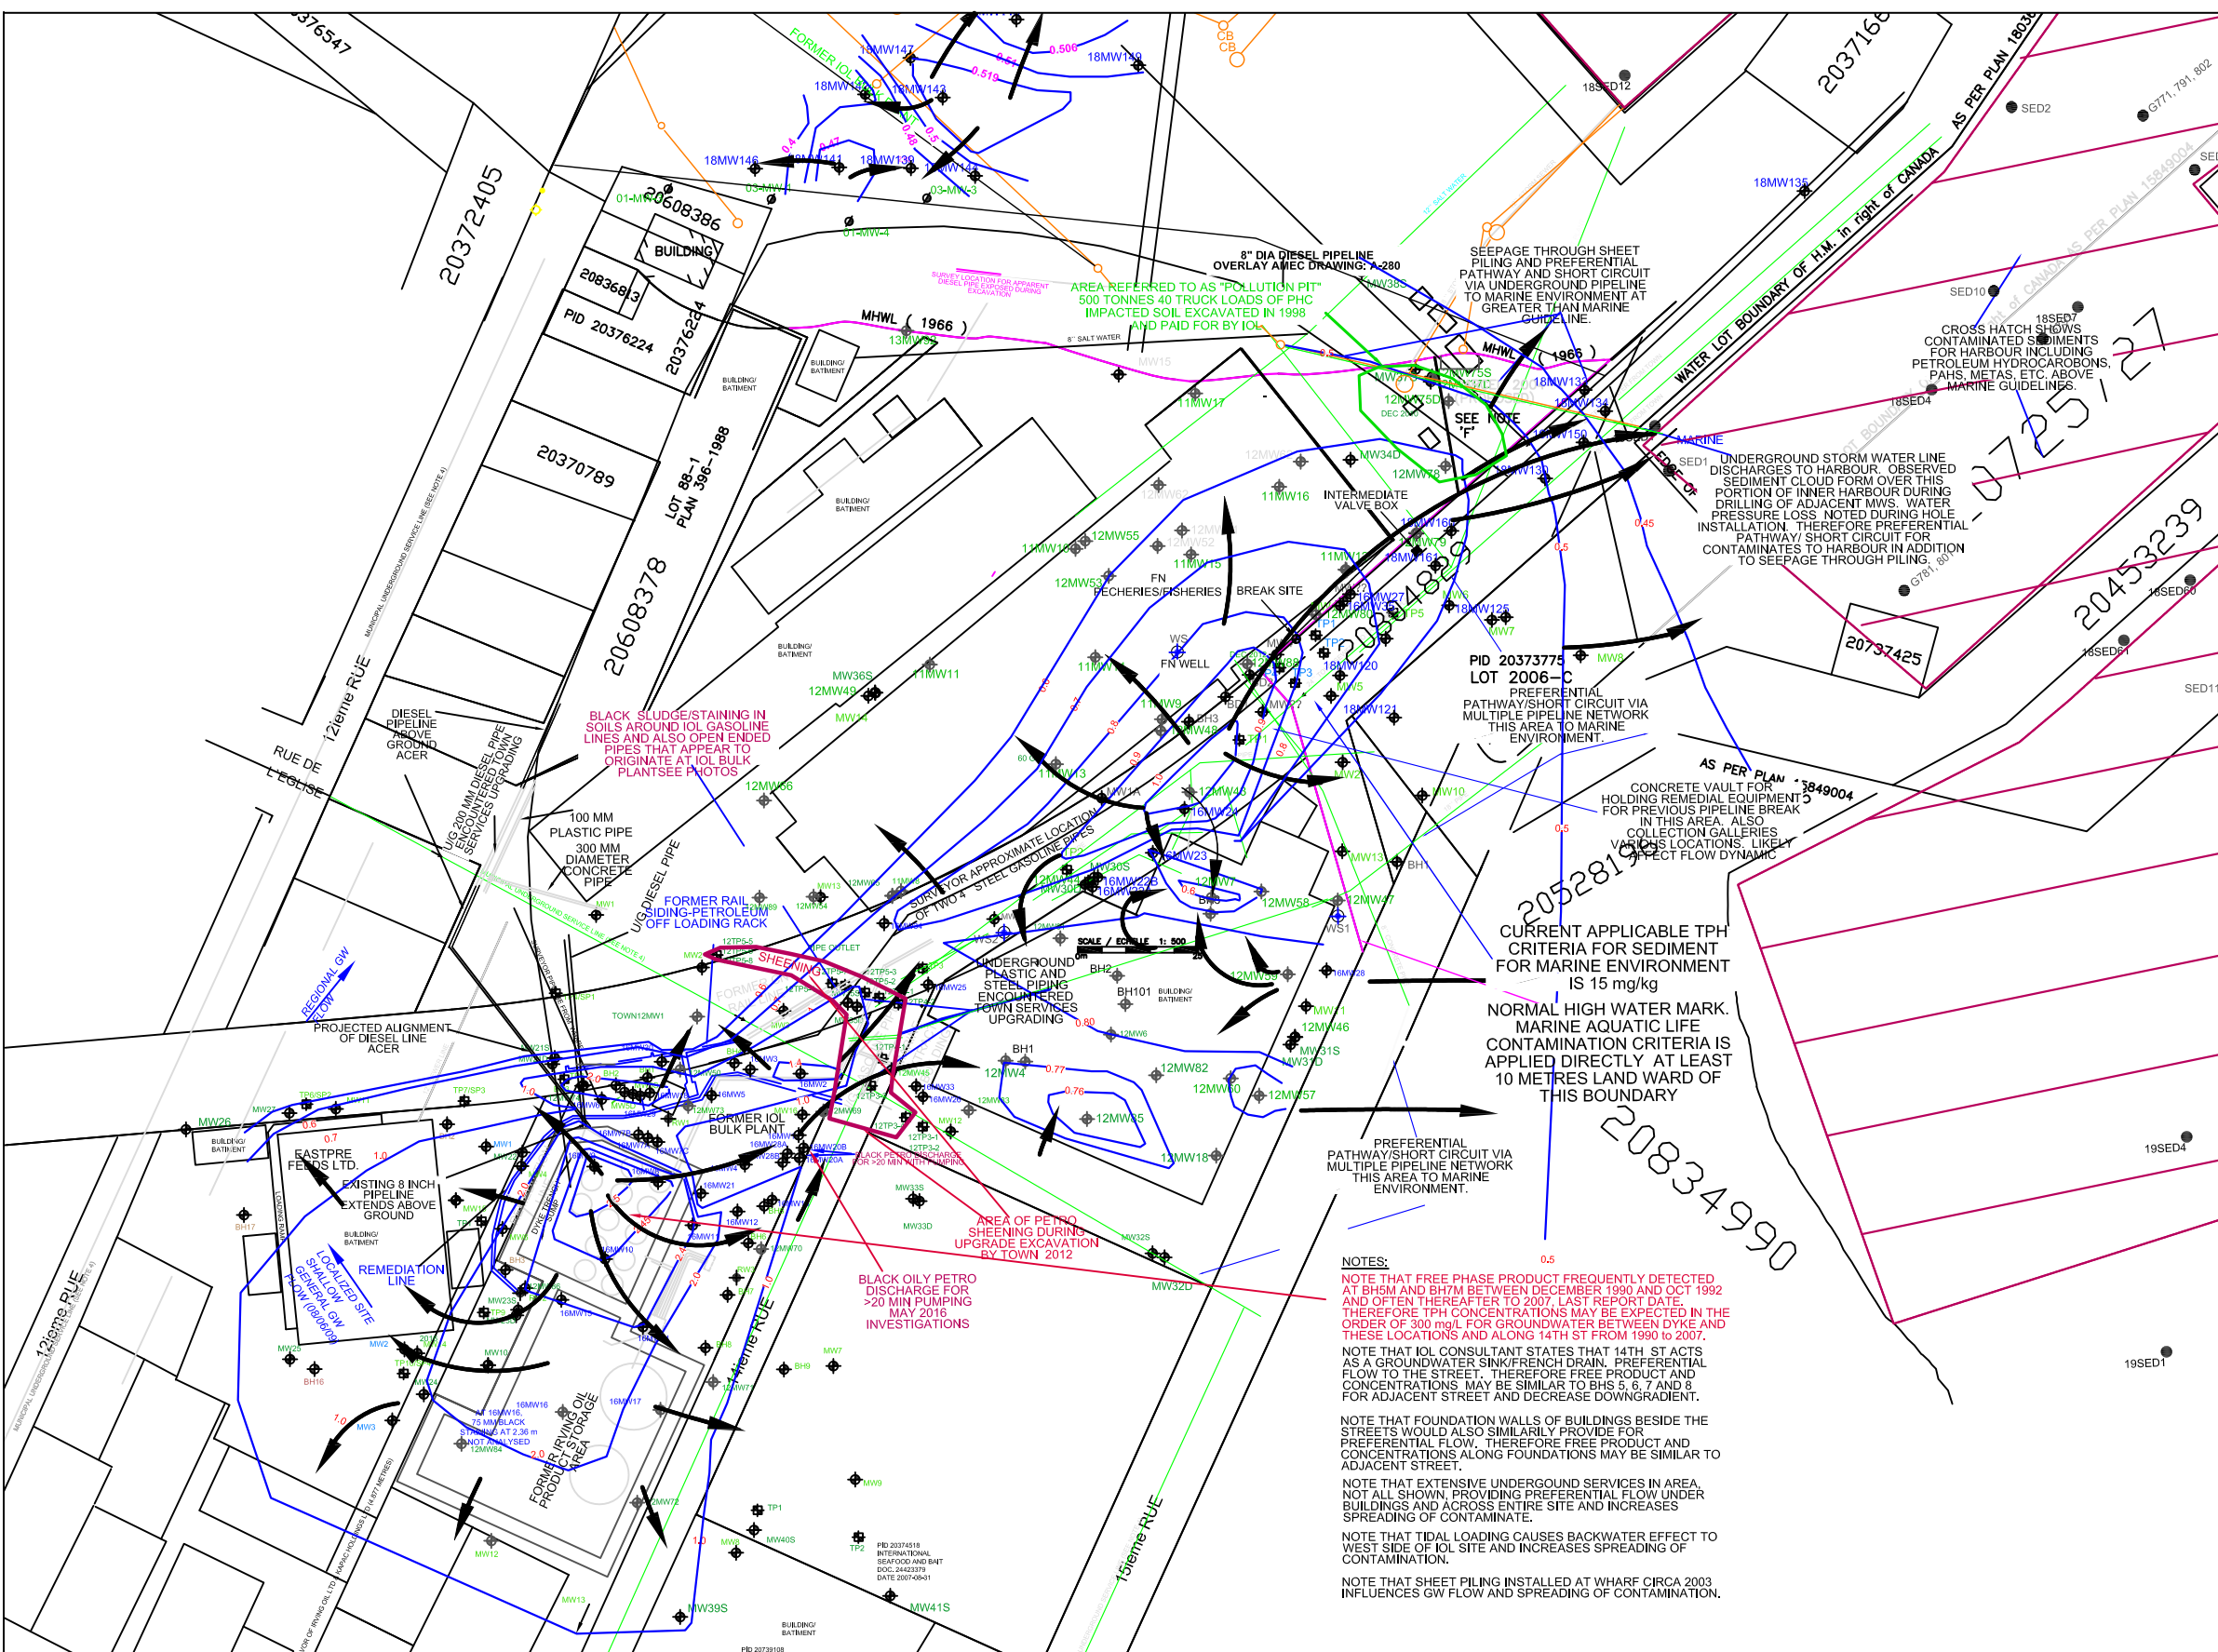
FIGURE 3-4

For this event the flow contours show flow occurring from the IOL bulk plant property toward 14<sup>th</sup> St. and continuing into the driveway area between the FN and MEL properties and former CN ROW. Flow also occurs along the driveway between the FN and MEL properties that is in a landward direction from the DFO and FN property boundary that also splits north and south onto the FN and MEL properties, respectively.

1. As indicated above, extensive spreading of contamination has occurred due to a number of factors as detailed in Section 4.2. Groundwater flow conditions for ACER 2016 are shown in Figure 3-4 (also in Appendix 73) for a monitoring event on May 18, 2017 for a mid-level tide event. Flow behaviour showed similarities to previous IOL consultant reporting. Flow directions shown in ACER Figure 3-4 are similar to that shown on the IOL consultant groundwater flow drawing provided in Figure 1-9 (also in Appendix 24) for May 1999, that shows preferential flow originating from the area of the IOL bulk plant and former CN Rail tanker car offloading facilities along the former CN ROW containing multiple underground services including the **two IOL underground gasoline transfer lines (reported by an IOL consultant following pressure testing to be "suspected of having been leaking during their operating life" circa 1938)**, with flow splitting off in a northerly direction under the FN building and southerly direction under the MEL building.
