**PHASE II AND III  
ENVIRONMENTAL SITE ASSESSMENT  
AND REMEDIAL CONSIDERATIONS  
MARINE EXTRACT LIMITED  
PECHERIES FN FISHERIES LTEE  
EASTPRE FEEDS LTD.  
SHIPPAGAN, NB**

**For  
MARINE EXTRACT LTD  
PECHERIES FN FISHERIES LTEE/LTD  
EASTPRE FEEDS LTD.  
FINAL REPORT  
DATE: MARCH 6, 2020**

Date: March 6, 2020  
File: CBT 60-1

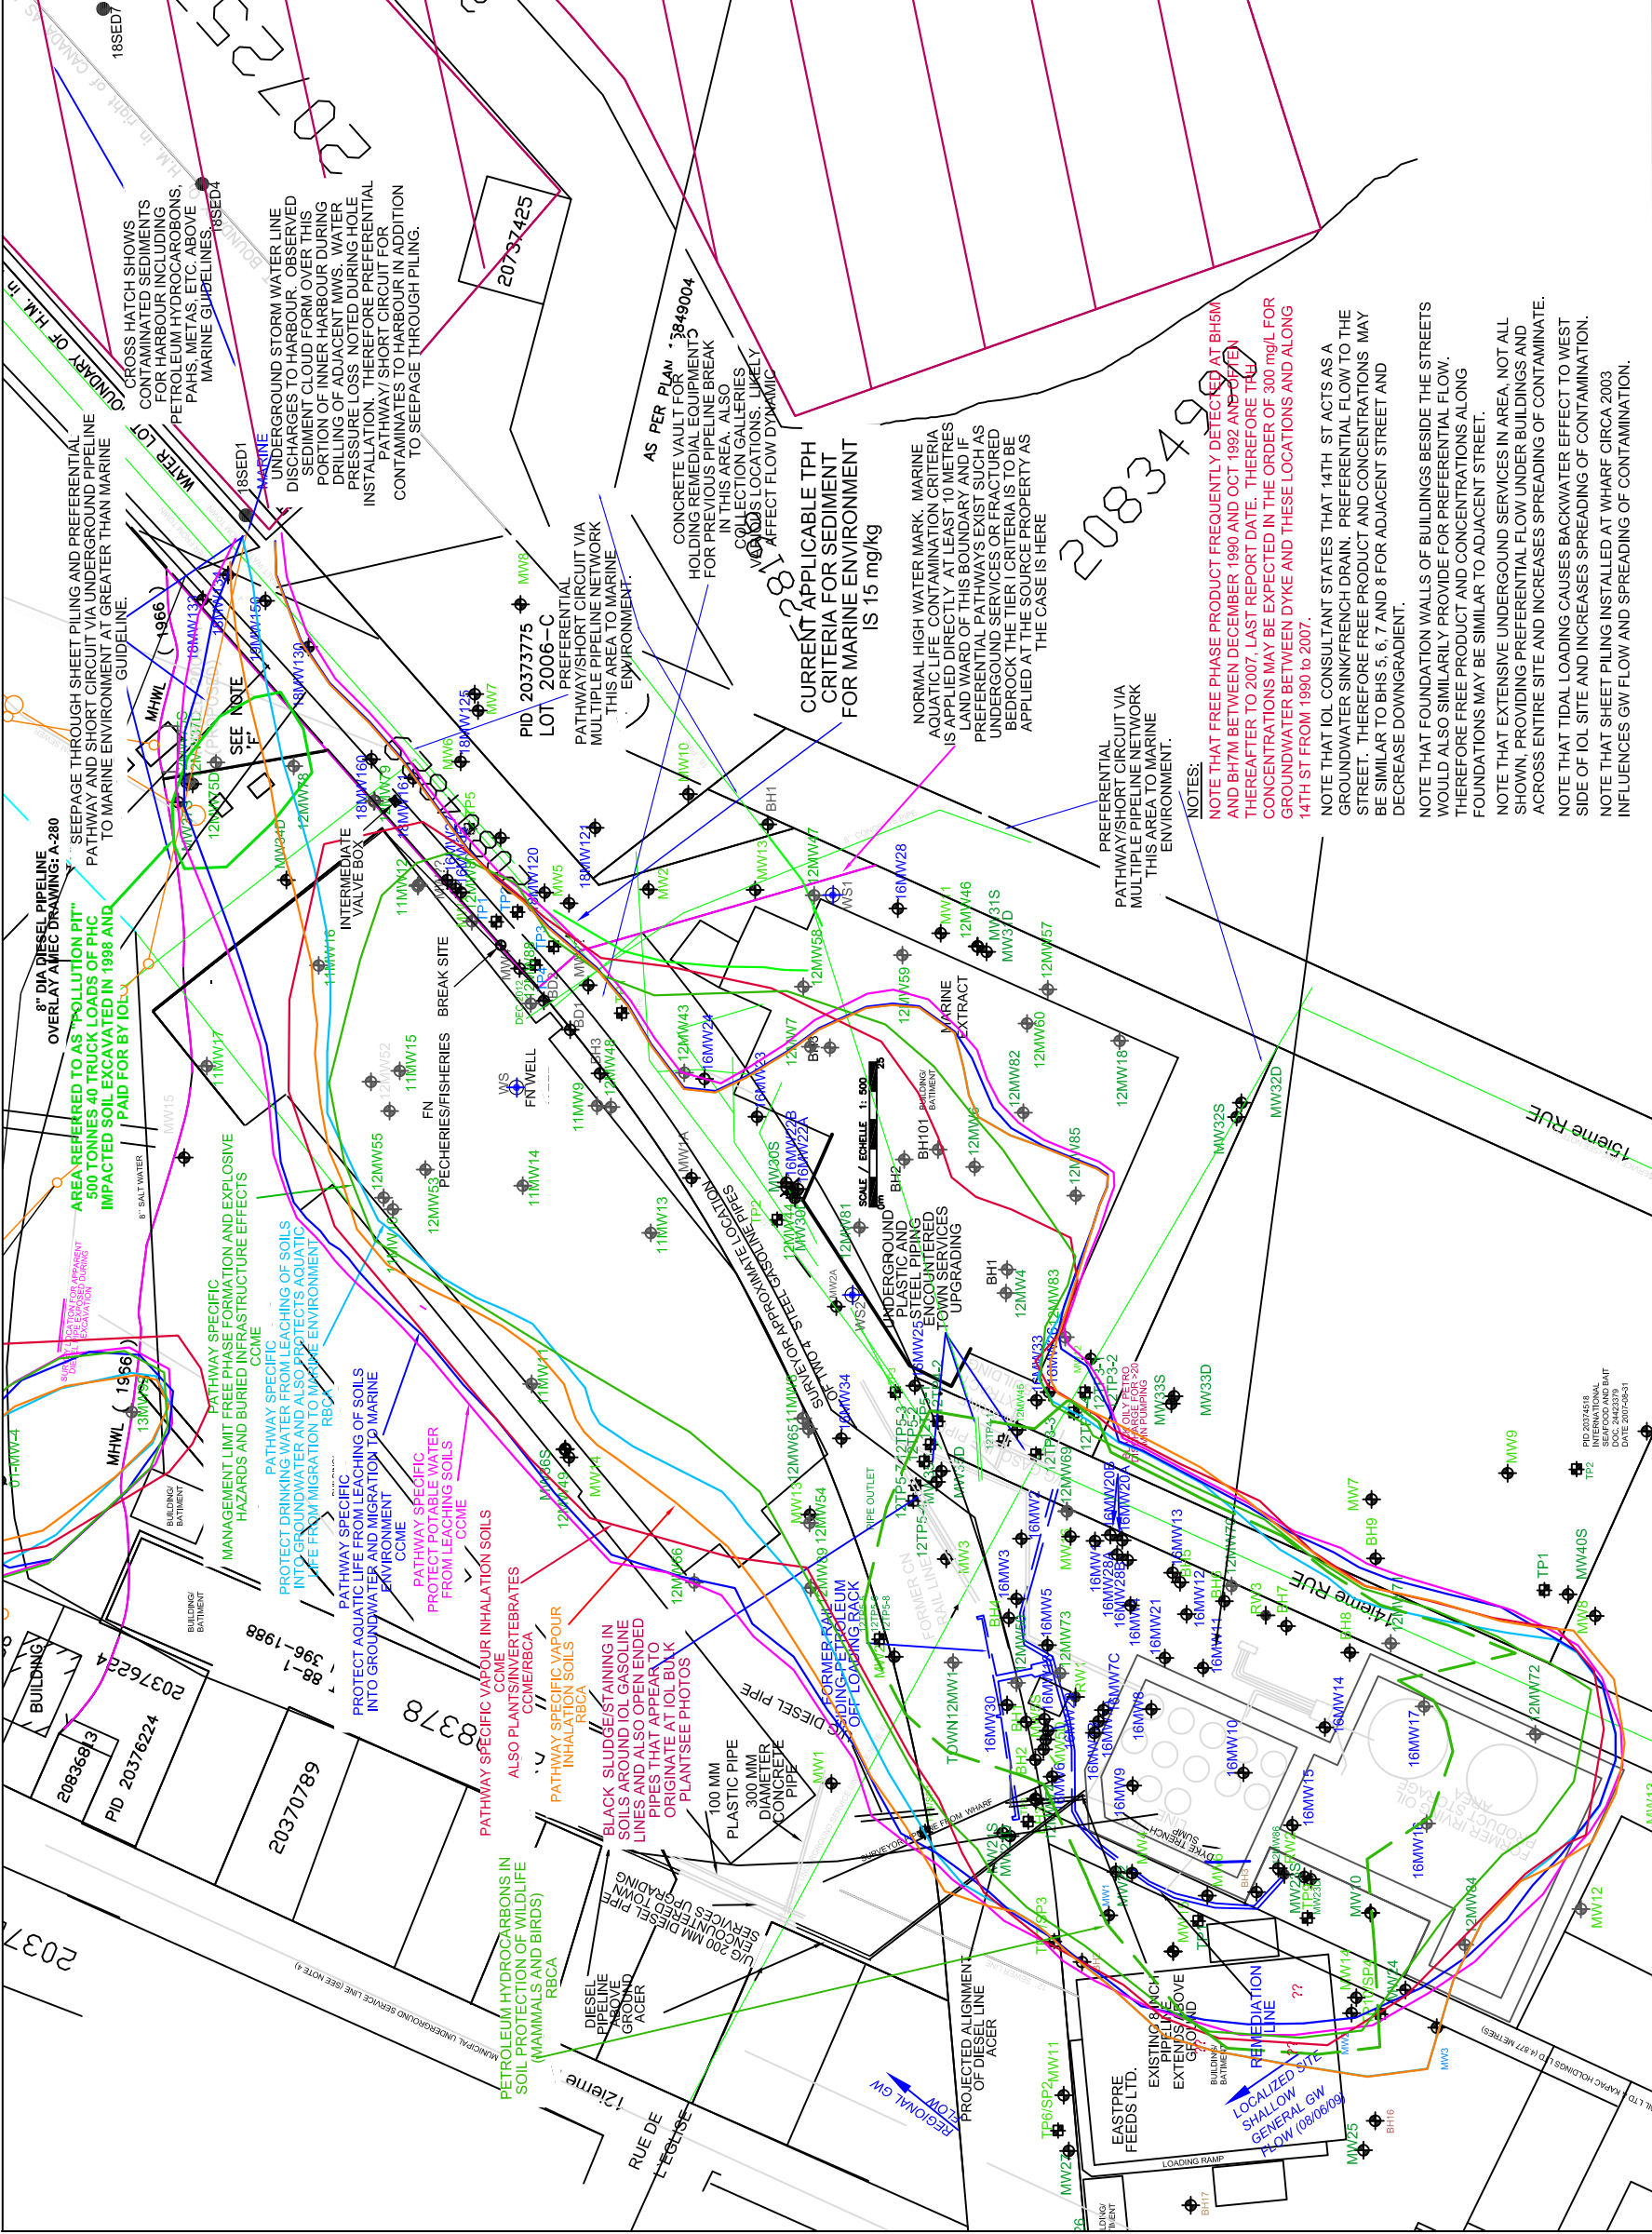
The laboratory certificates of analysis are contained in Appendix 74. The analysis results for the sampling programs carried out between 2009 and 2019 are provided in Tables 1 to 11 in Appendix 75. The footprints showing the extent of contamination are shown in Figure 3-5 (also contained in Appendix 76) for risks to human health and the marine environment. Analysis results for soils show petroleum hydrocarbon **concentrations exceeded RBCA commercial and industrial criteria with Potable Water Use** in consideration of human health, with inhalation of petroleum vapours for indoor air and leaching of petroleum hydrocarbons from soils to groundwater aquifers used for water supplies including the brackish saltwater aquifer used by FN for food grade operations as well as wells used for production of ice for fishing operations, being the primary risk of concern. This is applicable for the MEL, FN, EFL and Town properties as well as the IOL bulk plant and underground gasoline transfer line and SCH/DFO properties. See Table 1 in Appendix 75 and Figure 3-5 (also contained in Appendix 76).

The extent of contamination identified by ACER based on information collected to 2019 for soil and groundwater respectively, shown in Figures 3-5 and 3-6, also in Appendix 76 is similar to what is shown in previous environmental reports prepared by Three-D GeoConsultants Ltd. (Document A-281 a in Appendix 4), shown in ACER Figure 1-3 and Figure 1-4, for soil and groundwater contamination, respectively. The Three-D GeoConsultants Ltd. report included findings from the 1998 investigations of the nearby Department of Natural Resources and Energy (DNRE) and Small Craft Harbours (SCH) properties that included the MEL and FN properties (ARC report as Document A-332 with AG-438 having better figures, referring to Figures 2 and 4 for soil and groundwater contamination, respectively, in Appendix 22, and Appendix 23),.

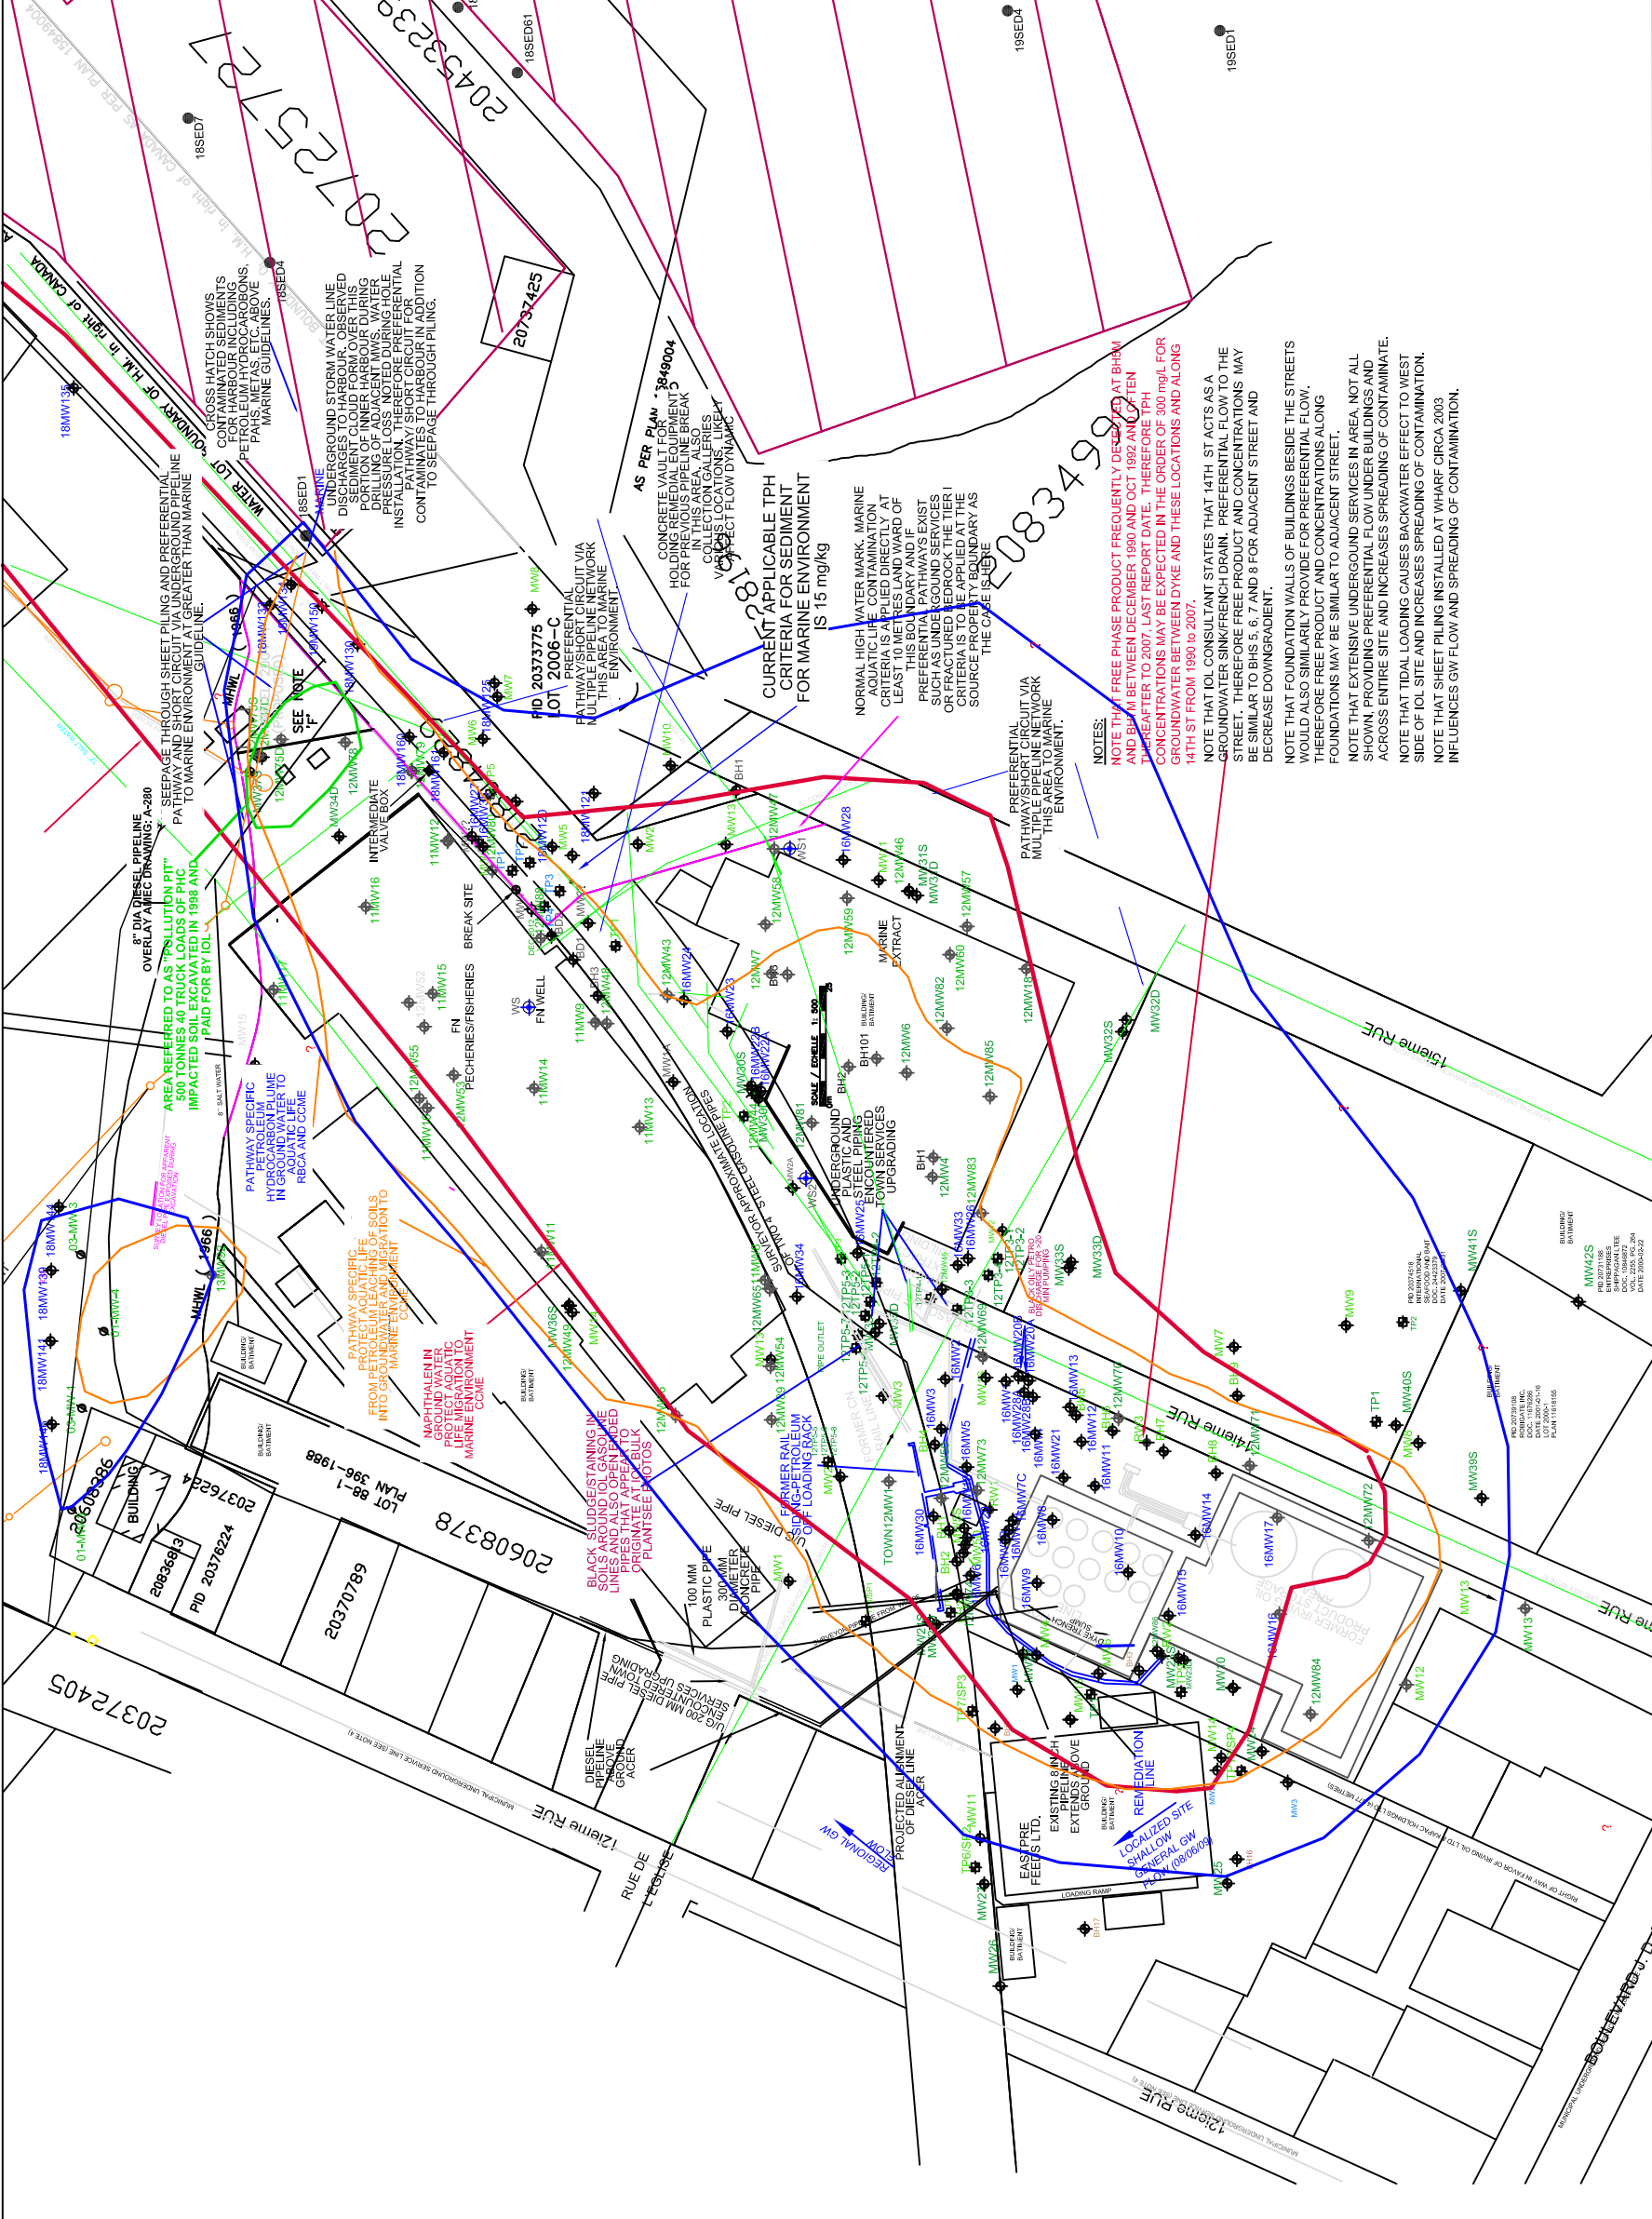
**Results for petroleum hydrocarbons analysis show that concentrations for Benzene, Toluene and Ethylbenzene were above the CCME guidelines for MAL in recognition of multiple preferential pathways applicable to the properties, MEL, FN, EFL and Town properties as well as the IOL bulk plant and underground gasoline transfer line and DFO properties in consideration of the groundwater to surface water pathway. See Table 16 in Appendix 77 and Figure 3-7 (also contained in Appendix 76).**

4. The extent/footprint of contamination identified by the IOL consultant for the EFL, FN, MEL, Town, SCH/DFO for soils and groundwater shown on Figures 1-6 and 1-7 (also contained in Appendix 24), is consistent with the current ACER investigations as shown in Figure 3-5 for soils and Figure 3-7 for groundwater and human health. The extent of contamination for the aquatic site specific pathway and preferential flow considerations identified by ACER is shown in Figure 3-7 (provided in Appendix 76). Concentrations are elevated along the preferential flow pathways as demonstrated by the contamination contours in Figures 4-1 and 4-2 for soil and groundwater (also provided in Appendix 97), respectively, and the IOL consultant Figures 1-6 and 1-7 for soil and groundwater, respectively (also contained in Appendix 24). Concentrations are generally expected to be higher for preferential flow pathways.

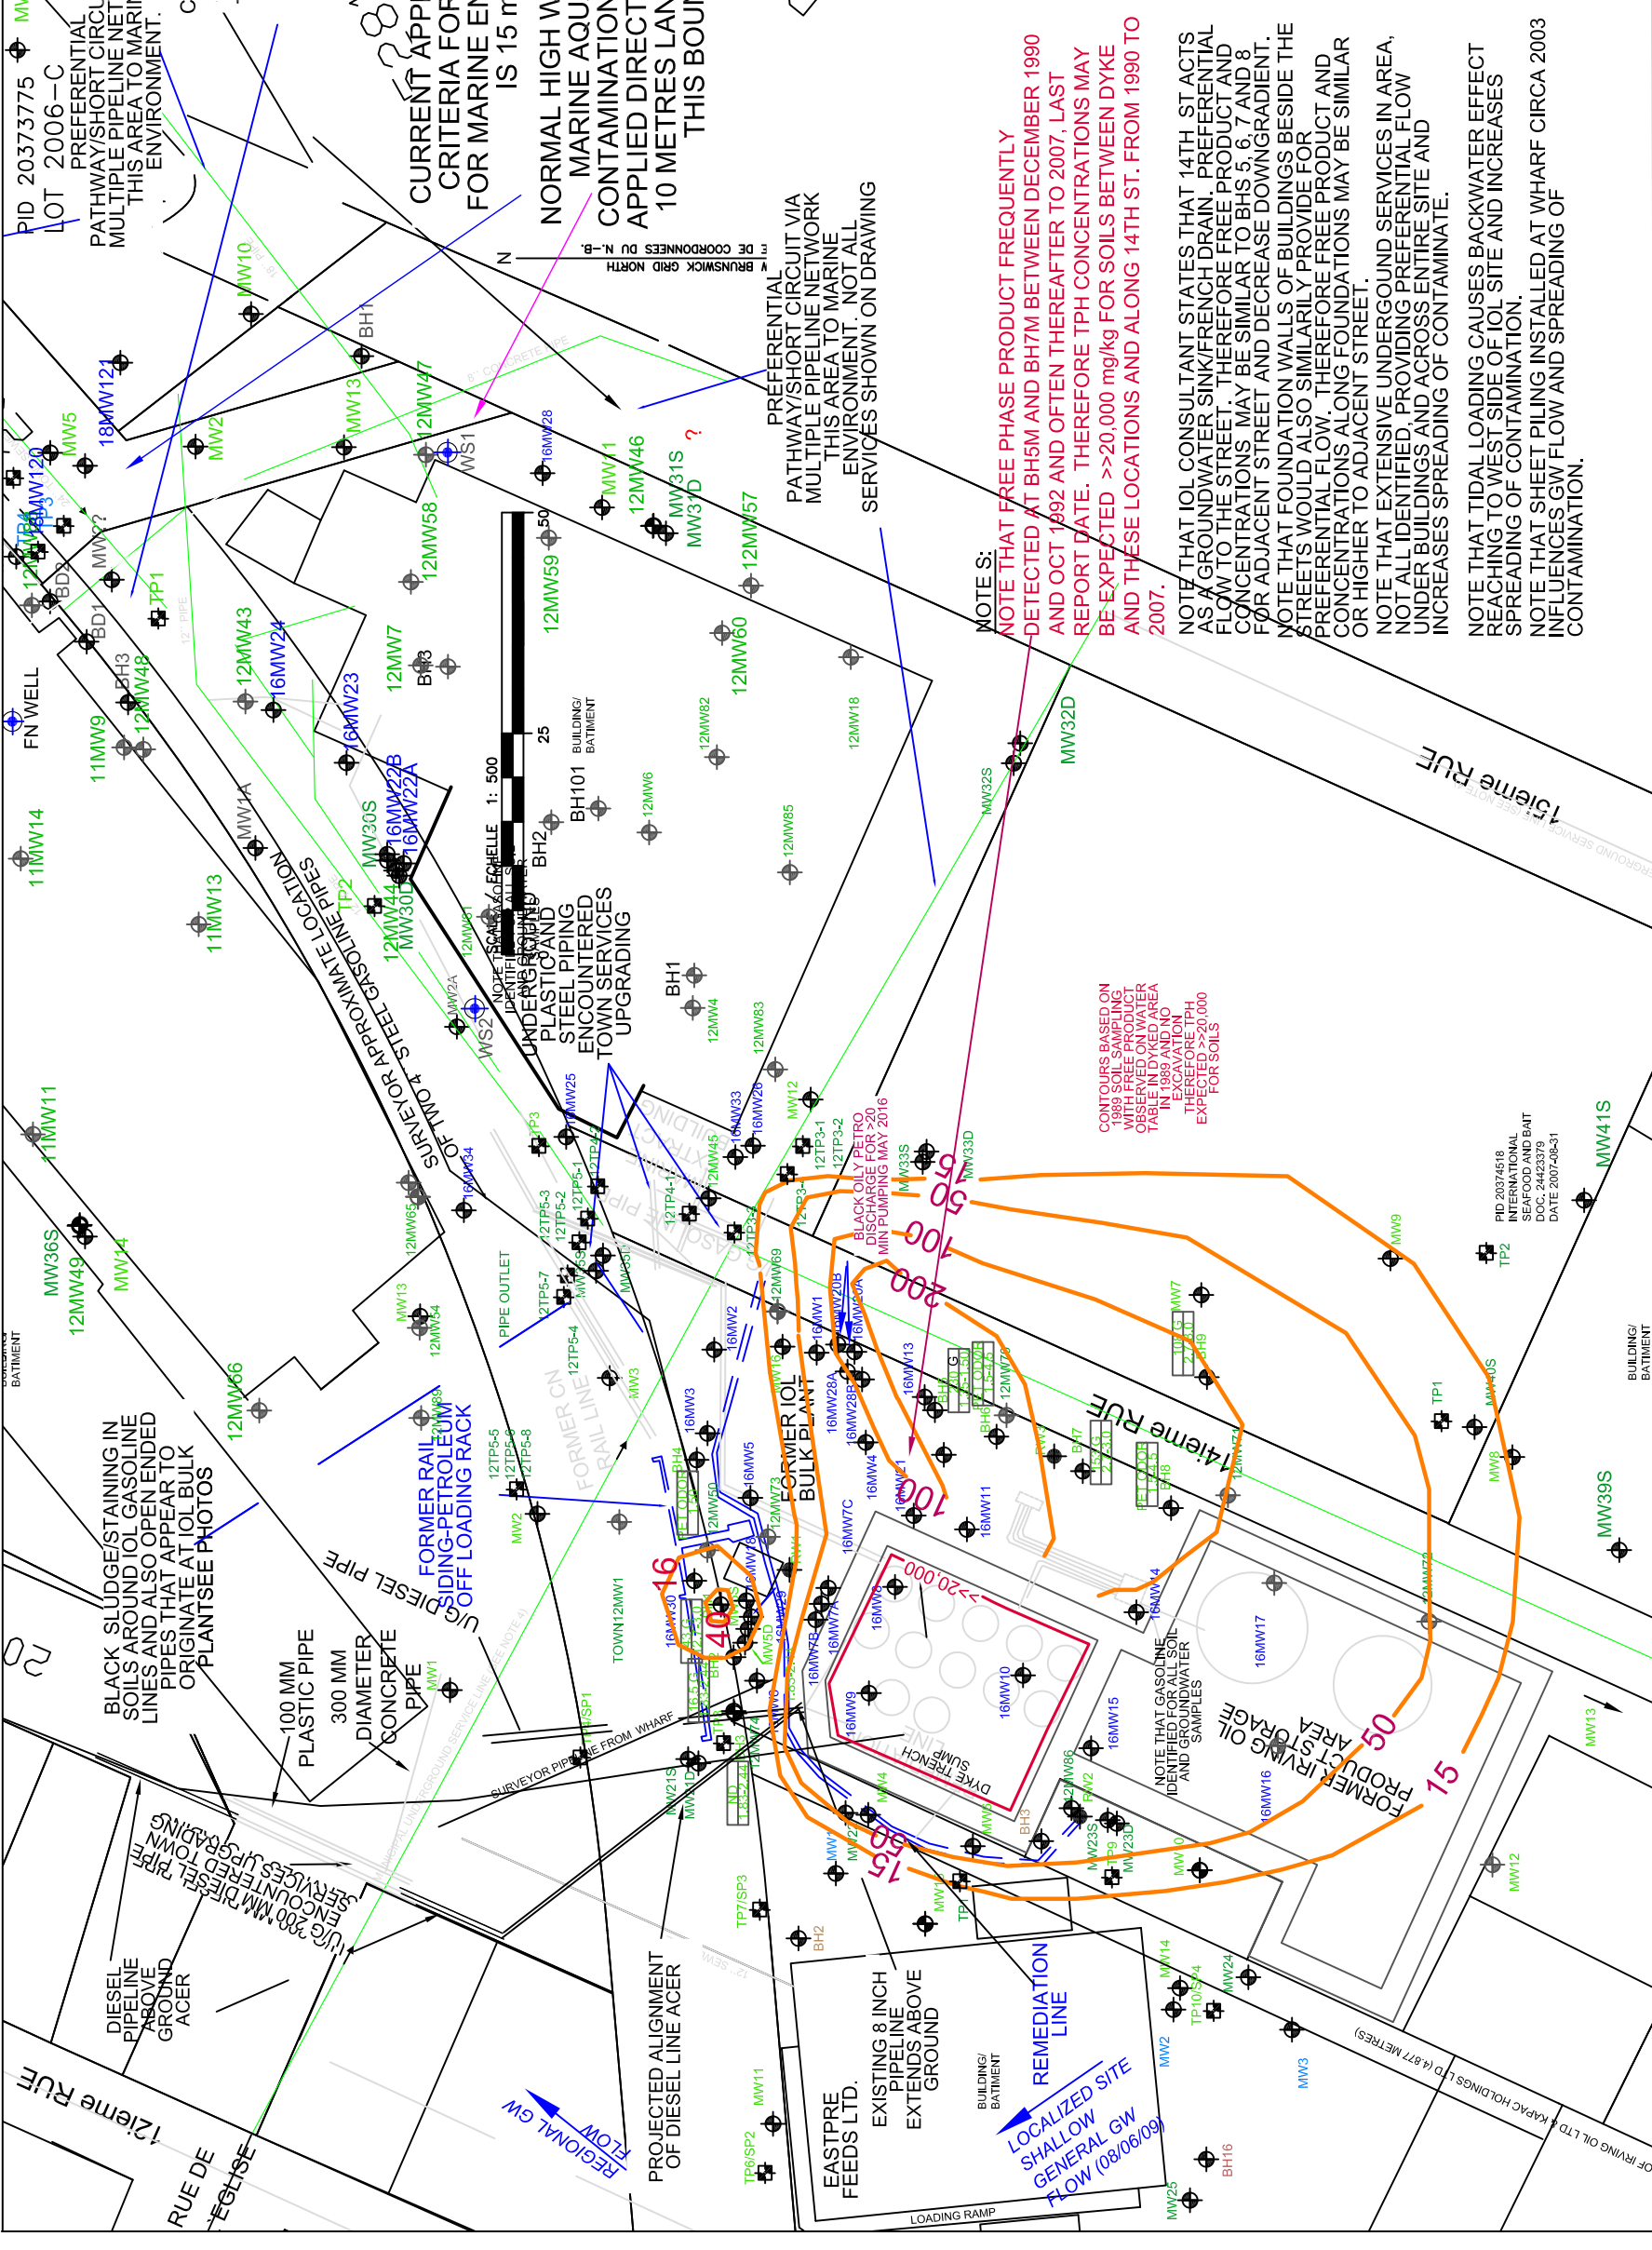
**FIGURE 4-3**  
**TPH CONTAMINATE CONTOURS FOR SOIL FOR IOL SITE NOVEMBER 1989**  
**ALSO SHOWN IN FIGURE 4-5 AS OVERLAY ON WMS DRAWING**

TPH concentration contours for soil and groundwater for the IOL bulk plant area in 1989 are shown in Figures 4-3 and 4-4, respectively, based on sampling data by the IOL consultant WMS (later became ARC) (A-450, in Appendix 101), following a spill of 3000 gallons of petroleum product. The concentration contours are also provided in Figures 4-5 and 4-6 as overlays on the original ARC drawing showing the footprint of contamination in the soil and groundwater, respectively. The basic premises noted in the introduction to Section 4.3 were applied for contouring purposes. The figures show conservative values of 100 mg/L for groundwater and 20,000 mg/kg for soils to reflect that concentrations inside the dike would be expected to be higher and visually demonstrates this to facilitate discussions.

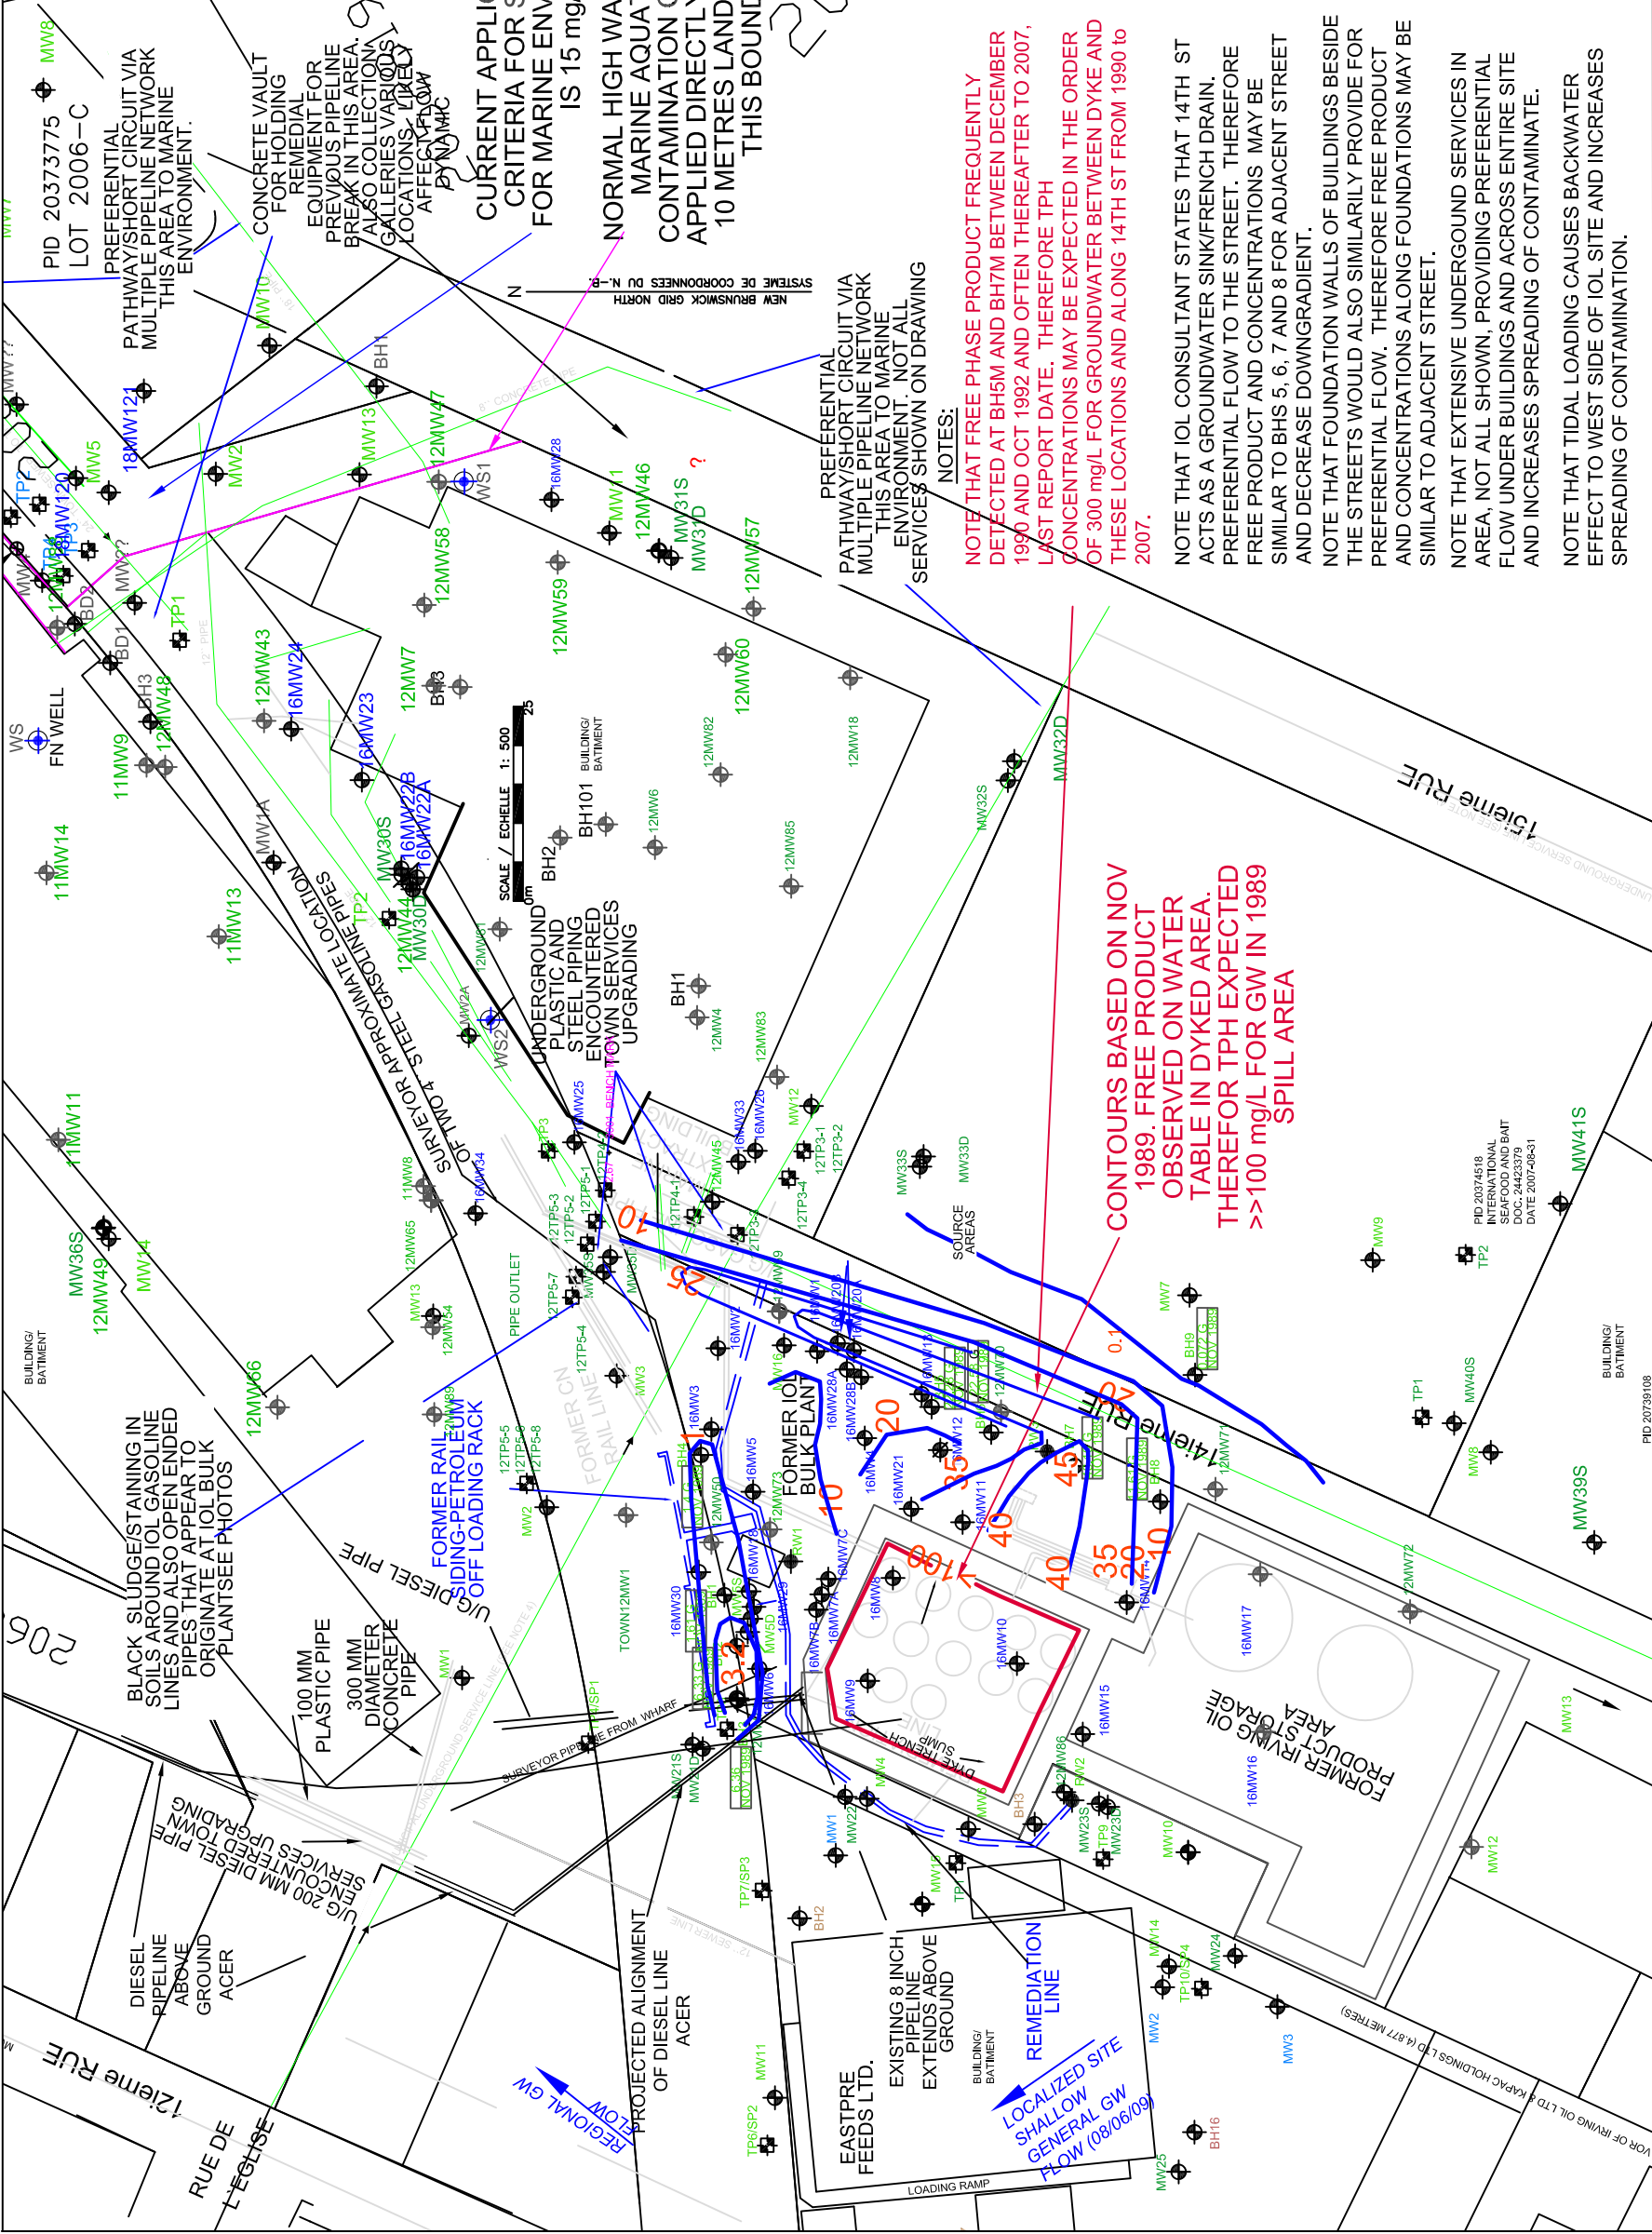
**FIGURE 4-4**

The contamination contours for soil and groundwater shown on the ARC 1989 site drawing, Figures 4-5 and 4-6, respectively, illustrates the IOL bulk plant site to be the source of contamination and also further emphasizes that contamination appears to have migrated off site and could also be indicative of historical spills having occurred to give this result and/or that the liner in the tank farm does not provide adequate containment.

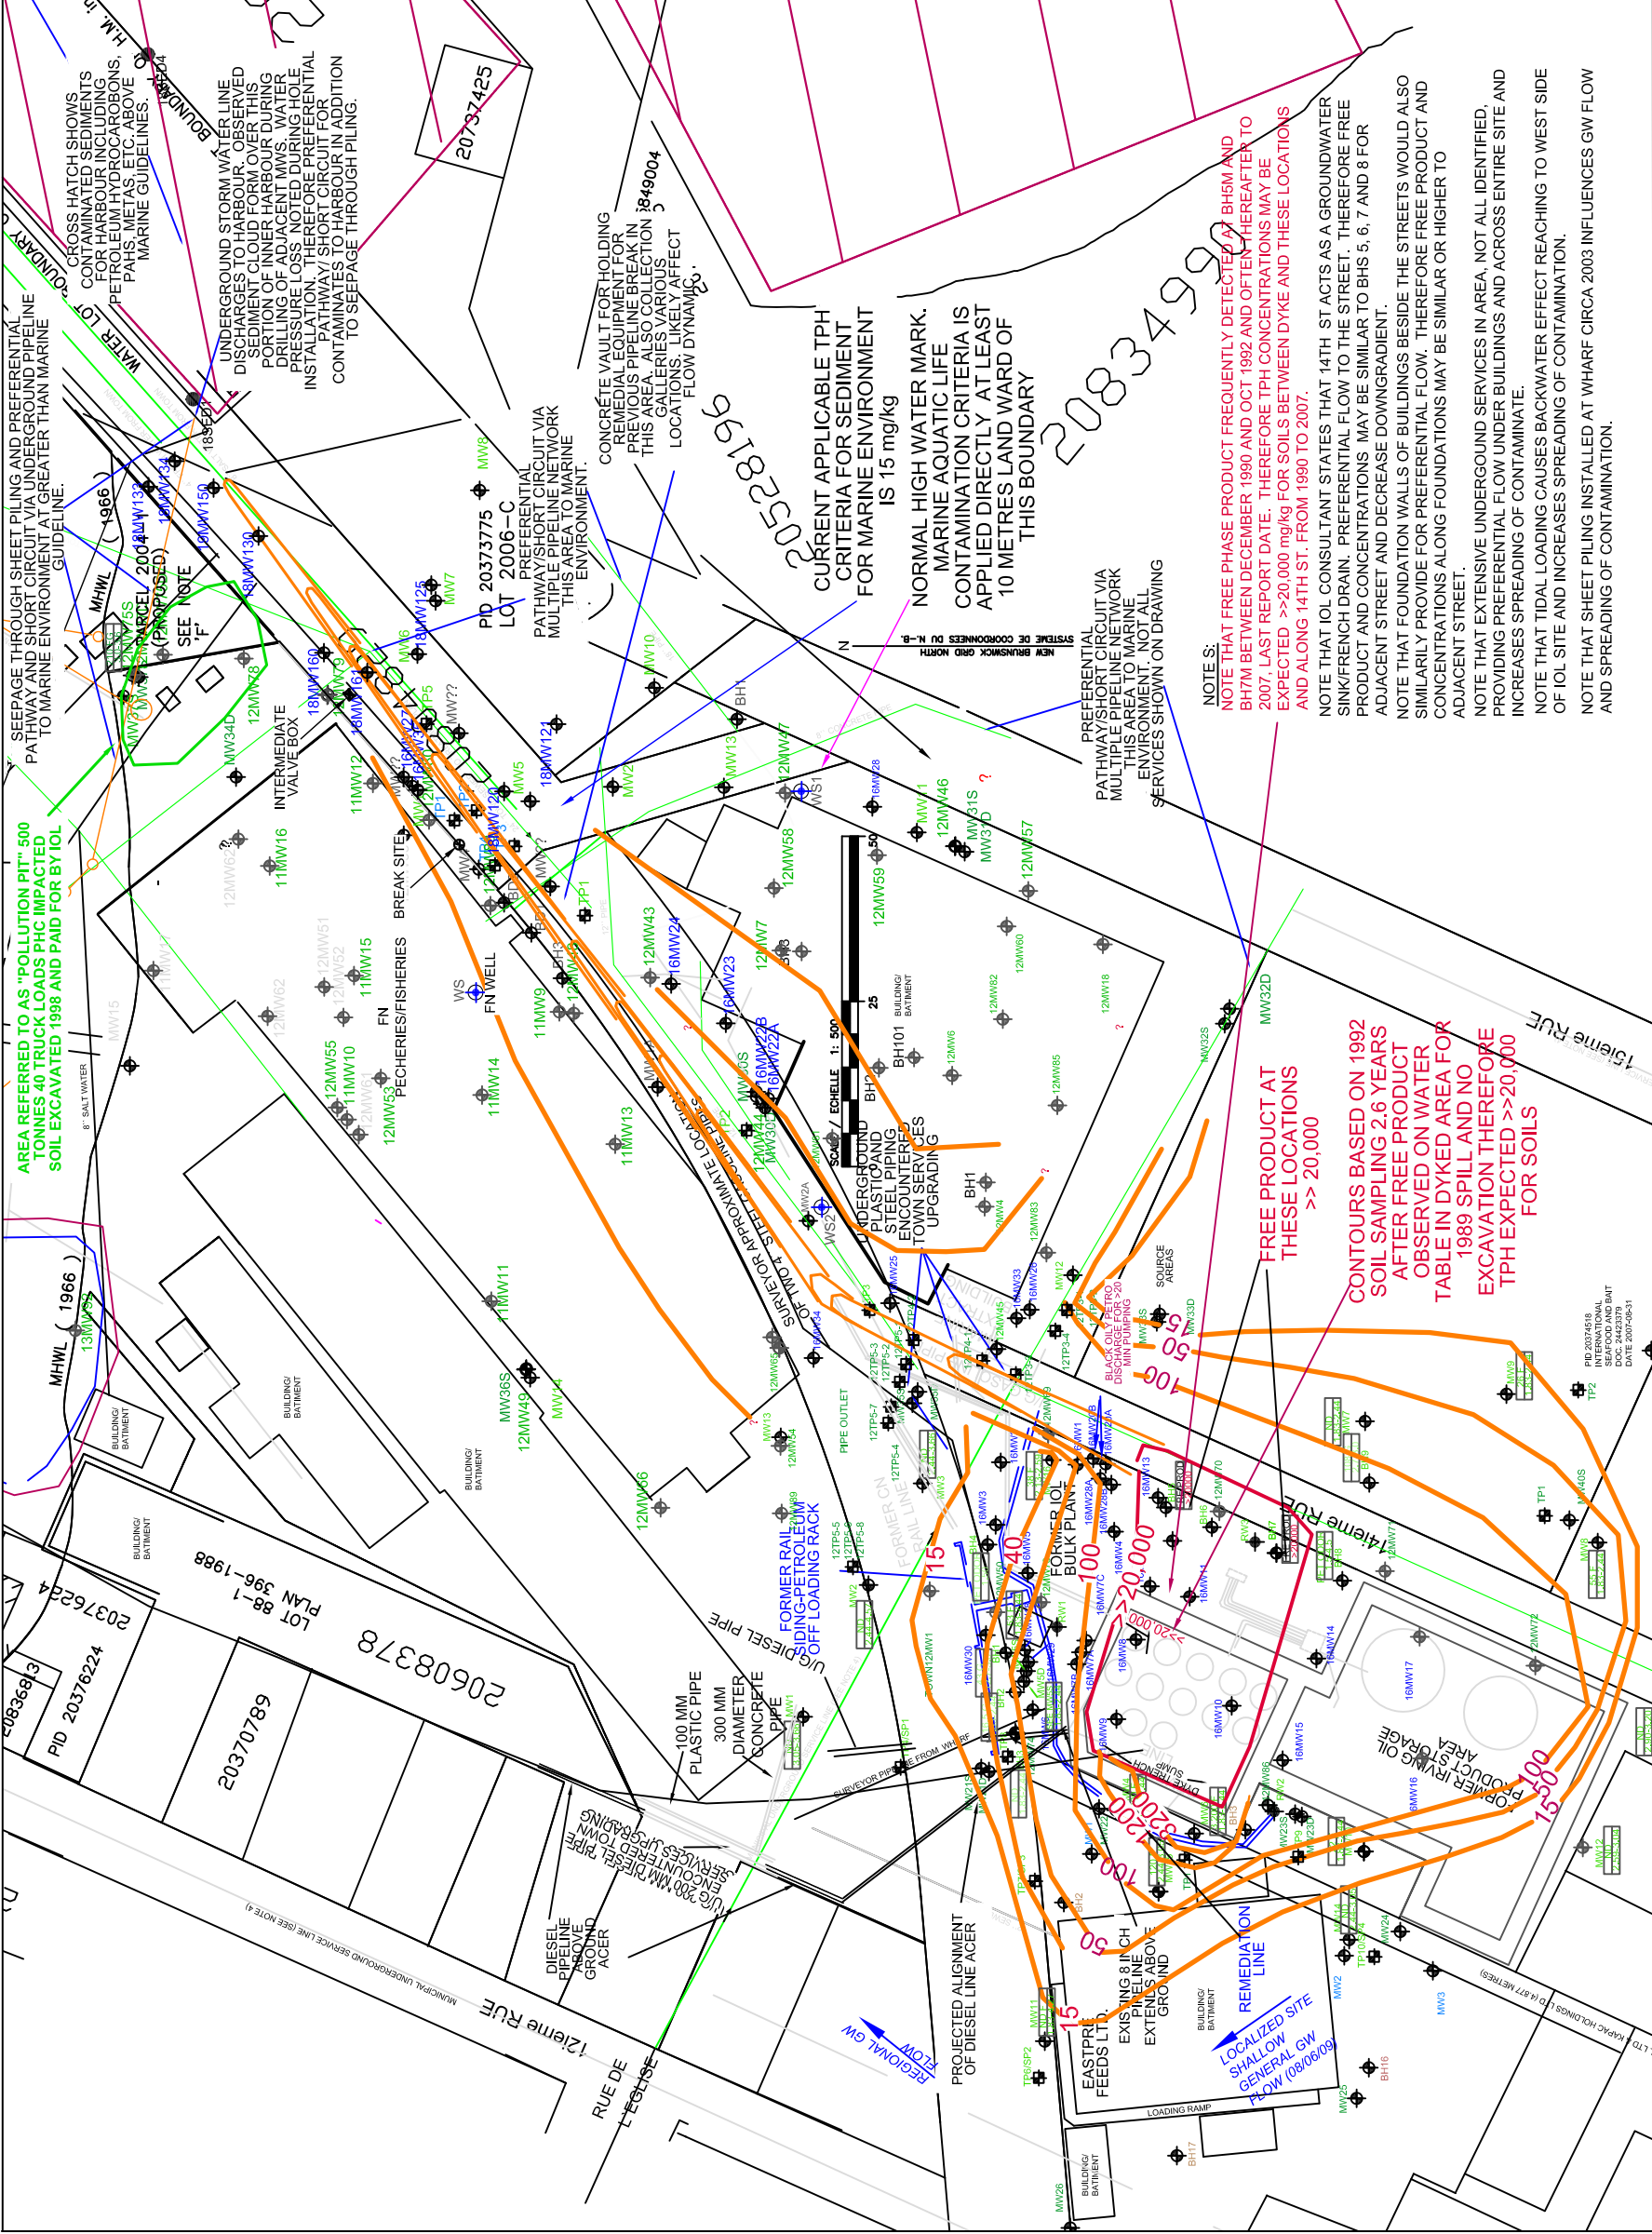
FILE NAME: Fig 4-7 1992 So Iso  
JOB NO.: CBI 60-1  
MADE: GP  
CHKD: GP  
DATE: Nov 15 2019

- footprints with elevated concentrations in the soil, indicative of sources of contamination, in 1992 includes the tank farm and the tanker truck unloading facility, similar to 1989, but with the tanker car unloading facility no longer appearing to show a definable pattern based on soils as previously evident.

- the additional intrusive sampling locations show a larger footprint, indicating significant migration of contamination has occurred.
- concentrations for TPH in soil are significantly higher for 1992, compared with locations previously sampled in 1989. Values indicating possible free product presence in the soil, being much greater than 20,000mg/kg, identified in the fuel oil and gasoline range compared with a maximum value of 230 mg/kg in the gasoline range in 1989. Concentrations for TPH in the groundwater indicating possible free product, greater than 300,000 mg/L, as fuel oil and gasoline. Values are significantly higher for 1992 compared with locations previously
