**PHASE II AND III  
ENVIRONMENTAL SITE ASSESSMENT  
AND REMEDIAL CONSIDERATIONS  
MARINE EXTRACT LIMITED  
PECHERIES FN FISHERIES LTEE  
EASTPRE FEEDS LTD.  
SHIPPAGAN, NB**

**For  
MARINE EXTRACT LTD  
PECHERIES FN FISHERIES LTEE/LTD  
EASTPRE FEEDS LTD.  
FINAL REPORT  
DATE: MARCH 6, 2020**

Date: March 6, 2020  
File: CBT 60-1

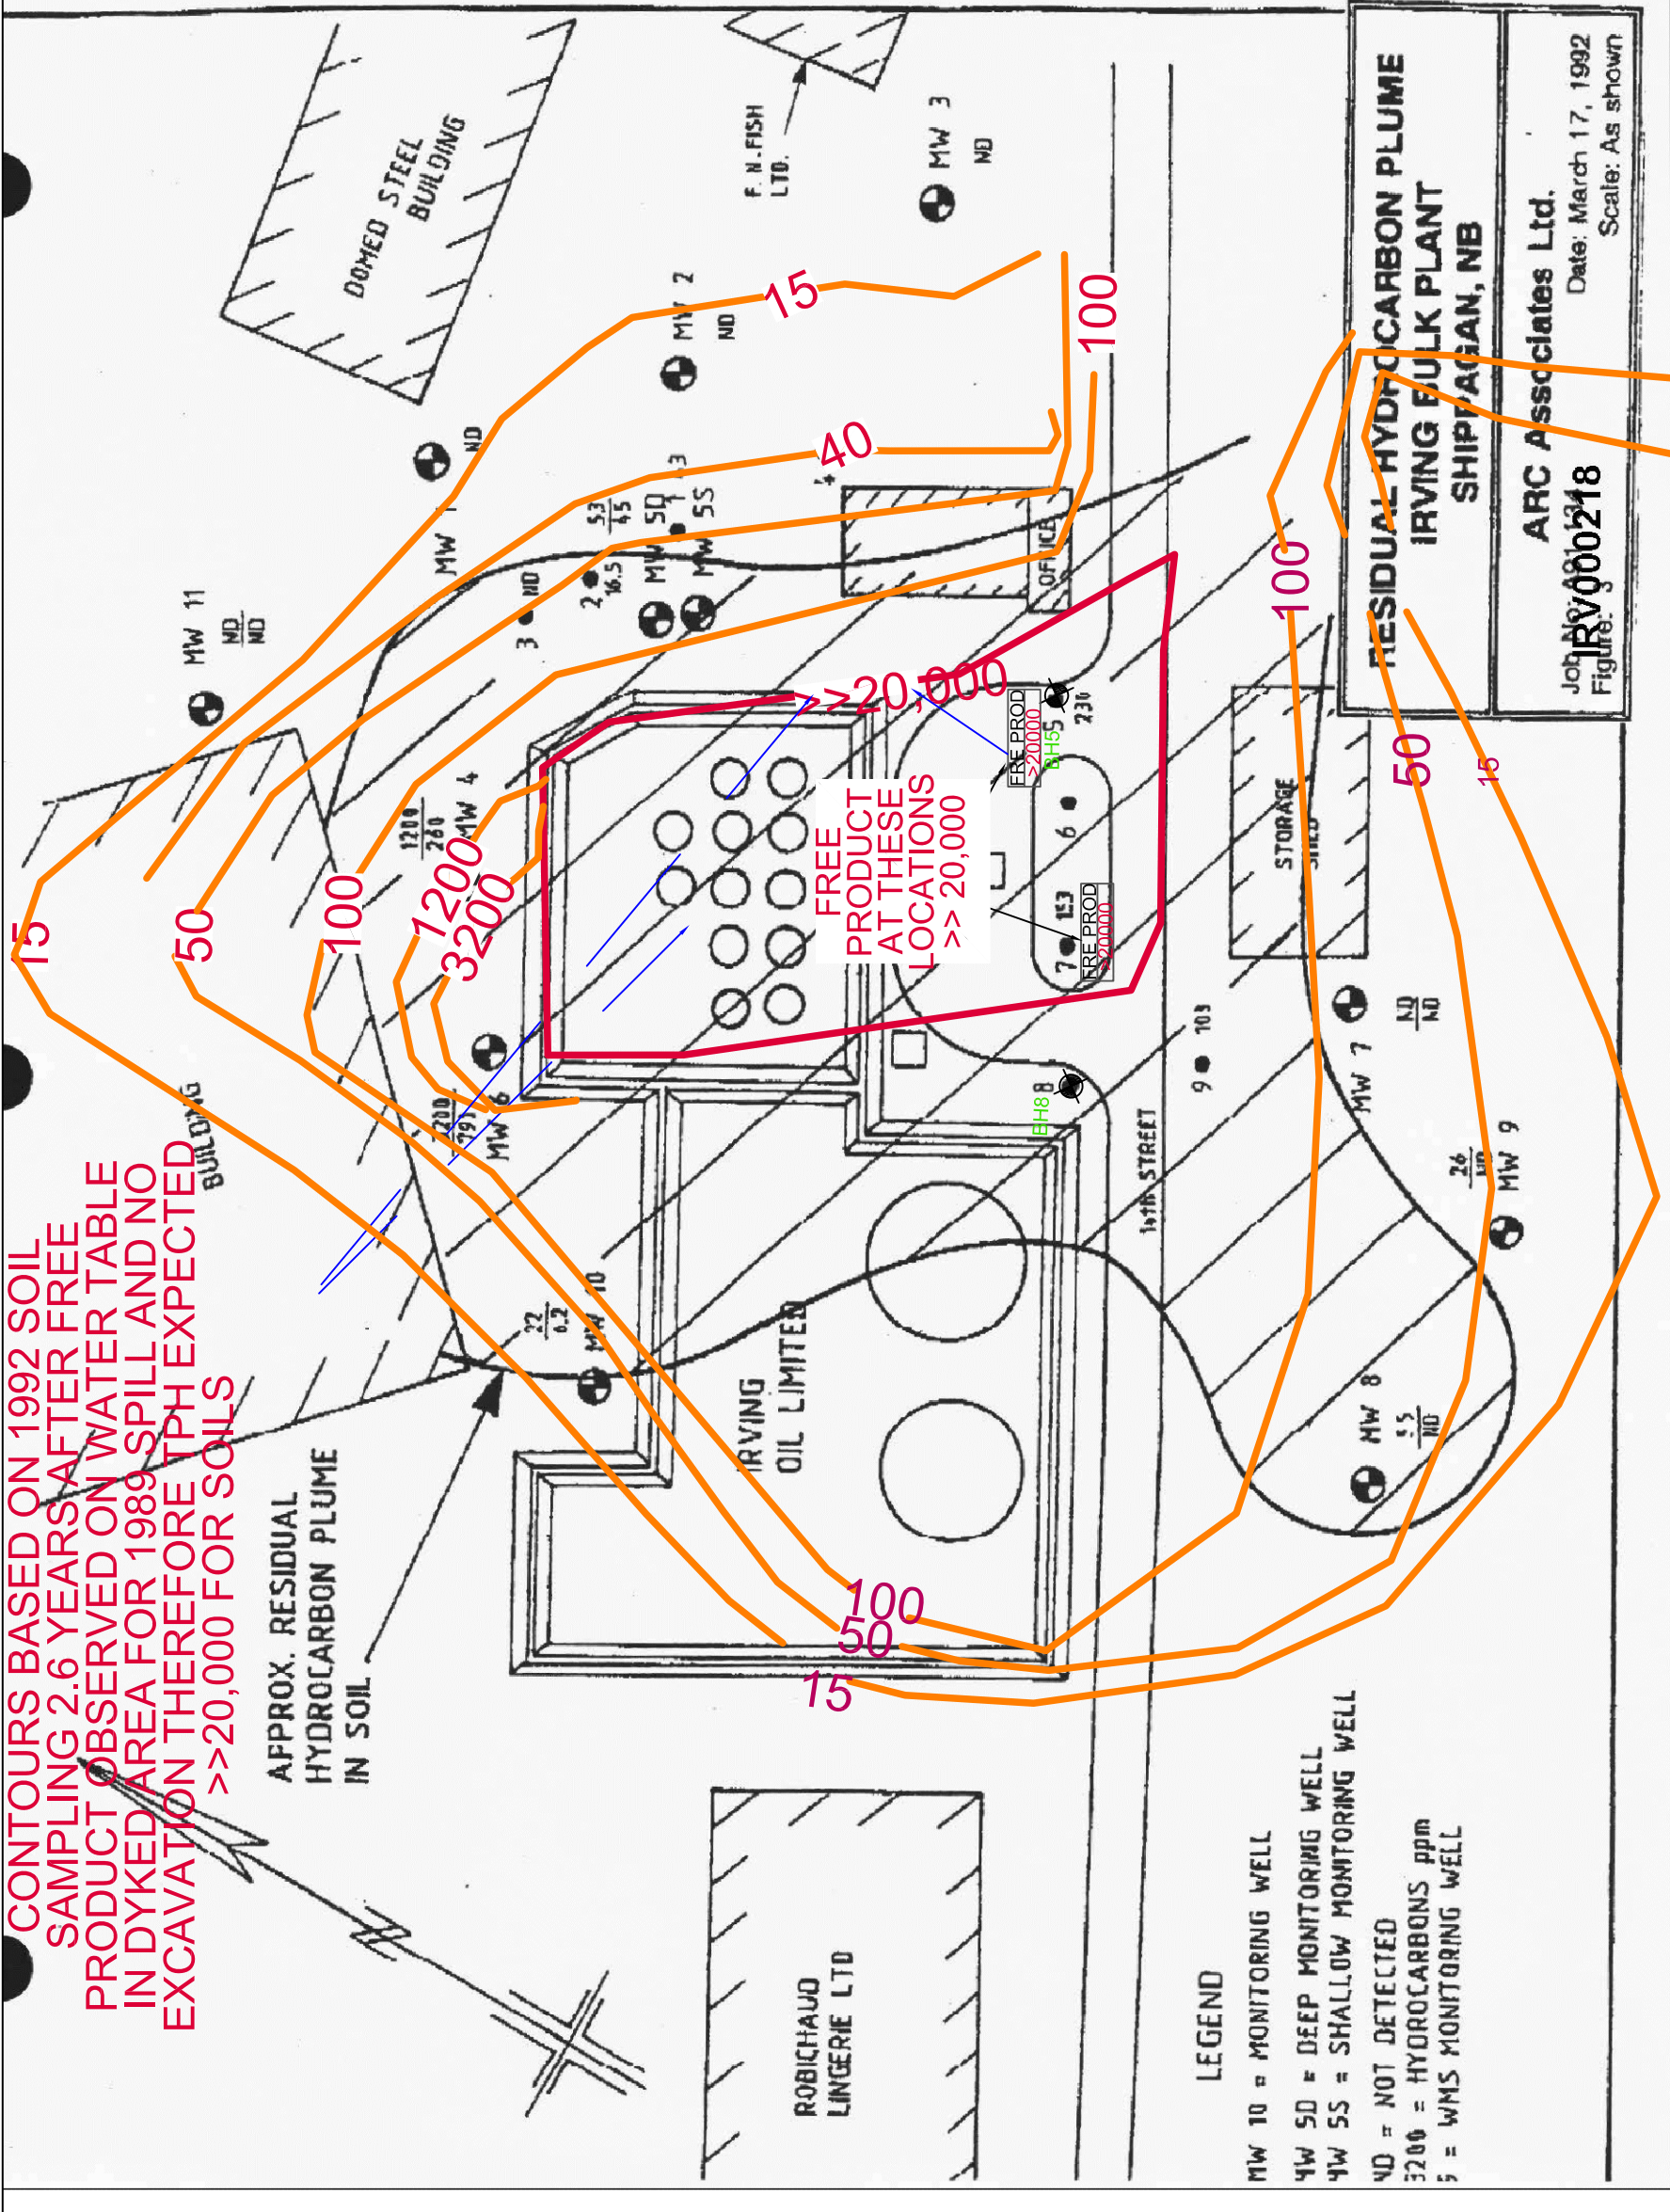
**CONTOURS BASED ON 1992 SOIL SAMPLING 2.6 YEARS AFTER FREE PRODUCT OBSERVED ON WATER TABLE IN DYKED AREA FOR 1989 SPILL AND NO EXCAVATION THEREFORE TPH EXPECTED >>20,000 FOR SOILS**

**APPROX. RESIDUAL HYDROCARBON PLUME IN SOIL**

**FREE PRODUCT AT THESE LOCATIONS >> 20,000**

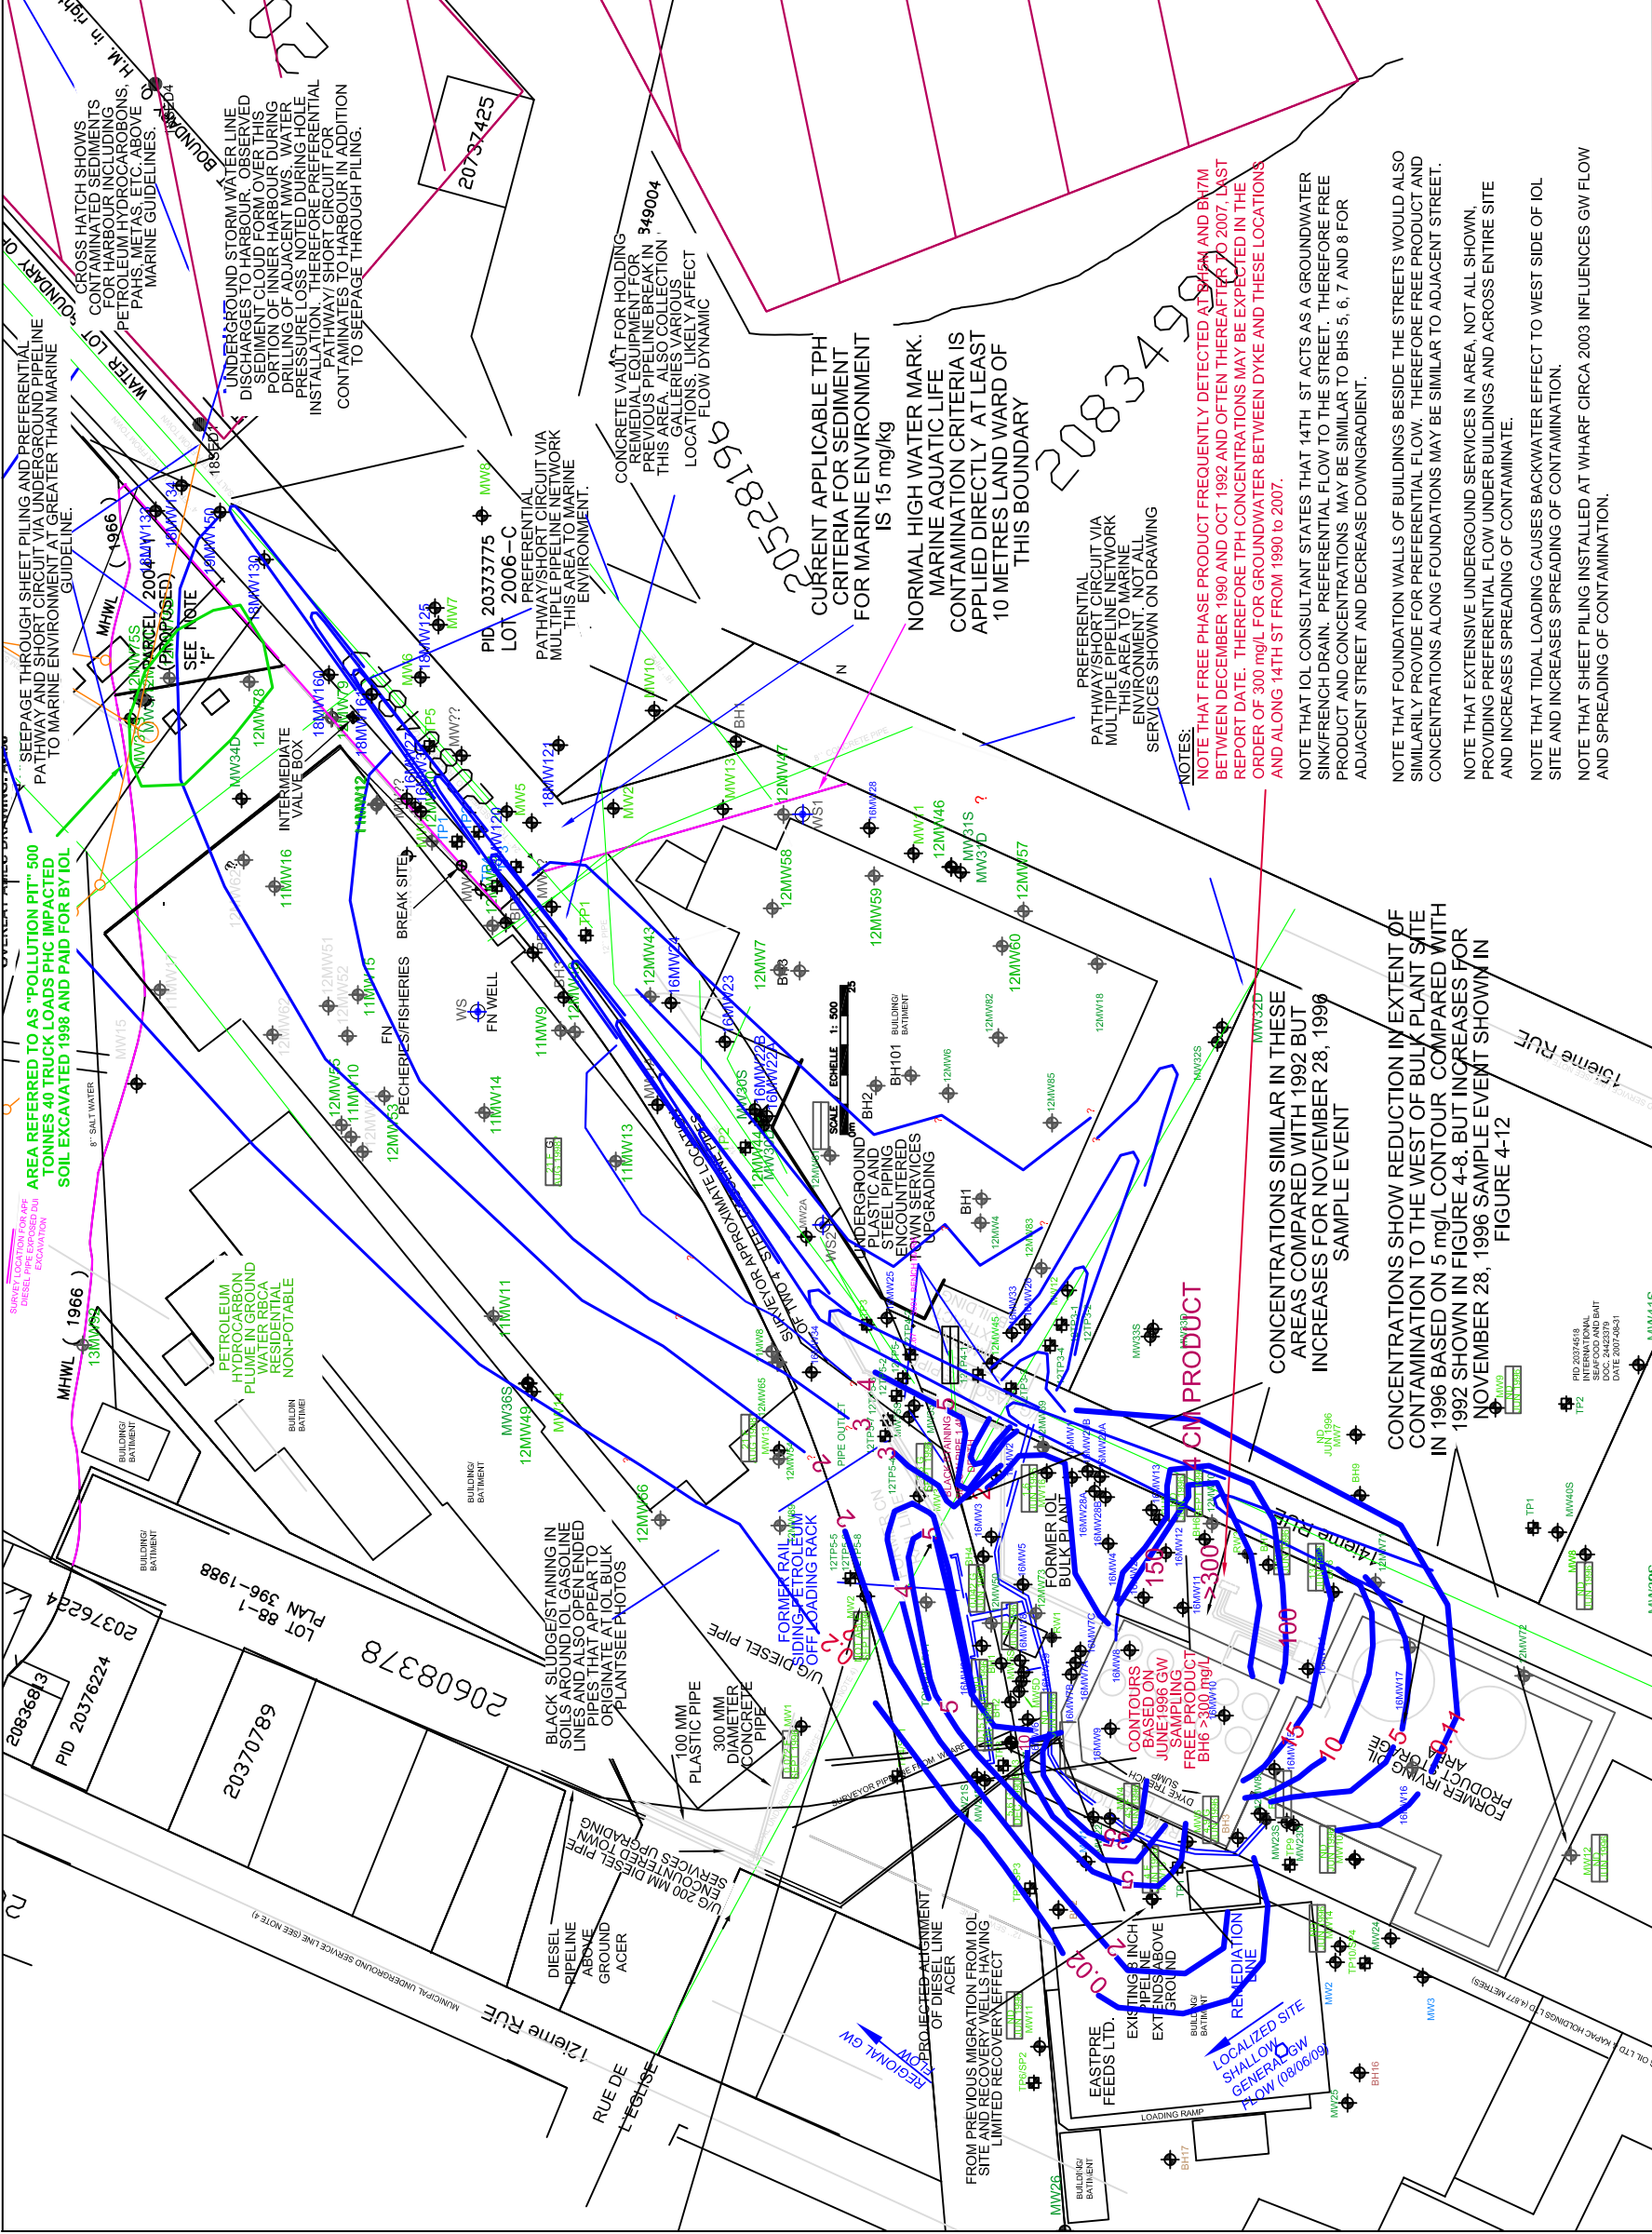
**FIGURE 4-11**

NOTE THAT SHEET PILING INSTALLED AT WHARF CIRCA 2003 INFLUENCES GW FLOW AND SPREADING OF CONTAMINATION.

With the exception of BH5 through BH8 adjacent to 14th St., concentrations were commonly in the 2,000 to 8,000 mg/L range for a number of the perimeter wells as shown on Figure 4-11 for June 1996. However, increases from 40,000 to 90,000 mg/L could occur often with spiked increases of 100,000 mg/L not being uncommon. However, major increases were also noted periodically but with results for November 28, 1996 being unusually notable. Free product was reported for BH6 between June and November 1996, with adjacent BH7 ranging from 119,000 mg/L in June to a low of 57,000 mg/L for September 4<sup>th</sup> sampling and then spiked to 310,000 mg/L on November 28, 1996. Spikes also occurred for the November 28, 1996 sampling with values at MW15 showing 200,000 mg/L compared with a value of 4mg/L in June and MW4 spiking from 43 to 130 mg/L.

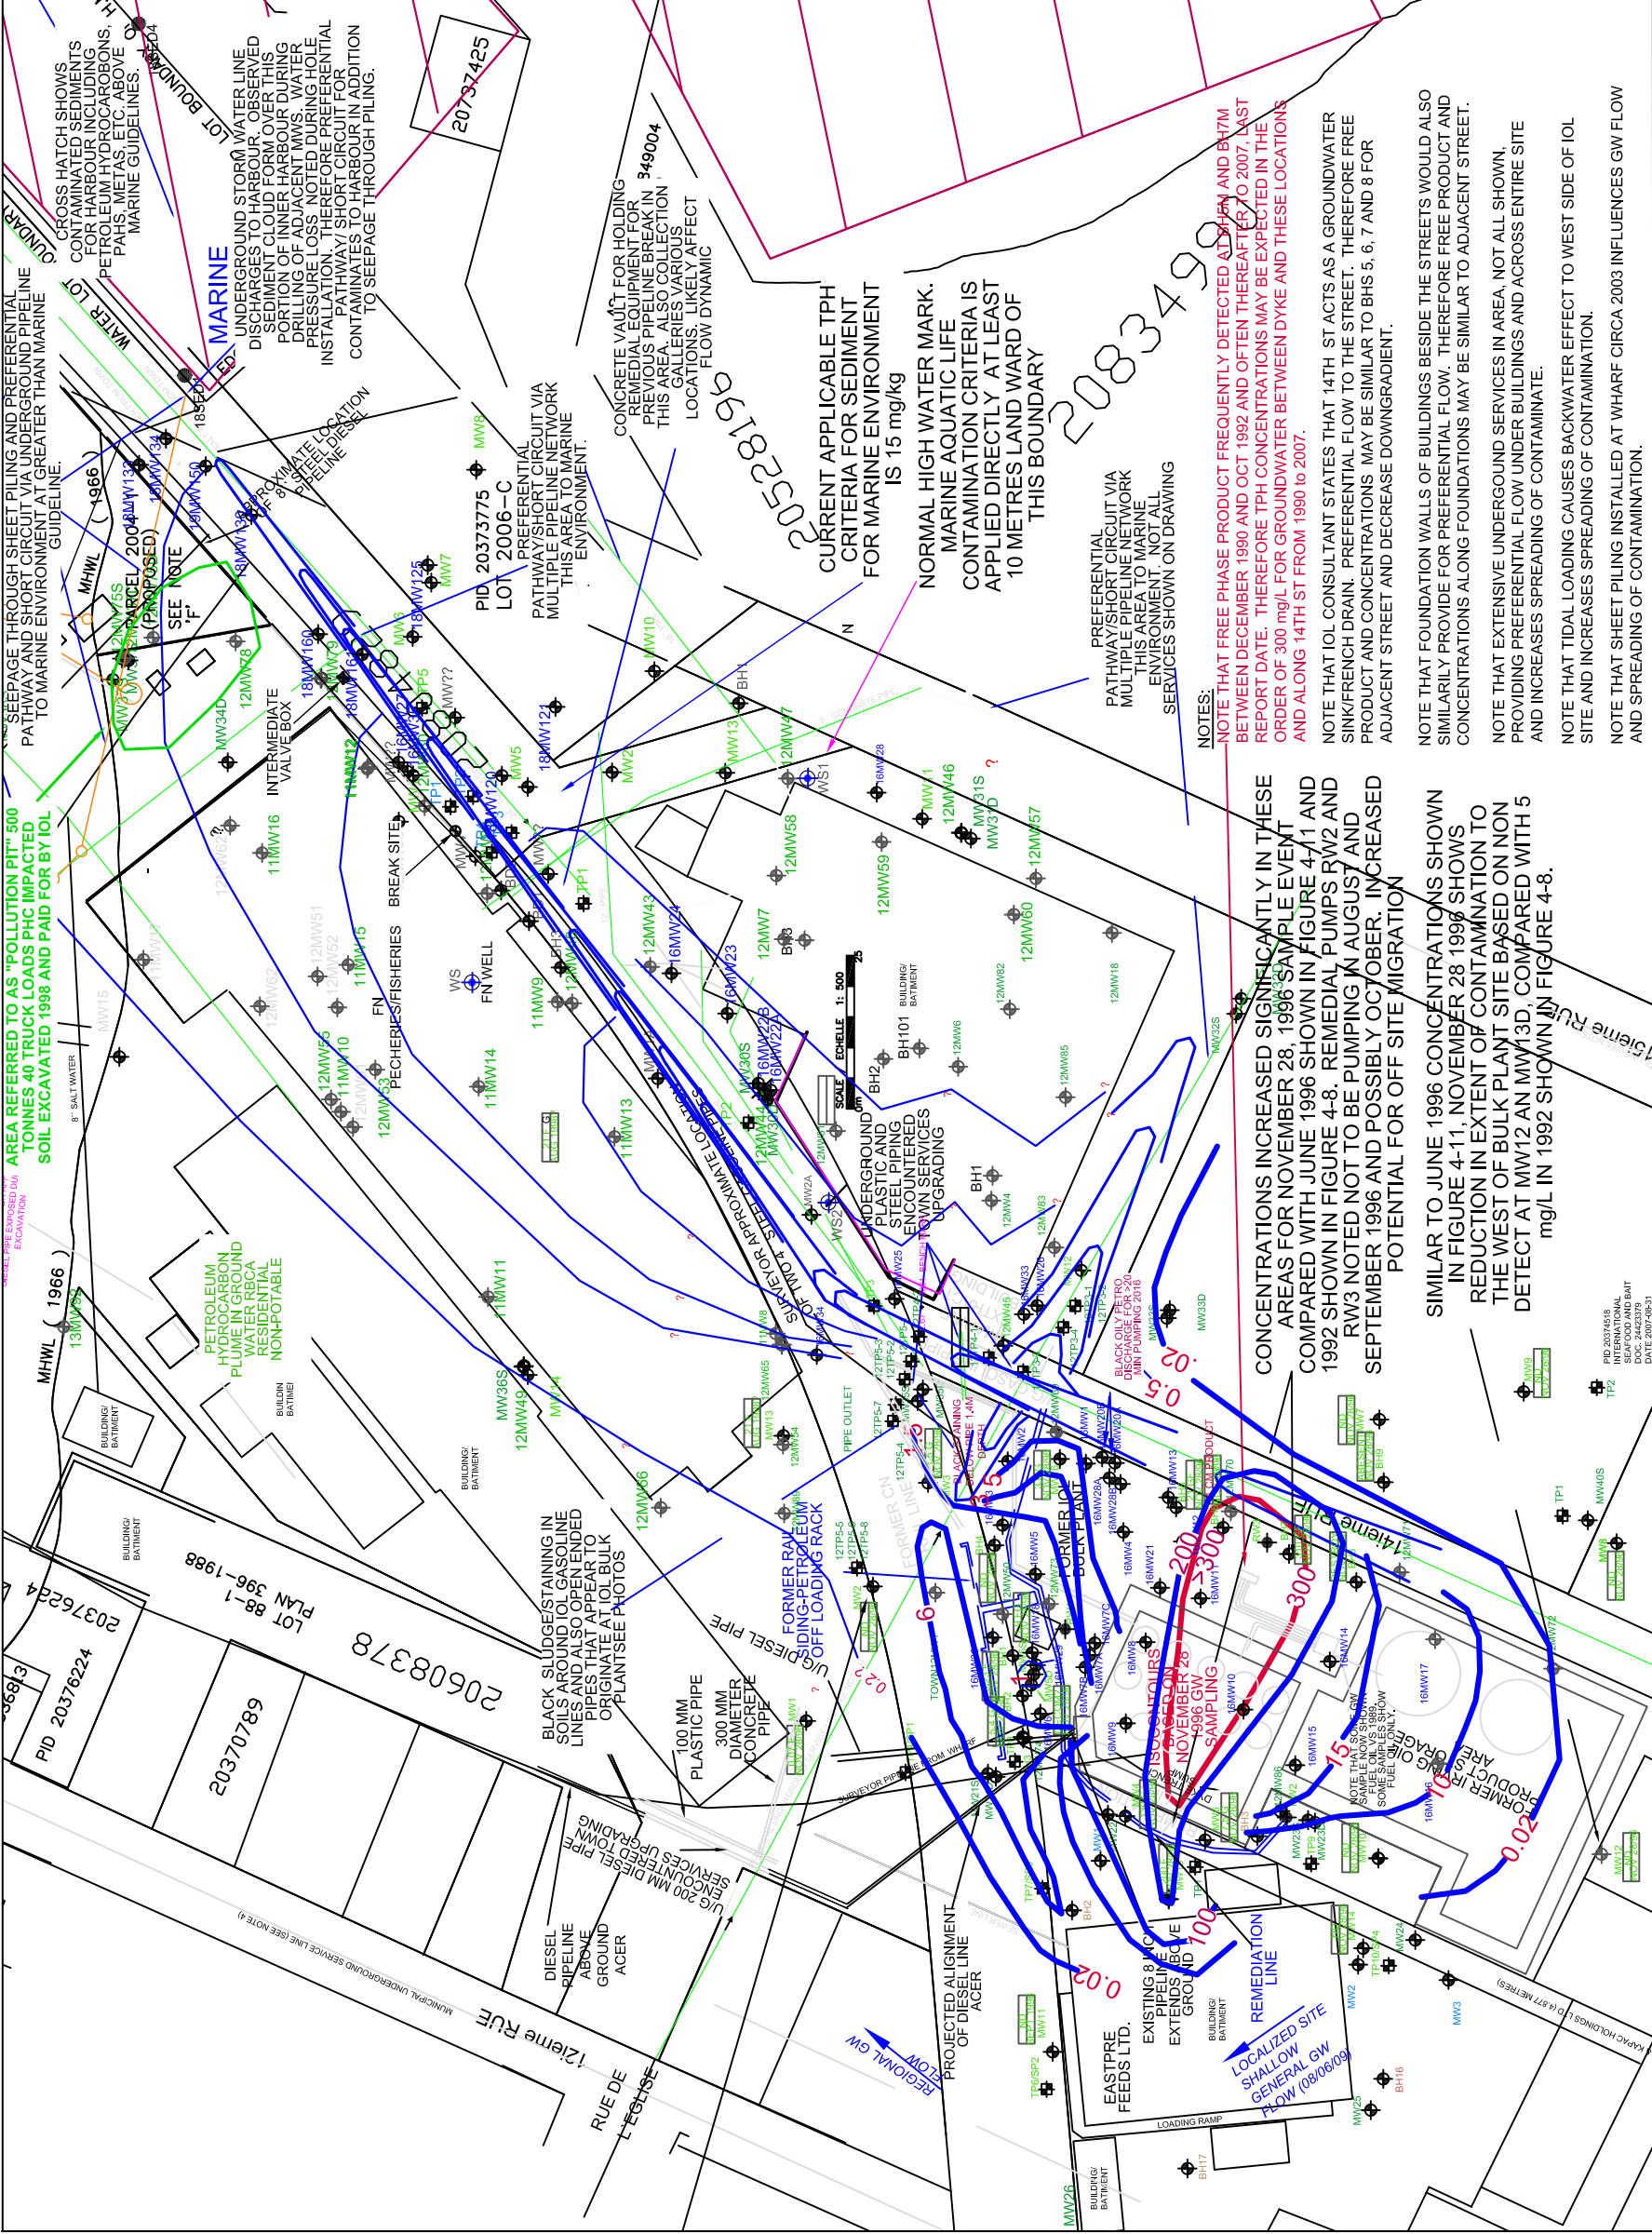
**FIGURE 4-12**  
 TPH CONTAMINATE CONTOURS FOR GROUNDWATER FOR IOL SITE NOVEMBER 1996 SHOWING INCREASED CONCENTRATIONS BUT REDUCED CONTAMINATION FOOTPRINT ALSO SHOWN IN FIGURE 4-14 AS OVERLAY ON ARC SITE DRAWING

**CONCENTRATIONS INCREASED SIGNIFICANTLY IN THESE AREAS FOR NOVEMBER 28, 1996 SAMPLE EVENT COMPARED WITH JUNE 1996 SHOWN IN FIGURE 4-11 AND 1992 SHOWN IN FIGURE 4-8. REMEDIAL PUMPS RW2 AND RW3 NOTED NOT TO BE PUMPING IN AUGUST AND SEPTEMBER 1996 AND POSSIBLY OCTOBER. INCREASED POTENTIAL FOR OFF SITE MIGRATION**

**SIMILAR TO JUNE 1996 CONCENTRATIONS SHOWN IN FIGURE 4-11, NOVEMBER 28 1996 SHOWS REDUCTION IN EXTENT OF CONTAMINATION TO THE WEST OF BULK PLANT SITE BASED ON NON DETECT AT MW12 AN MW3D, COMPARED WITH 5 mg/L IN 1992 SHOWN IN FIGURE 4-8.**

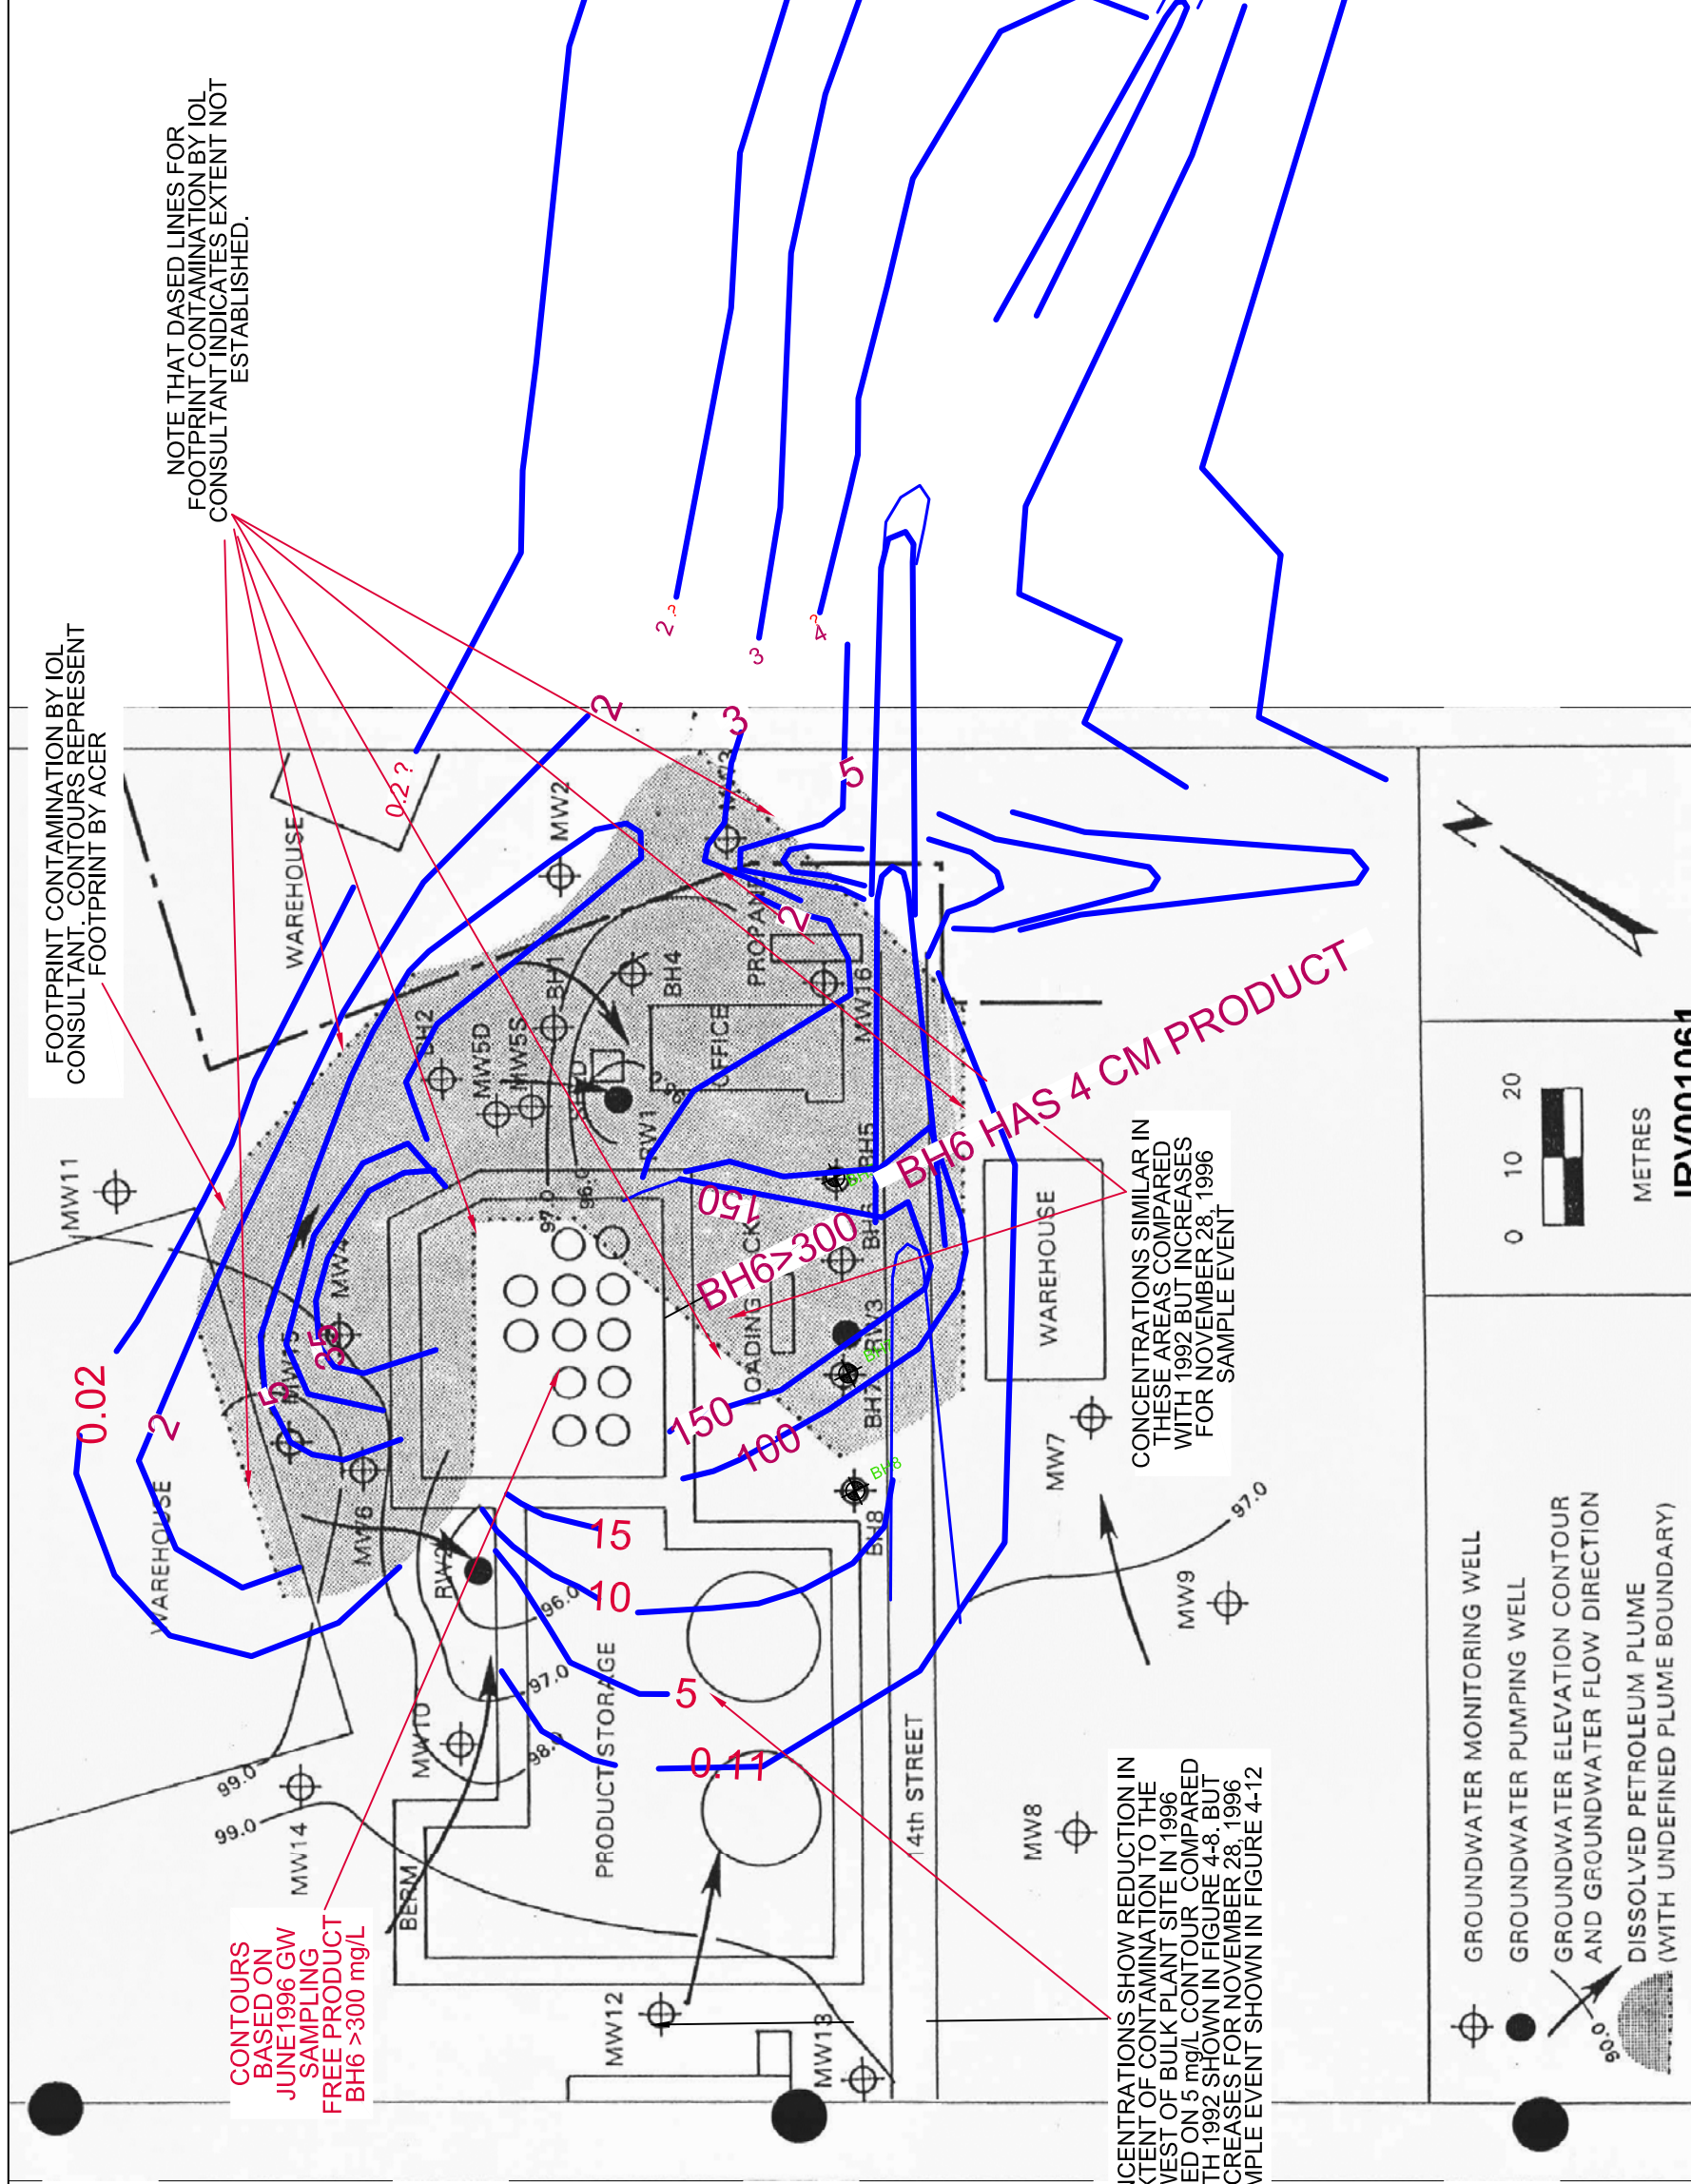
FIGURE 4-13  
TPH CONTAMINATE CONTOURS FOR GROUNDWATER FOR IOL SITE JUNE 1996 SHOWING REDUCED CONCENTRATION AND CONTAMINATION FOOTPRINT TO 1992 FROM ACER FIGURE 4-11 AS OVERLAY ON ARC SITE DRAWING

CONCENTRATIONS SHOW REDUCTION IN EXTENT OF CONTAMINATION TO THE WEST OF BULK PLANT SITE IN 1996 BASED ON 5 mg/L CONTOUR COMPARED WITH 1992 SHOWN IN FIGURE 4-8. BUT INCREASES FOR NOVEMBER 28, 1996 SAMPLE EVENT SHOWN IN FIGURE 4-12

CONCENTRATIONS SIMILAR IN THESE AREAS COMPARED WITH 1992 BUT INCREASES FOR NOVEMBER 28, 1996 SAMPLE EVENT

CONCENTRATIONS INCREASED SIGNIFICANTLY IN THESE AREAS FOR NOVEMBER 28, 1996 SAMPLE EVENT COMPARED WITH JUNE 1996 SHOWN IN FIGURE 4-11 AND 1992 SHOWN IN FIGURE 4-8. REMEDIAL PUMPS RW2 AND RW3 NOTED NOT TO BE PUMPING IN AUGUST AND SEPTEMBER 1996 AND POSSIBLY OCTOBER. INCREASED POTENTIAL FOR OFF SITE MIGRATION

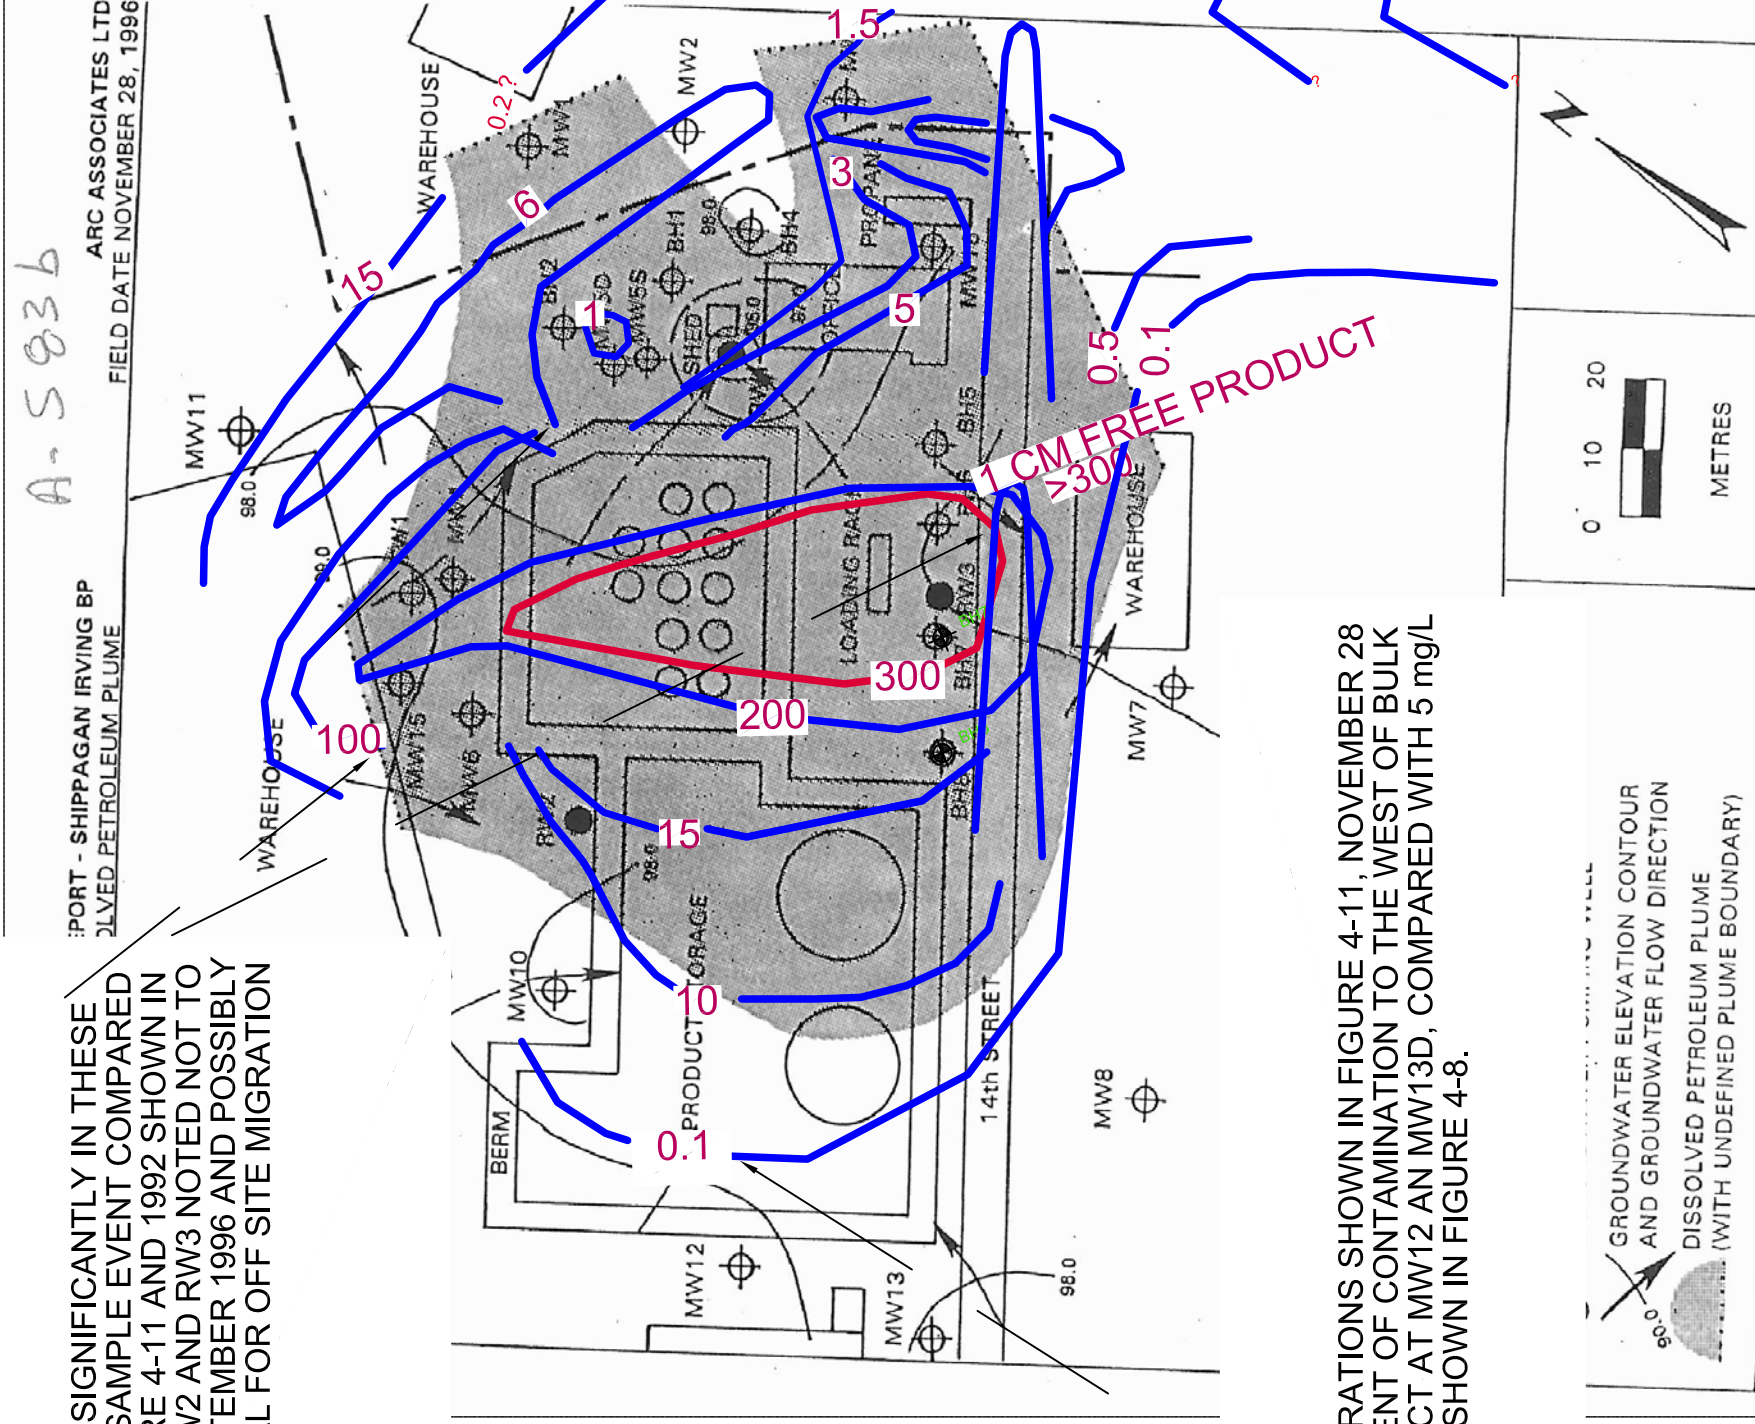
**FIGURE 4-14**

SIMILAR TO JUNE 1996 CONCENTRATIONS SHOWN IN FIGURE 4-11, NOVEMBER 28 1996 SHOWS REDUCTION IN EXTENT OF CONTAMINATION TO THE WEST OF BULK PLANT SITE BASED ON NON DETECT AT MW12 AN MW13D, COMPARED WITH 5 mg/L IN 1992 SHOWN IN FIGURE 4-8.

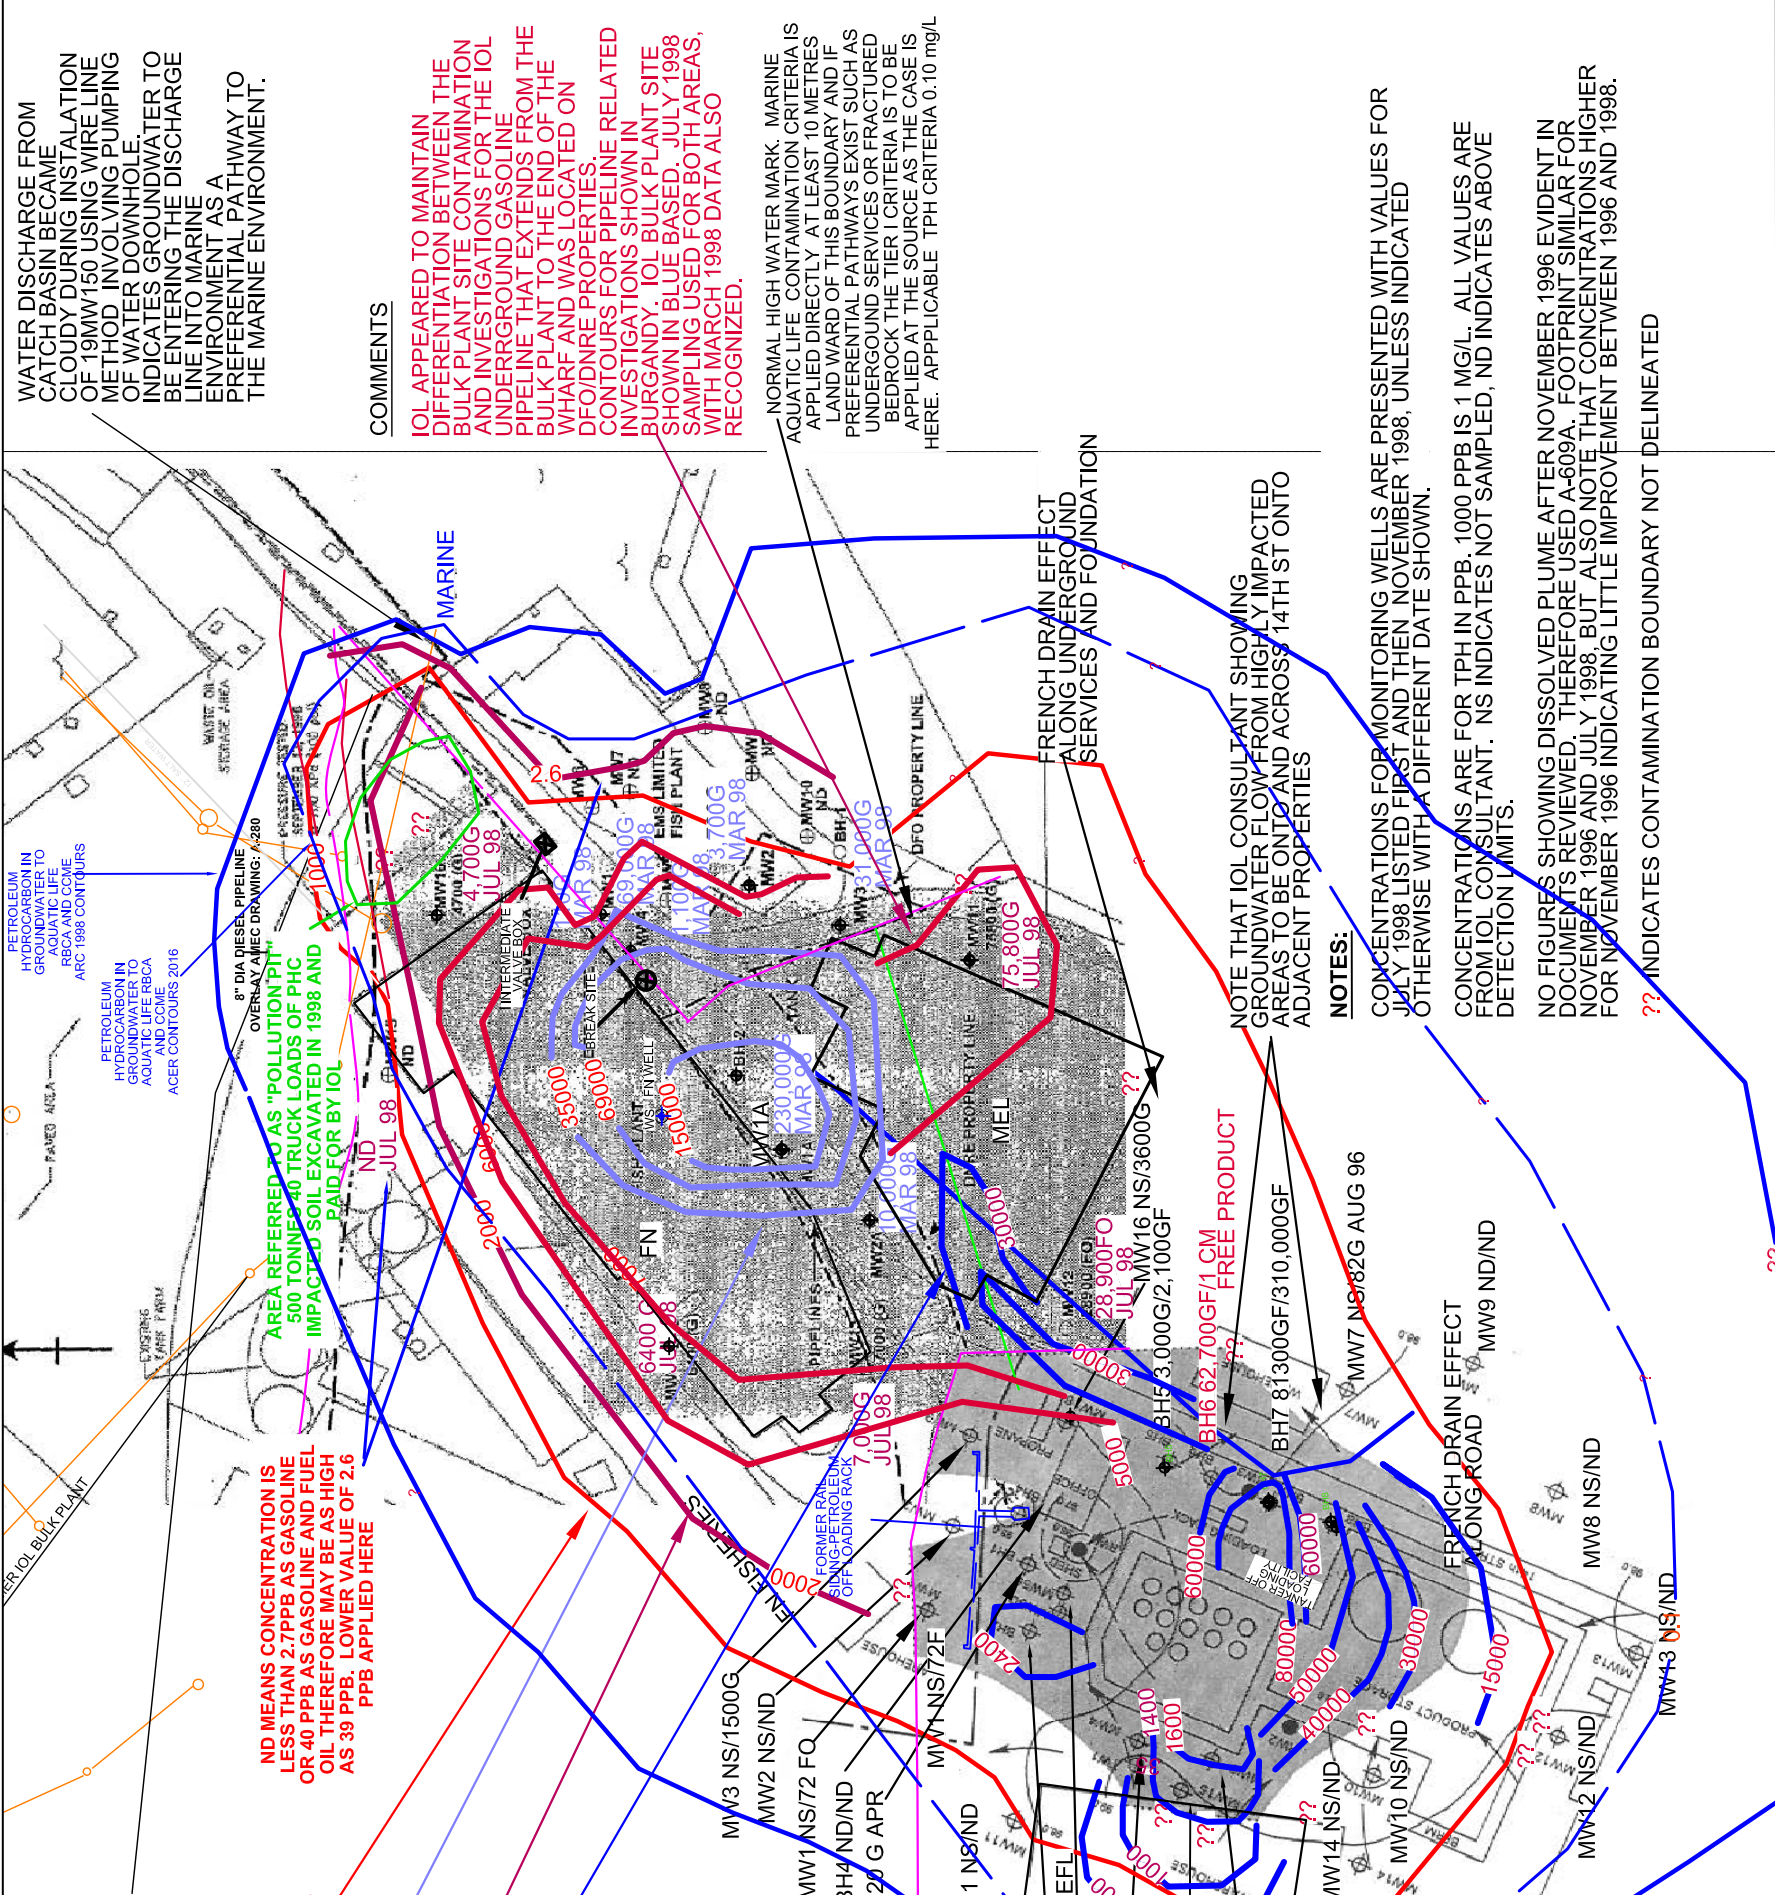
FIGURE 4-16

- as indicated on Figure 4-16, a maximum concentration of 230,000 mg/L was reported adjacent to the pipeline with a peak value of 80,000 mg/L reported for the IOL bulk plant site for the same month, but noting that free product and concentrations of 310,000 mg/L was reported near 14<sup>th</sup> St. for the IOL bulk plant in the previous.

NO FIGURES SHOWING DISSOLVED PLUME AFTER NOVEMBER 1996 EVIDENT IN DOCUMENTS REVIEWED. THEREFORE USED A-609A. FOOTPRINT SIMILAR FOR NOVEMBER 1996 AND JULY 1998. BUT ALSO NOTE THAT CONCENTRATIONS HIGHER FOR NOVEMBER 1996 INDICATING LITTLE IMPROVEMENT BETWEEN 1996 AND 1998.

INDICATES CONTAMINATION BOUNDARY NOT DELINEATED
